VESSEL CORROSION INSPECTION REPORT

Vessel: **Asia Unity**
Area: **MAIN_DECK**
Inspection Photos: **18**

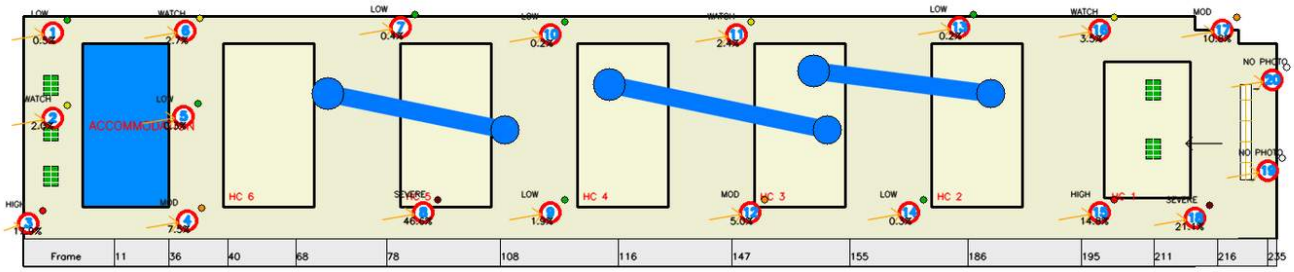
Asia Unity — MAIN DECK CORROSION MAP

20 fixed inspection points aligned to approved main deck reference map

Numbered markers follow the approved 20-point main deck map. White marker means no photo uploaded.

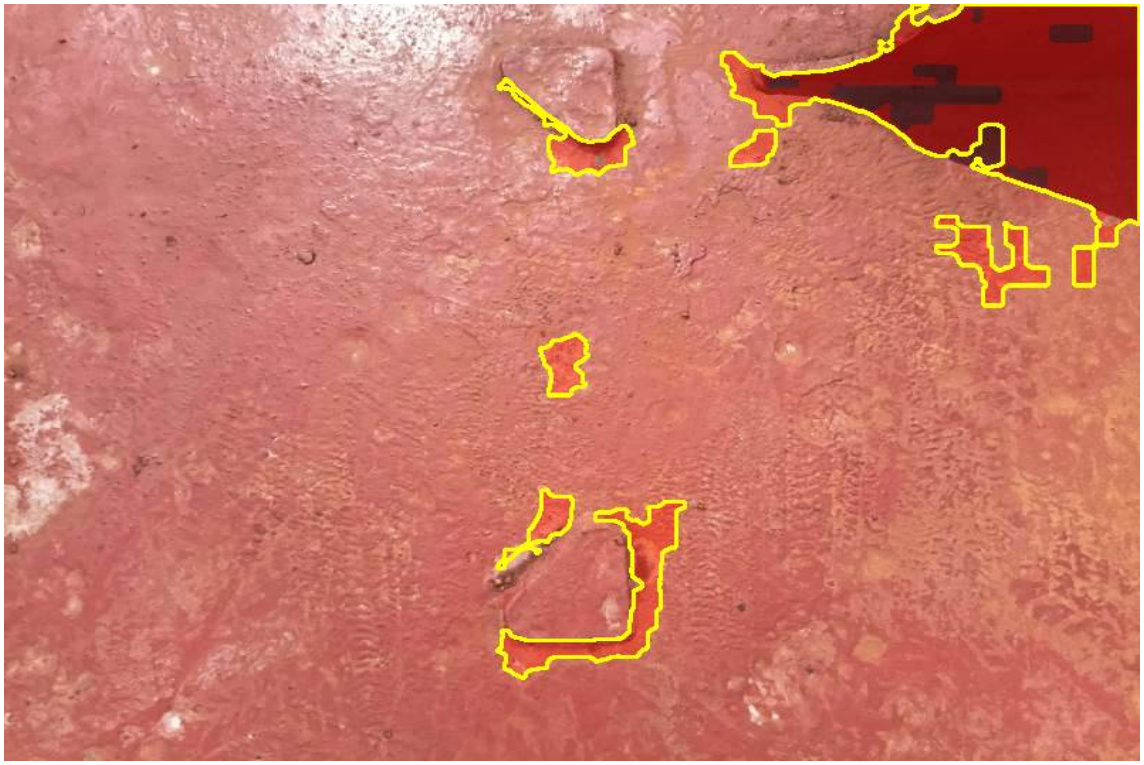
Inspection Photo 4

Location	image12.jpg
Rust %	7.55
Severity	MODERATE

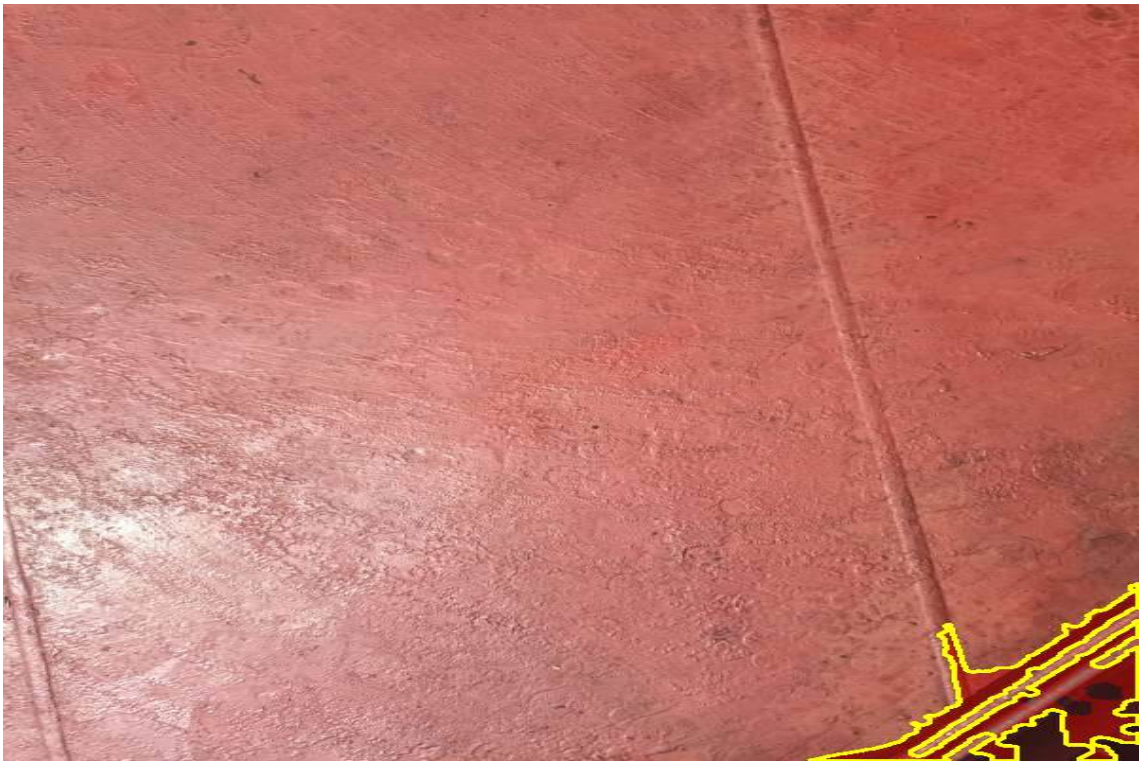
Inspection Photo 9

Location	image18.jpg
Rust %	1.91
Severity	LOW

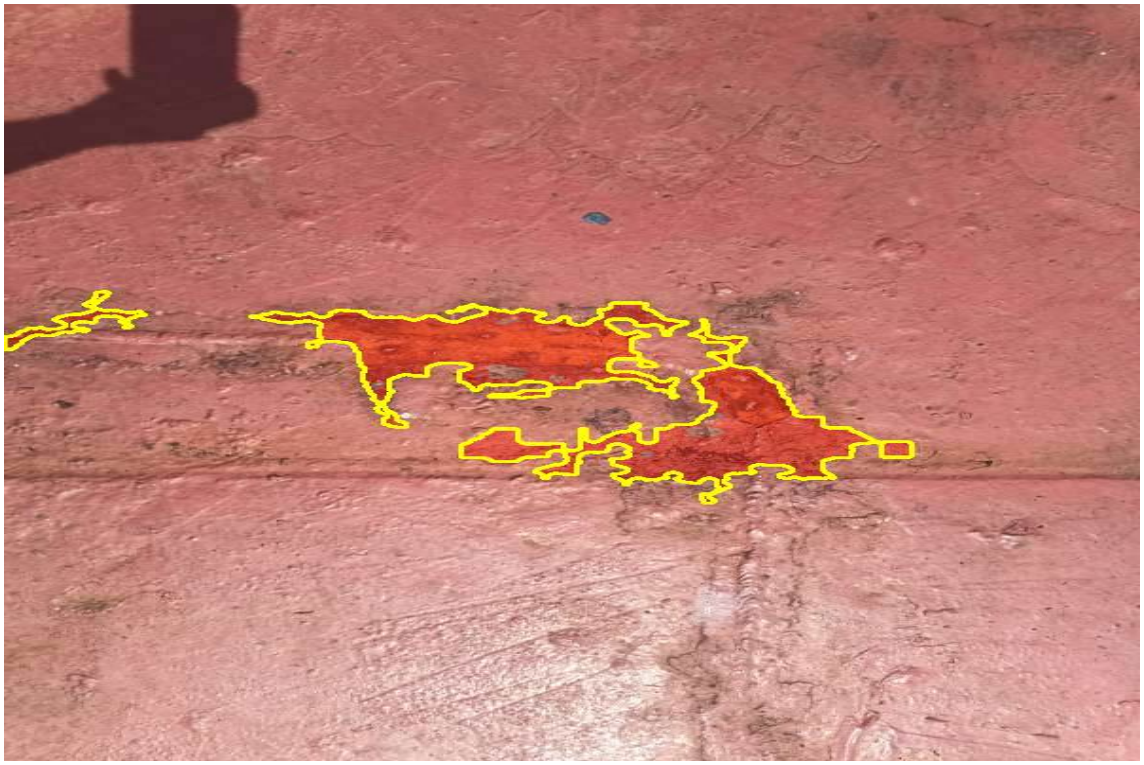
Inspection Photo 12

Location	image20.jpg
Rust %	5.01
Severity	MODERATE

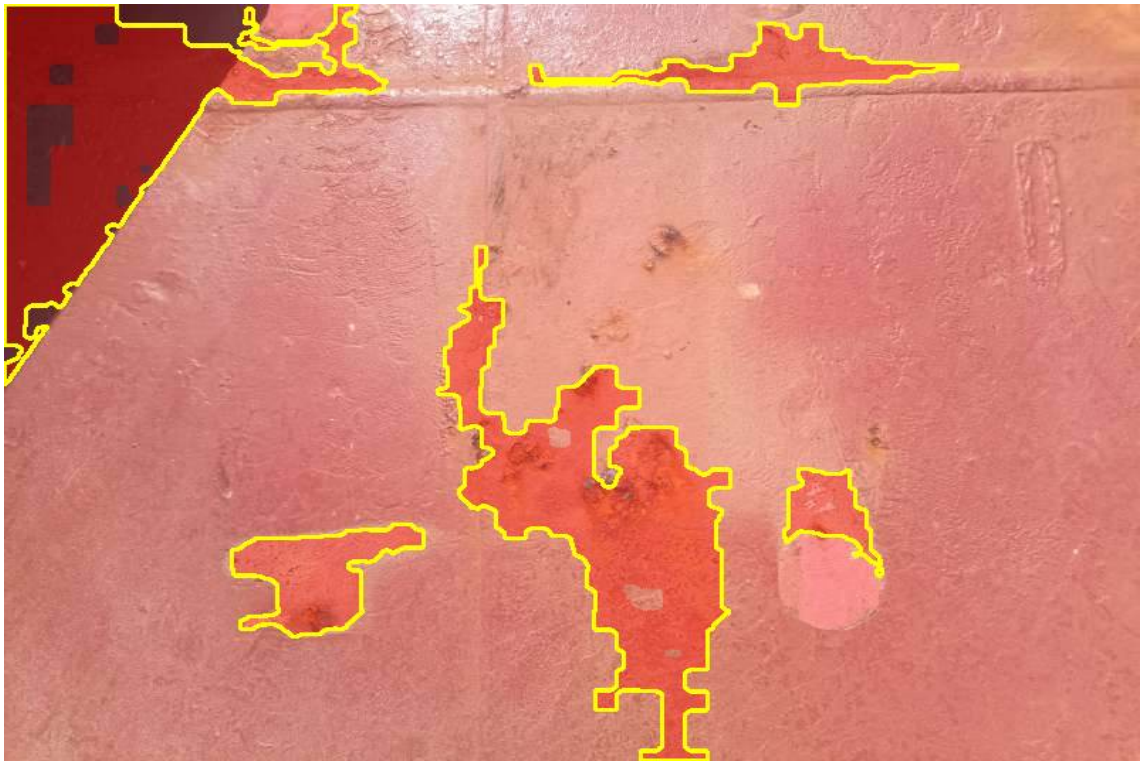
Inspection Photo 15

Location	image6.jpg
Rust %	14.85
Severity	HIGH

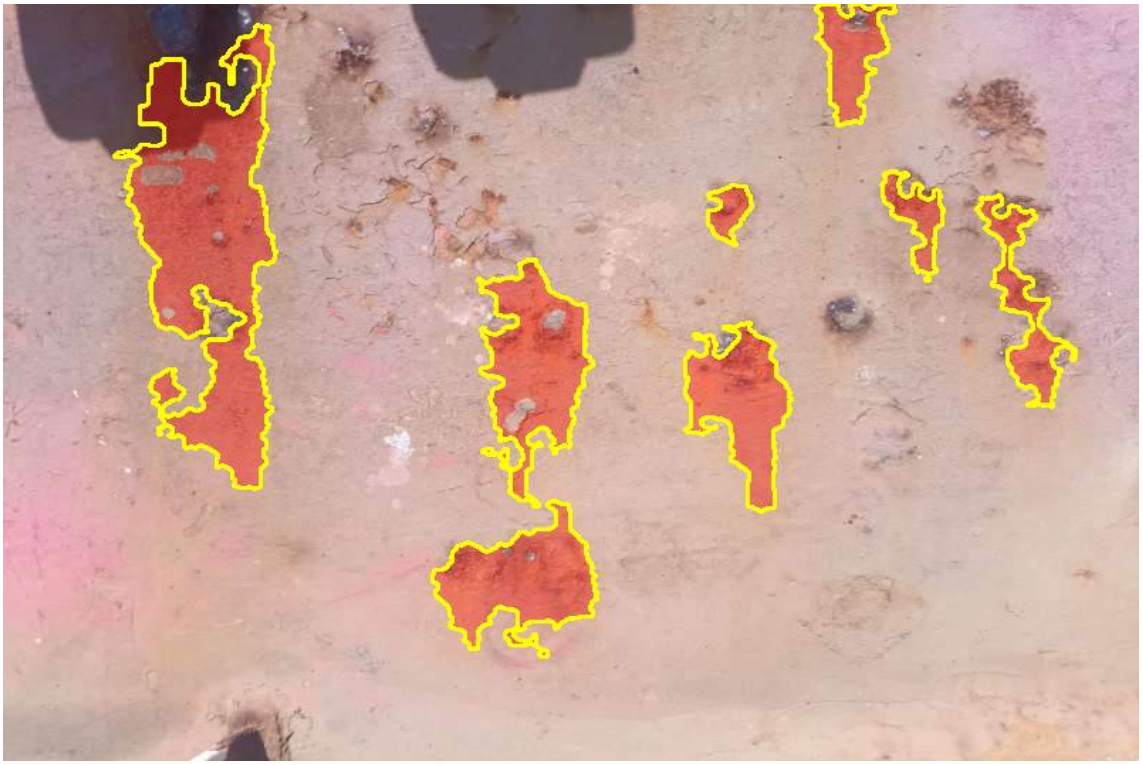
Inspection Photo 17

Location	image8.jpg
Rust %	10.77
Severity	HIGH

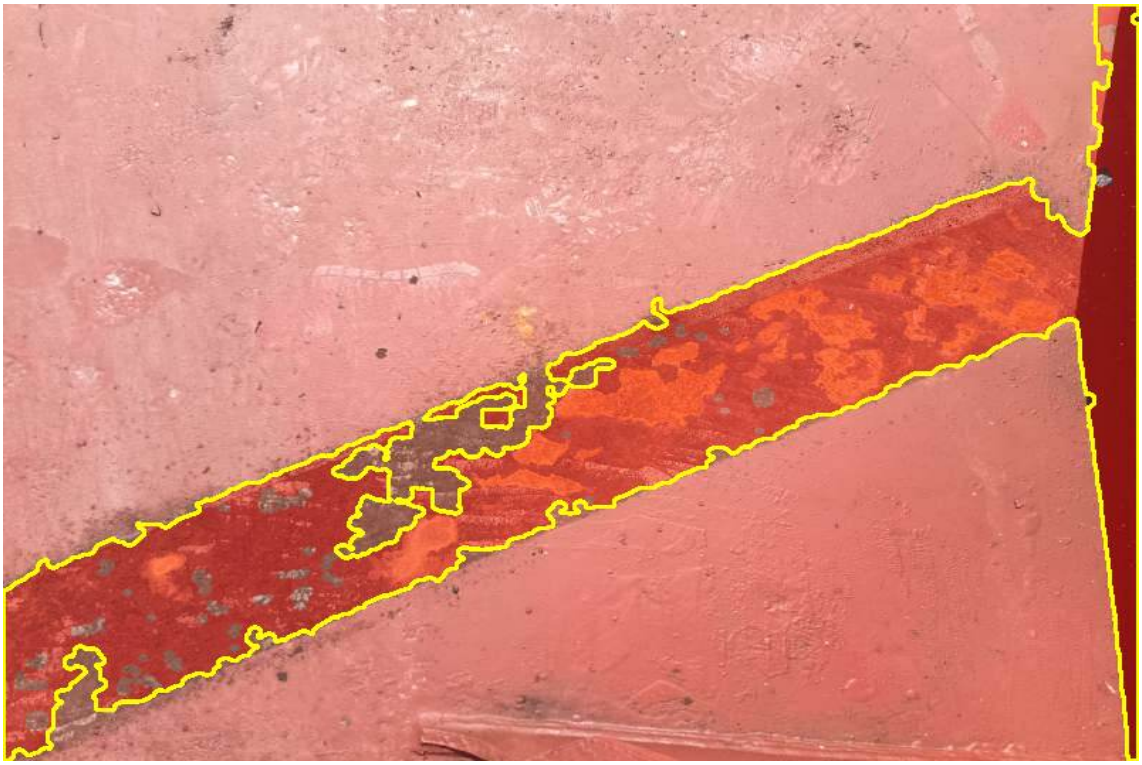
Inspection Photo 18

Location	image9.jpg
Rust %	21.09
Severity	SEVERE
