VESSEL CORROSION INSPECTION REPORT

Vessel: **Batavia Express**
Area: **CARGO_HOLD**
Inspection Photos: **4**

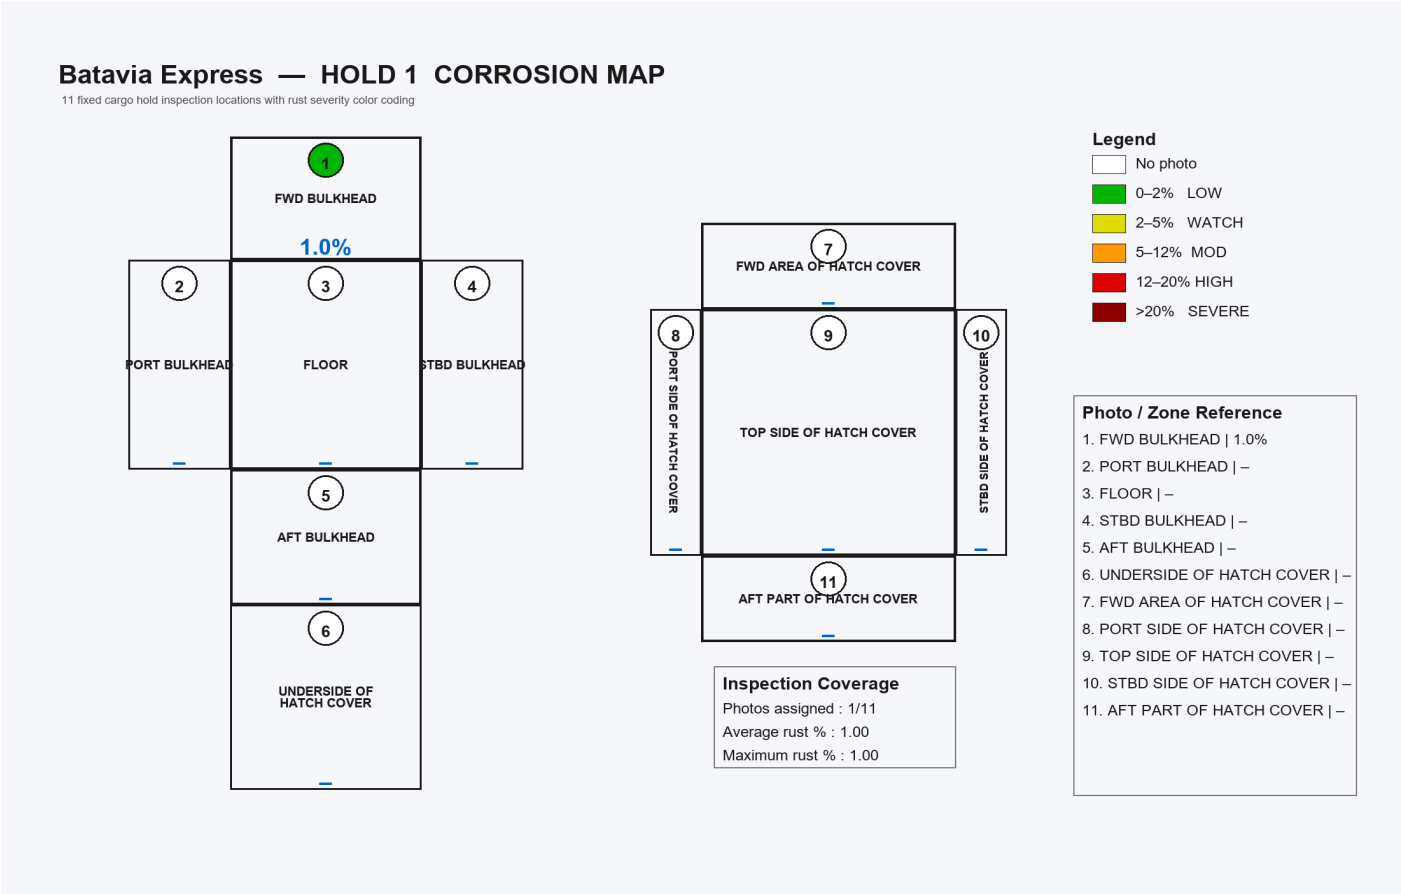
Cargo Hold Corrosion Map - Hold 1

Metric	Value
Inspection Photos	4
Average Rust %	1.7
Maximum Rust %	2.85

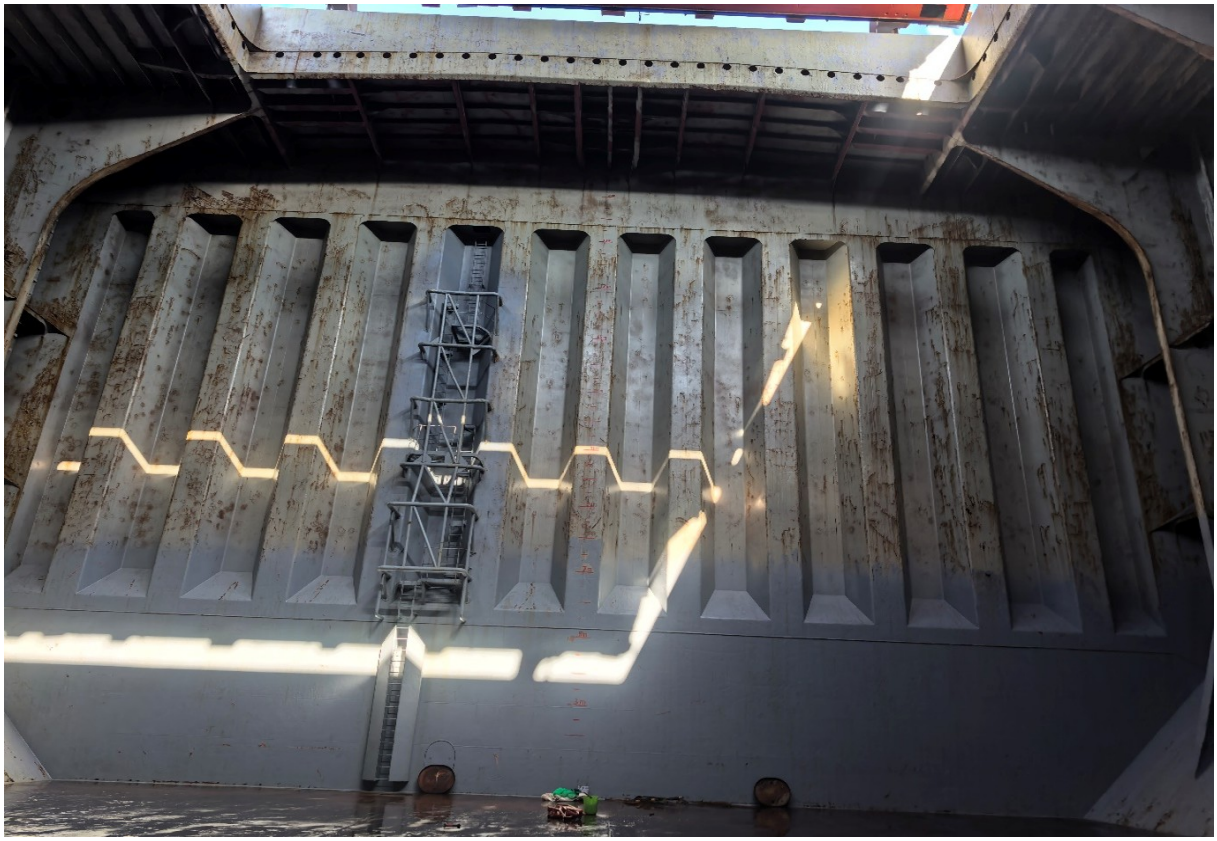
Inspection Photo 4

Location	hold1_fwd_bulkhead
Rust %	1.00
Severity	LOW
Reviewer	-
Notes	-
Reviewed At	2026-03-12T08:21:53.575+00:00
