VESSEL CORROSION INSPECTION REPORT

Vessel: **Eagle Express**
Area: **CARGO_HOLD**
Inspection Photos: **1**

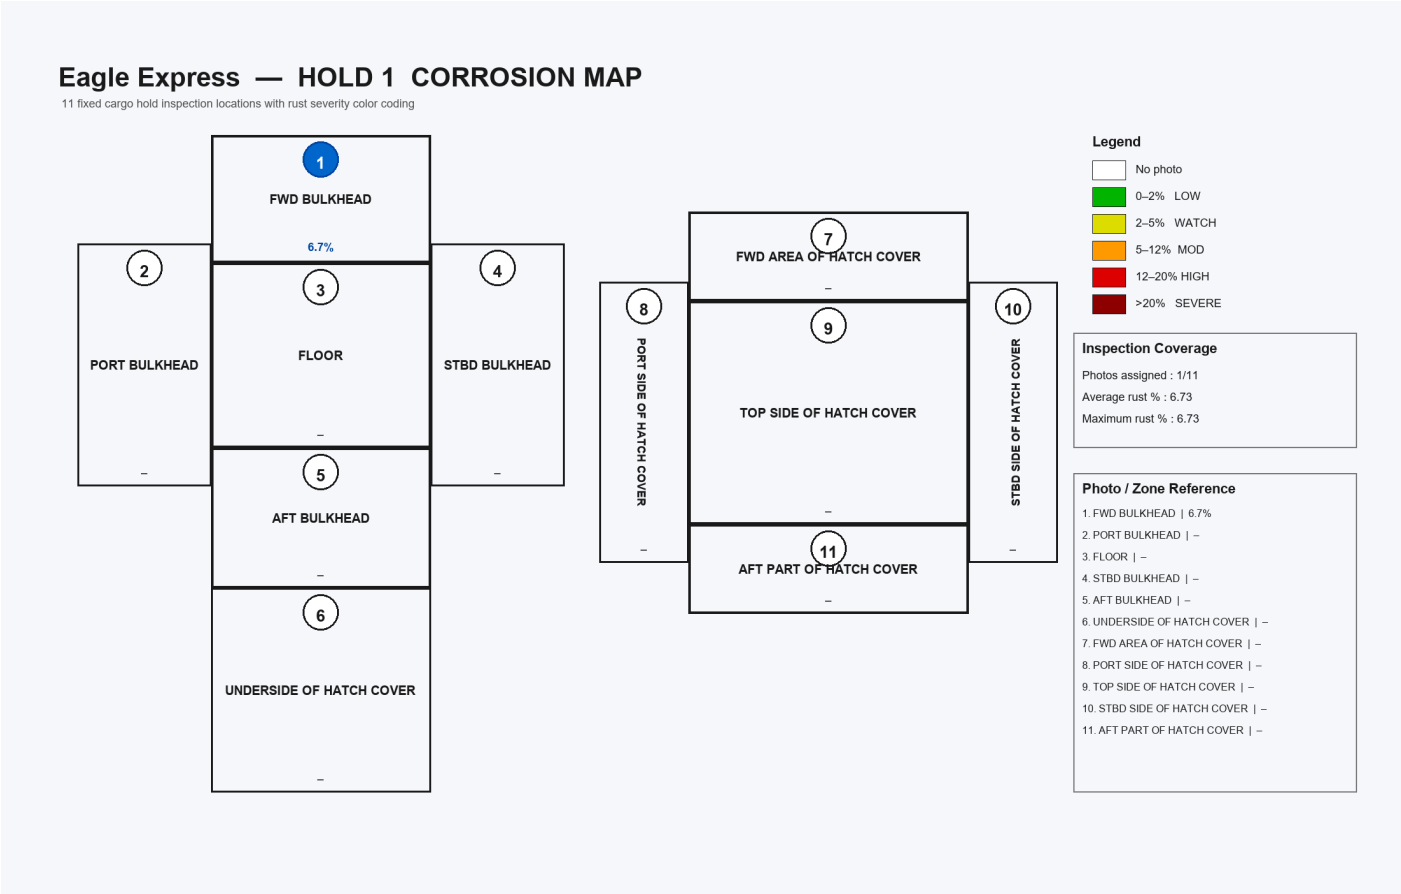
Inspection Photo 1

Location	hold1_fwd_bulkhead
Rust %	6.73
Severity	MODERATE
Reviewer	-
Notes	-
Reviewed At	2026-03-14T01:40:01.403+00:00
