VESSEL CORROSION INSPECTION REPORT

Vessel: **Sumatera Express**
Area: **CARGO_HOLD**
Inspection Photos: **10**

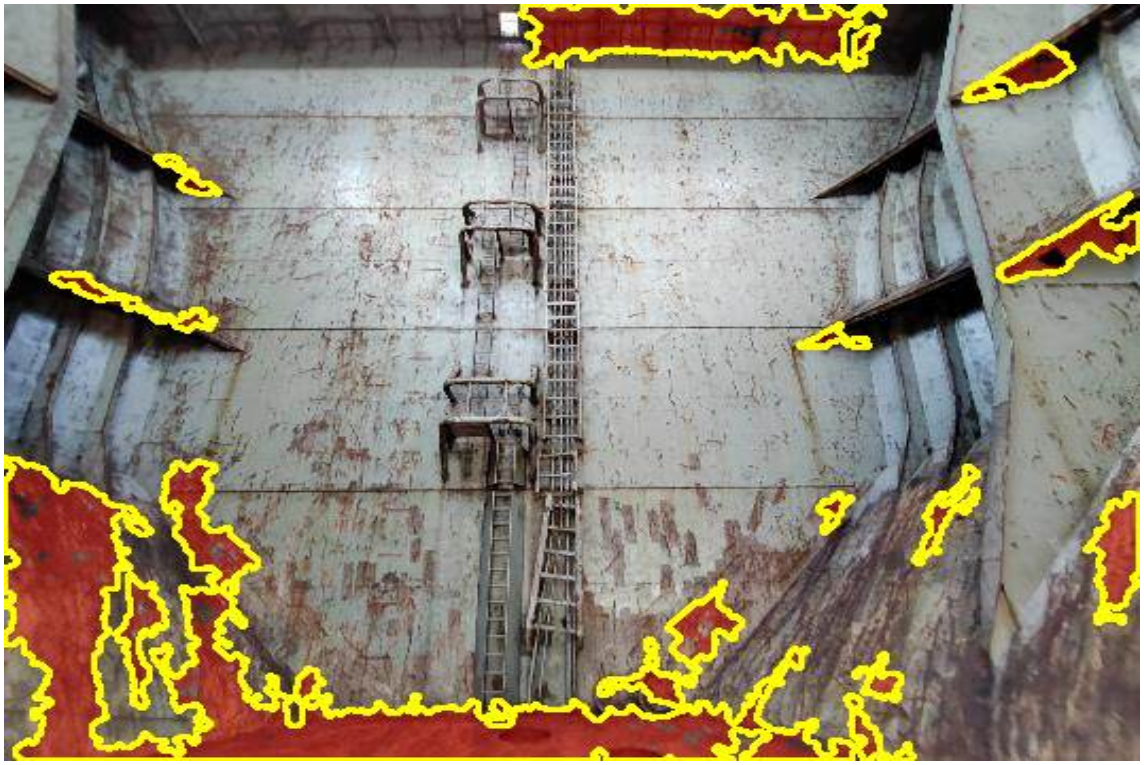
Inspection Photo 1

Location	Hold No. 1_0.jpg
Rust %	13.25
Severity	HIGH

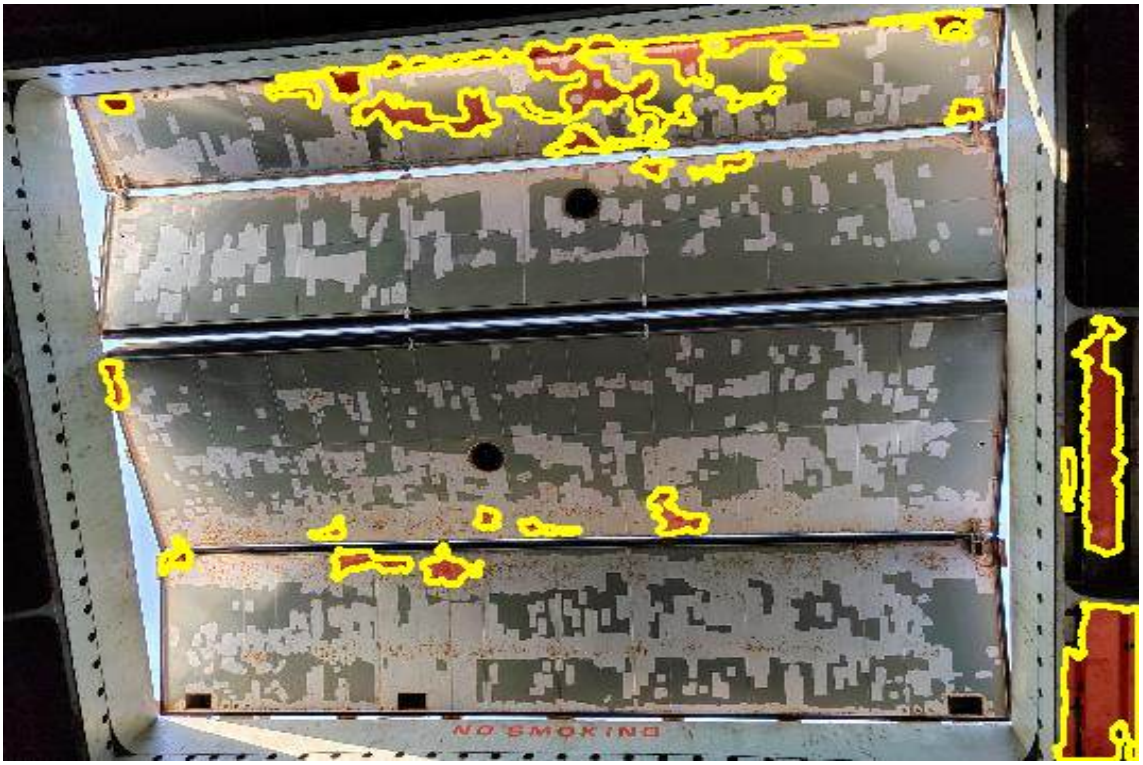
Inspection Photo 6

Location	Hold No. 1_4.jpg
Rust %	5.57
Severity	MODERATE

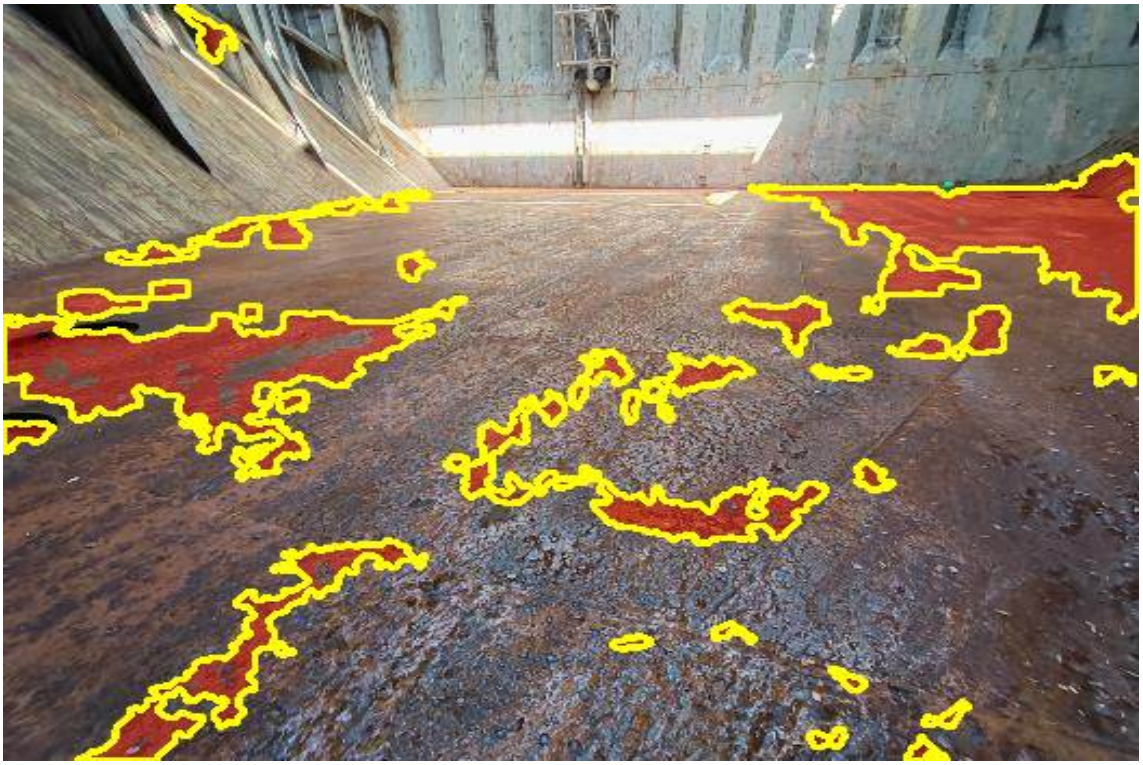
Inspection Photo 7

Location	Hold No. 1_5.jpg
Rust %	12.20
Severity	HIGH
