VESSEL CORROSION INSPECTION REPORT

Vessel: **Sumatera Express**
Area: **CARGO_HOLD**
Inspection Photos: **20**

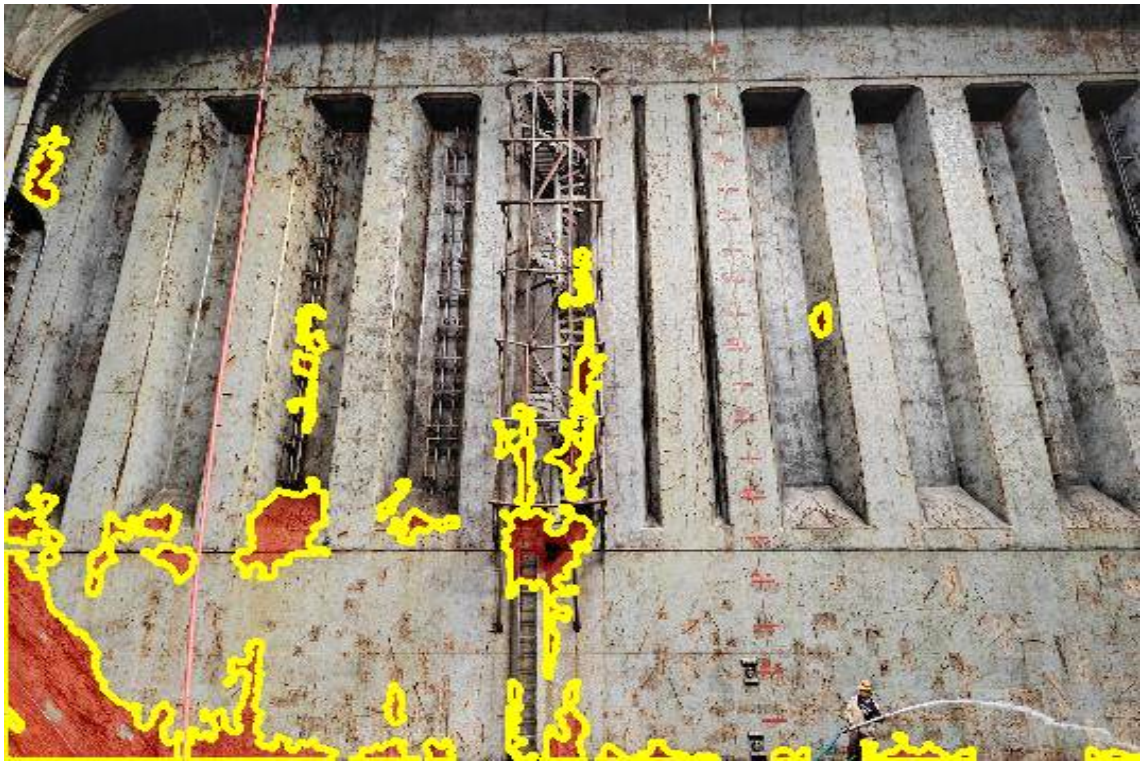
Inspection Photo 11

Location	Hold No. 2_0.jpg
Rust %	6.51
Severity	MODERATE

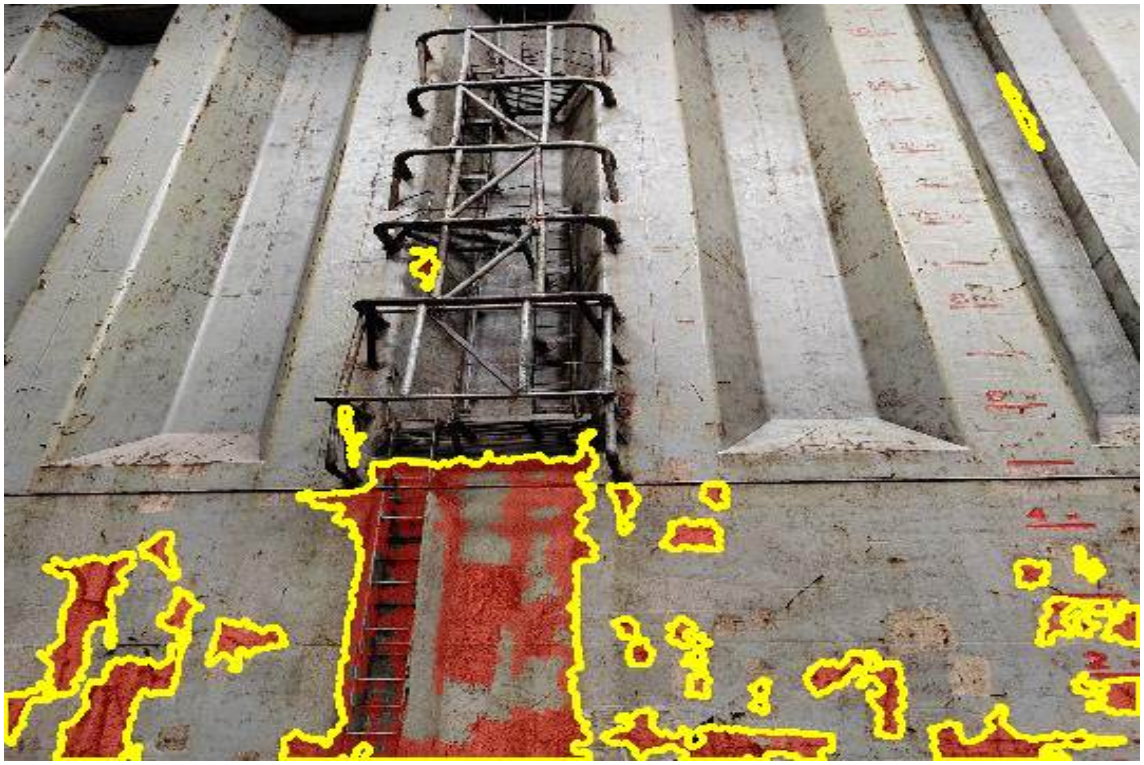
Inspection Photo 12

Location	Hold No. 2_1.jpg
Rust %	10.88
Severity	HIGH

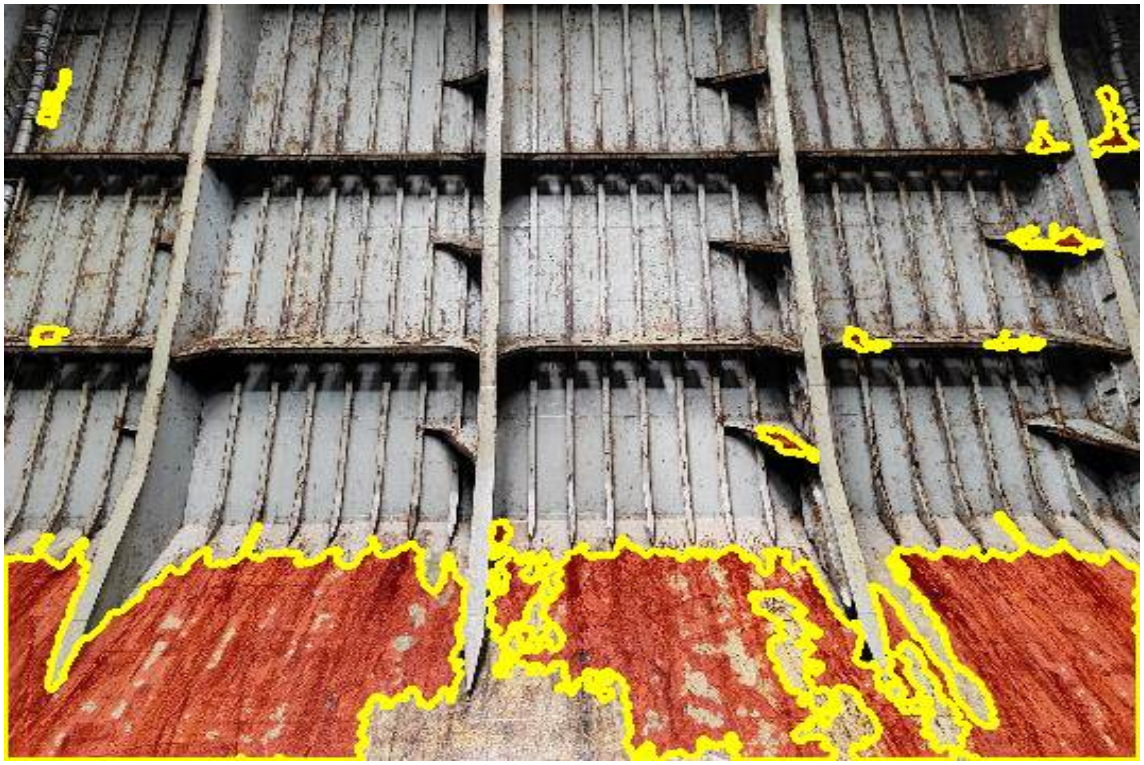
Inspection Photo 15

Location	Hold No. 2_3.jpg
Rust %	20.34
Severity	SEVERE

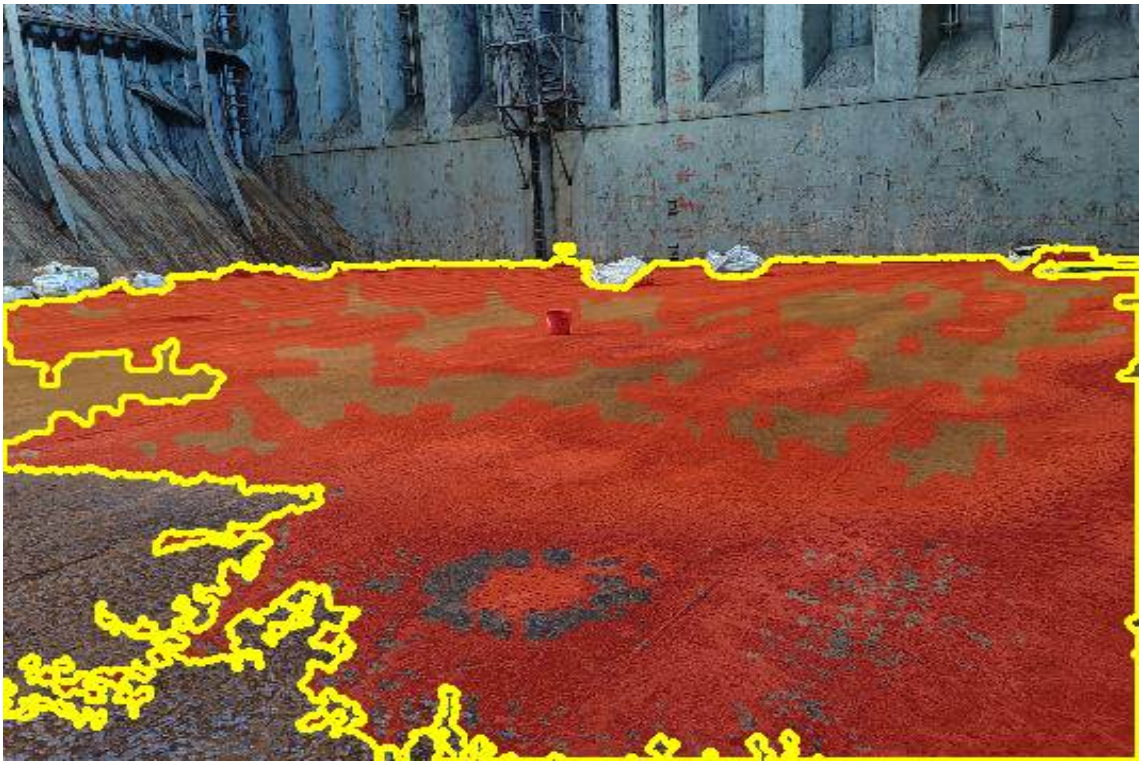
Inspection Photo 16

Location	Hold No. 2_4.jpg
Rust %	45.47
Severity	SEVERE
