# Why the Vasa Sank:
## 10 Problems and Some Antidotes for Software Projects

**Richard E. Fairley,** *Oregon Health and Sciences University*

In 1628, the Royal Swedish Navy launched the Vasa. After sailing only about 1,300 meters, it sank. The authors review the project's problems, including why the ship was unstable and why it was still launched. They interpret the case in terms of today's large, complex software projects and present some antidotes.

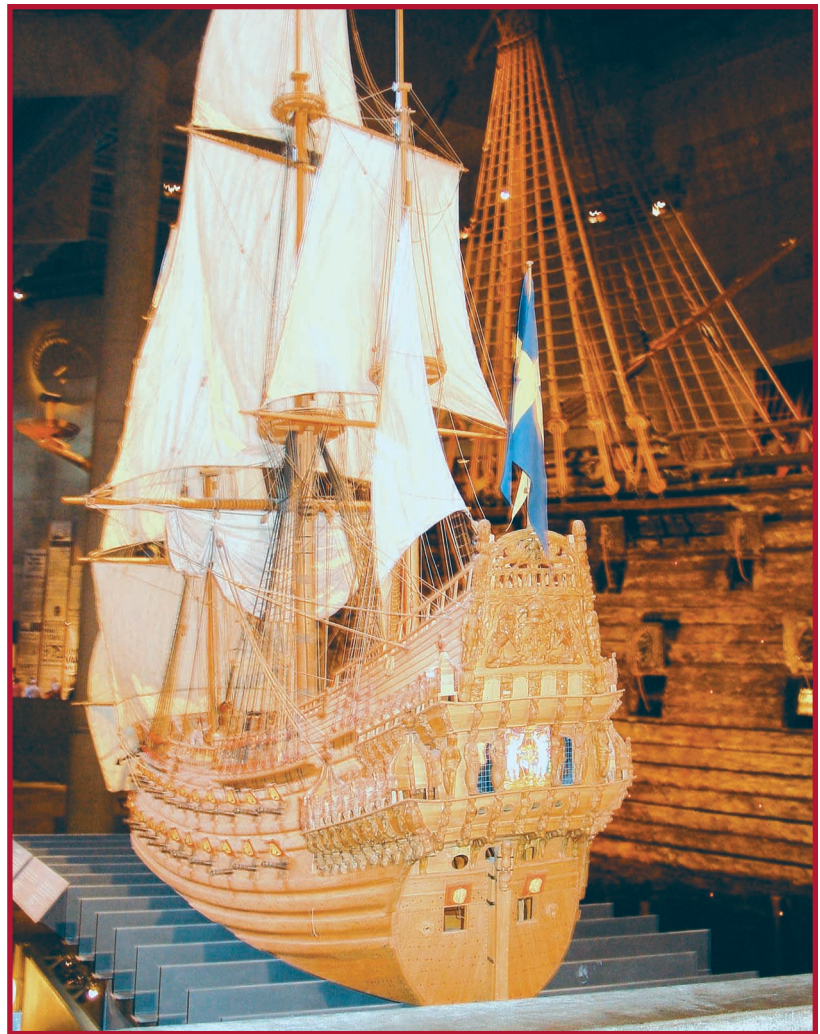
**Figure 1. The restored Vasa, housed in Stockholm's Vasa Museum (model in foreground, Vasa in background).**

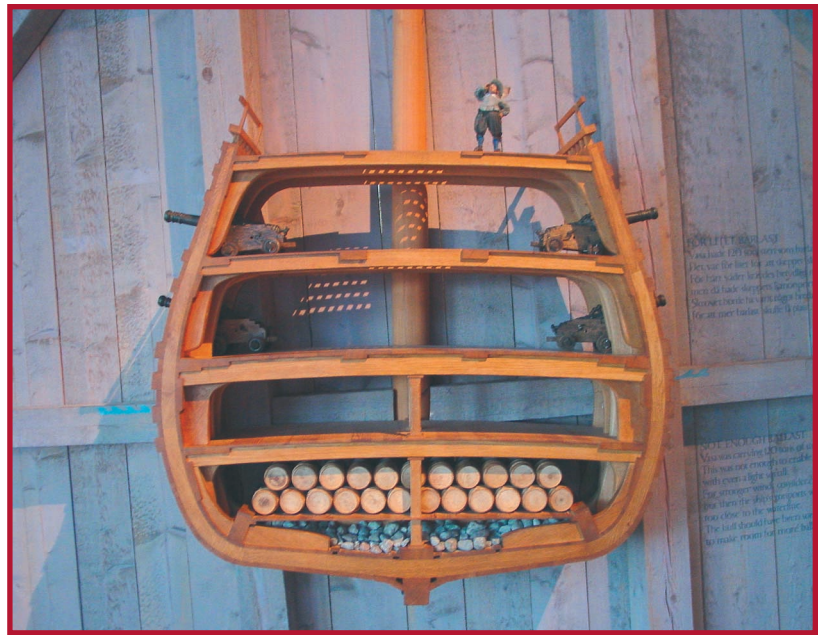
How he scaled up the 111-foot Vasa to 135 feet was constrained by its existing keel, which contained the traditional three scarfs. He added a fourth scarf to lengthen the keel, but the resulting keel is thin in relation to its length, and its depth is quite shallow for a ship of this size.

Hybertsson's assistant, Hein Jacobsson, later said that the Vasa was built one foot, five inches wider than originally planned to accommodate the two gun decks. However, the keel was already laid, so they could make that change in width only in the upper parts of the ship. This raised the center of gravity and contributed to the Vasa's instability (sailing ships are extremely sensitive to the location of the center of gravity; a few centimeters can make a large difference). Also, those outfitting the ship for its first voyage found that the shallow keel did not provide enough space in the hold for the amount of ballast needed to stabilize a 135-foot ship. The keel's thinness required extra bracing timbers in the hold, further restricting the space available for ballast.

**Figure 5. A cross section of the Vasa showing its shallow keel and its multiple decks, including the two gun decks.**
