Asset inspection report, Riverside works

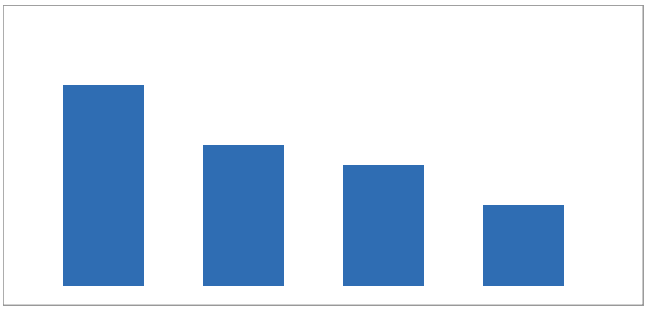
Condition grade summary: two structures need repair within twelve months.
