# Asset inspection report, Riverside works

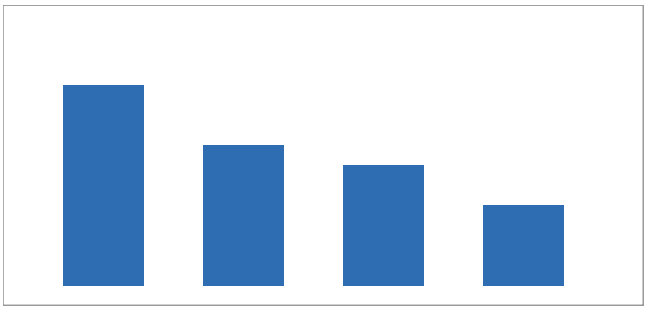
Condition grade summary: two structures need repair within twelve months.
