INVENTORY OF HAZARDOUS MATERIALS, IHM (PART I)
BY VISWA LAB, SINGAPORE

Report of Investigation IHM (Part I) for M/V SSL THAMIRABARANI IMO 9312468 according to IMO Hongkong Convention and EU Ship Recycling Regulation

Viswa Report No : SSL THAMIRABARANI 2025 Rev. 2

Report Date: 04-11-2025

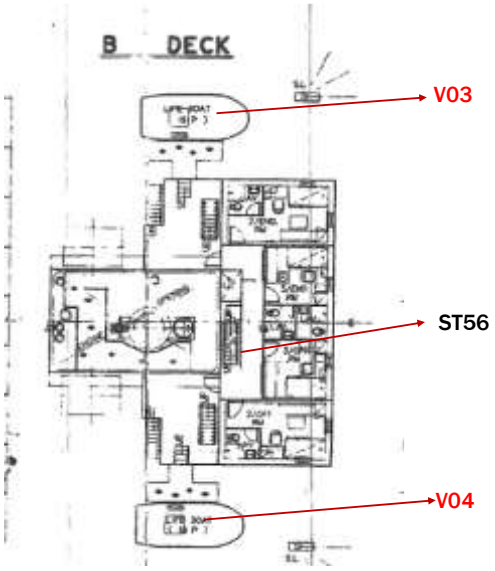
1	Life / Rescue Boat Port Motor Starting Battery Rocket 12V, 90AH x 2 Nos (V03)	B Deck	Lead and Lead Compounds	Maintenance Free Lead Acid Batteries	20.0	Kg	Contained Lead and Lead Compounds
2	Life / Rescue Boat Starboard Motor Starting Battery Rocket 12V, 90AH x 2 Nos (V04)	B Deck	Lead and Lead Compounds	Maintenance Free Lead Acid Batteries	20.0	Kg	Contained Lead and Lead Compounds

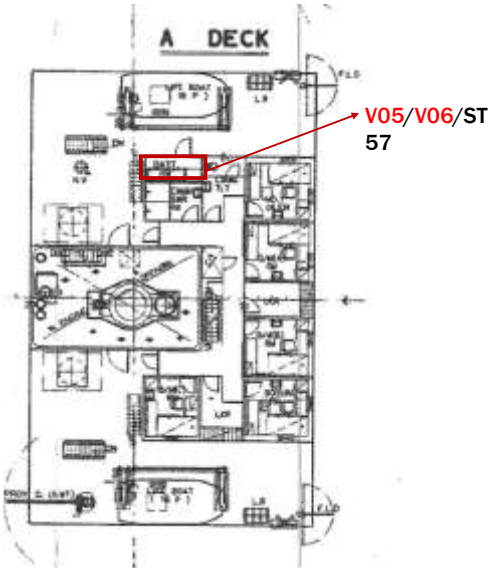
1	GMDSS Radio Battery Exide, 12V, 200 AH x 6 Nos (V05)	A Deck-Battery RM	Lead and Lead Compounds	Maintenance Free Lead Acid Batteries	120.0	Kg	Contained Lead and Lead Compounds
2	General Use Battery Rocket, 12 V, 200AH x 6 Nos (V06)	A Deck-Battery RM	Lead and Lead Compounds	Maintenance Free Lead Acid Batteries	120.0	Kg	Contained Lead and Lead Compounds

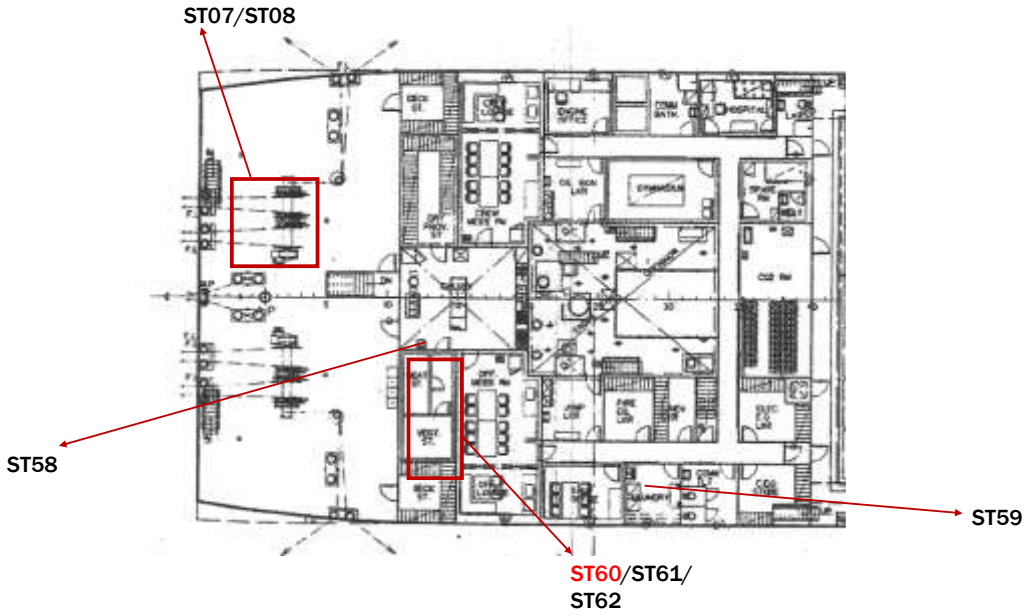
1	Wall Panel (ST60)	Upper Deck-Ref Chamber-Meat	Ozone Depleting Substances	Foam Insulation	30.0 KG	Contained Hydrochloro Fluorocarban (ODS). Assuming all foam insulation in Cold Room Chamber wall panel contained ODS

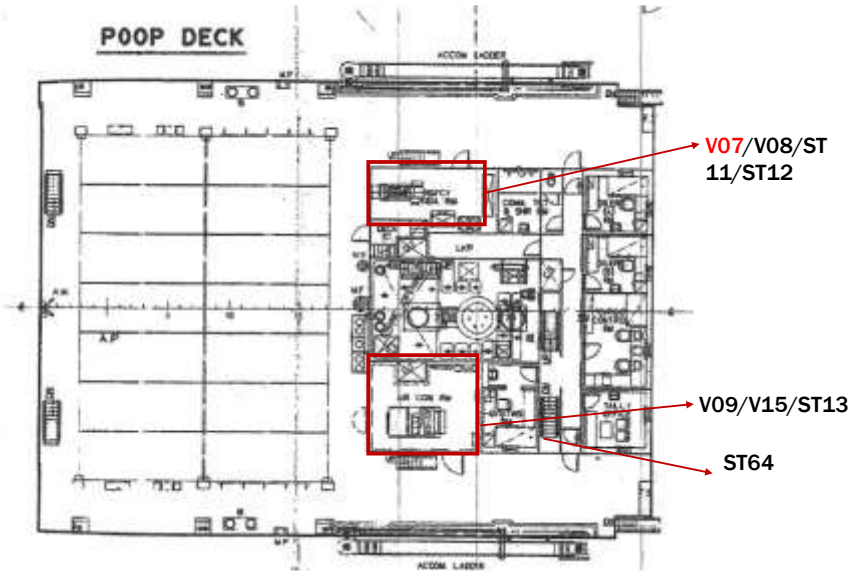
1	Emergency generator Starting Battery Amaron BL1000 RMF x 2 Nos (V07)	Poop Deck-Emer Generator Room	Lead and Lead Compounds	Maintenance Free Lead Acid Batteries	80.0	Kg	Contained Lead and Lead Compounds

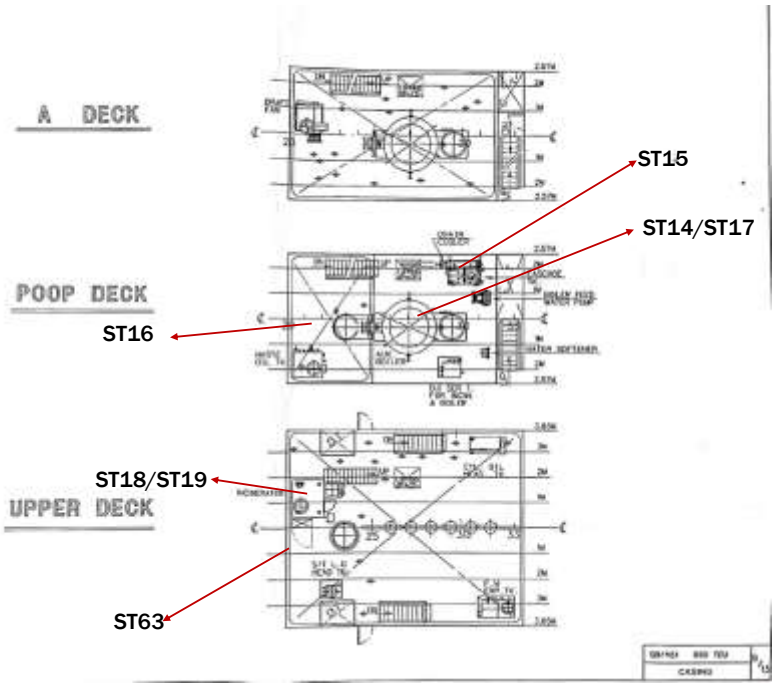
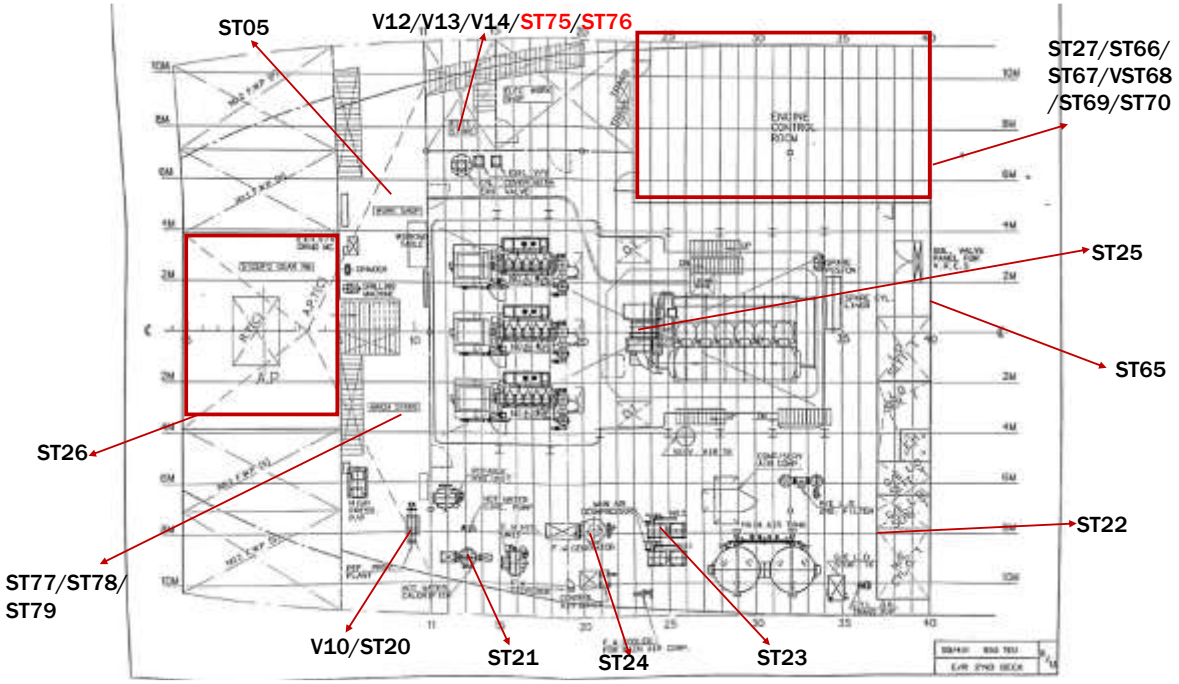
A DECK
ST15
ST14/ST17
POOP DECK
ST16
ST18/ST19
UPPER DECK
ST63

1	Spare Cable (ST75)	ER-2nd Deck-Electrician's Workshop	Lead and Lead Compounds	Outer sheath	5.0	Kg	Contained Lead and Lead Compounds
2	Spare Cable (ST76)	ER-2nd Deck-Electrician's Workshop	Lead and Lead Compounds	Inside Insulation layer	5.0	Kg	Contained Lead and Lead Compounds
