EARLY USER APPRAISAL OF THE MDARS INTERIOR ROBOT

ABSTRACT

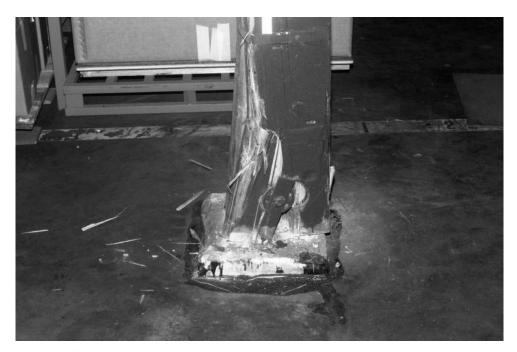
In another situation, a retro-reflective stripe was placed on a warehouse support column to serve as a navigational cue. Normally this would be a fairly robust cue since the post theoretically will not move. In this case, however, a forklift backed into the post, rudely displacing it by about five inches (Figure 11). This caused the platform to experience navigational errors, since the post no longer appeared to be at its expected location. The initial solution to this problem was to reposition the stripe on the post until the post was restored to its original configuration (at the gentle urging of several large men wielding sledgehammers).

Figure 11. Retro-reflective tape marker (top, center) on displaced support column after being struck by fork truck.
