Legon Fire Station Child Lab and E A Boateng Road Reconstruction Brief

Correct the selected area in the existing University of Ghana bicycle exploration game using 14 paired street comparisons, three annotated real aerial maps and six game overview references. The principal task is to replace unsupported tall institutional templates with the observed low buildings, yards, roof forms and connected road landscape. This brief follows the supplied sample format and addresses this new section only.

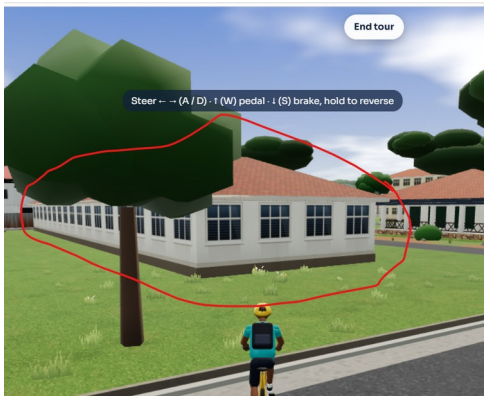
Pair 1

The marked game target is a tall, regular multi-storey block behind the veranda building. The real marked target is a low white wing with a long red roof, small dark openings and mature trees close to its facade. The height, window density and roof hierarchy are wrong. Sparse game planting also exposes buildings that the real canopy partly conceals.

The real foreground pavilion has a broad tiled roof, projecting gabled veranda, pale columns, dark glazed openings and a stone-faced raised base. A lower adjoining or neighbouring roof sequence continues behind and to the right. The blue outline identifies that low sequence, not every building in the photograph. Hedges, flower beds and trunks layer the frontage.

Use R1 to trace the outlined courtyard complex, its perimeter wings and internal cross paths. Keep the courtyard open; do not fill it with a taller block. Remove the unsupported extra storeys in the marked sightline, fit the long wing roof and opening rhythm, and retain the veranda as a distinct projection. Verify roof joints against R1 rather than merging all visible roofs into one pavilion. Fit window and column widths after matching the camera.

Keep the veranda floor and stone plinth above the immediate garden ground, with only supported access level changes. Rebuild the road curb, narrow verge, layered hedges and mature irregular canopy. Connect the courtyard edge and opposite roadside building to Pair 2 through R1; do not duplicate either complex.

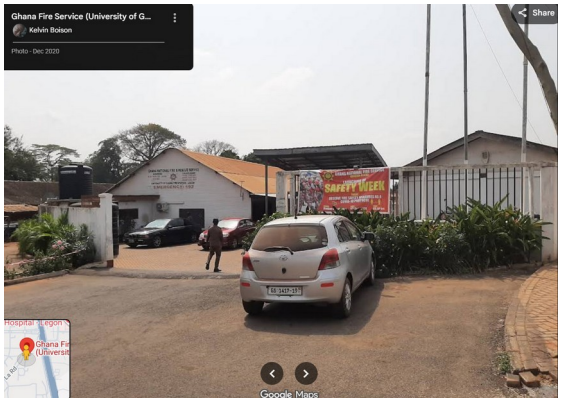
The game replaces the station with three-storey and two-storey classroom-style masses and repeated large windows. The real view shows low gabled service buildings and a thin open-sided canopy. Missing boundary walls, the water tank and yard geometry change both silhouette and function.

A pale gable on the left carries fire-service lettering behind a ribbed black elevated water tank. A second low pale gable stands to the right. Between them, a broad dark metal canopy on slender posts covers a red fire engine and part of the vehicle yard. A weathered pale wall with metal railing encloses planted ground at the front.

Use R3 to locate the station parcel and the Pair 3 direction. Replace only the station assets with individually traced low roof volumes. Model the canopy as a thin sloped or shallow pitched sheet with visible supporting beams and open sides, not a solid building or another storey. Put the tank on its visible support and preserve its separation from the gable. Reproduce only legible fire-service wording; do not fabricate obscured numbers.

Build a hardstanding vehicle yard, planted boundary strip, wall base, entrance curb transitions and practical vehicle clearance. Subtle weathering belongs on the wall and roof edges. Keep the yard approximately continuous at access level unless additional ground evidence establishes a larger step.

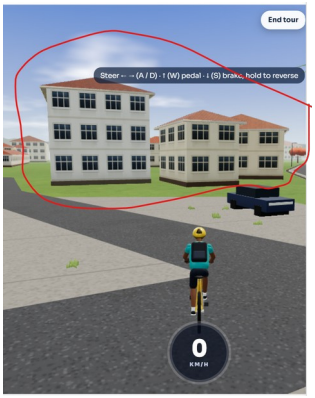
The game entrance leads across open grass to tall regular blocks and lacks the real enclosure. The exaggerated building heights, broad blank setback and simplified parking erase the reference entrance, wall corners and foreground paving.

The real entrance opens between pale boundary piers and low walls topped with dark metal bars. The gable on the left and canopy farther back define a compact working yard. A banner is attached near the right side; a utility pole and overhead lines cross the view. The foreground combines asphalt or worn hard ground with a block-paved pedestrian edge.

Use R3 and the Pair 4 arrow to place the real road mouth, entrance piers and boundary returns. Reuse the station and canopy from Pair 3, retaining the same roof corners and relative depths. Replace the large invented entrance arrangement with the visible piers, bars and opening. Add the banner as a panel with readable major words only where supported. Do not use a floating game destination label as a physical gate sign.

Fit the driveway to the existing road and yard without floating curbs or a lawn strip through the entrance. Match the right-hand paved edge, worn ground, nearby planting and pole offset. Cars and people are removable scale props; establish the gate and circulation with them hidden.

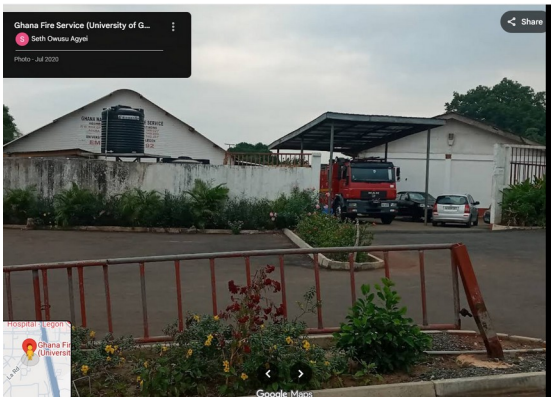
Pair 5

The game again presents a tall classroom group and open lawn. It omits the actual station enclosure and the low foreground metal barrier, while using parked cars as a substitute for the service-yard layout.

This real photograph repeats the station gable, tank, pale boundary wall, fire engine and open canopy seen in Pair 3. Its distinct framing adds a low reddish metal railing across the near foreground, planted flowers at its base and a hard street or forecourt surface. Mature trees sit behind the low roofs.

Replace the open green game forecourt with the evidenced asphalt or paved surface and planting strip. Retain gentle local curb transitions; the photograph does not establish a deep ditch or large terrace. Use weathered pale walls and dark canopy sheets, avoiding the game-wide bright terracotta hip-roof material.

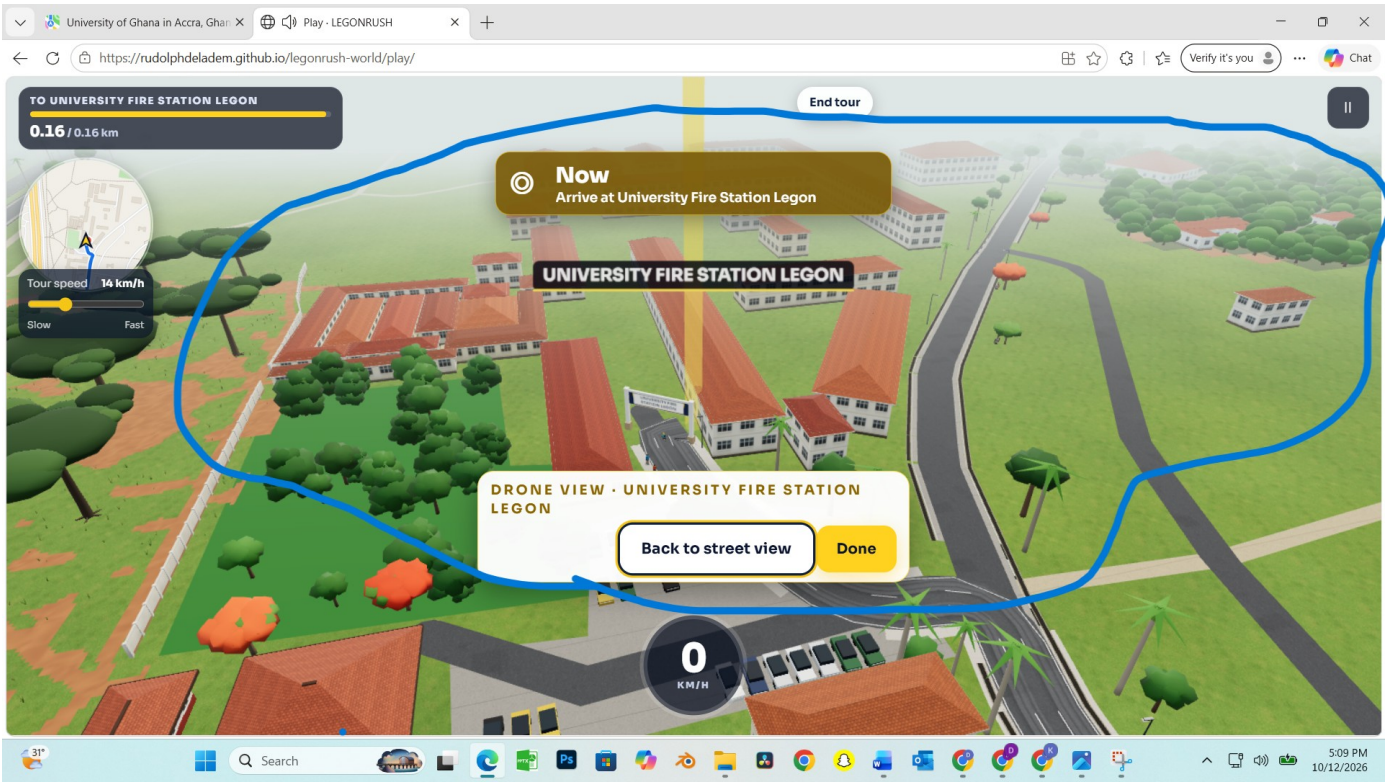
The outlined region is dominated by repeated white multi-storey blocks, long hip-roof bars, oversized lawn voids and simplified tree clumps. The station destination is represented by classroom architecture rather than the low gabled service buildings and open canopy in Pairs 3-5. Surface and enclosure differences disappear into green ground.

Register this camera to R3 using the through-road and station access, then to the wider reference layout only where overlap is evidenced. Replace the selected station template, recover yard and boundary geometry, and check each neighbouring long roof independently. Retain courtyard buildings only after their outlines and open spaces agree with the real maps. Match building massing before recolouring.

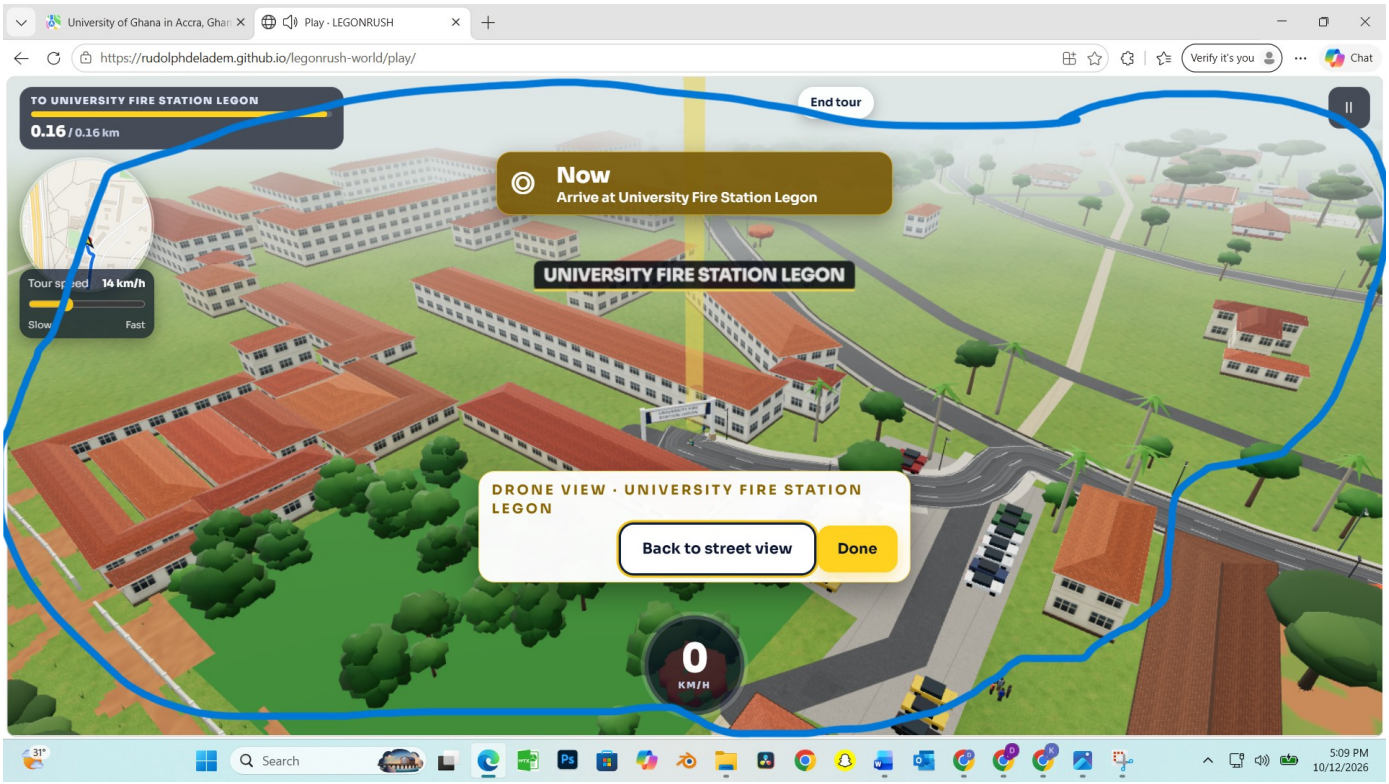
This angle exposes long, repetitive two-storey roof bars beside open lawn and an isolated small block across the road. The station marker lands among taller generic buildings. Real roof segmentation, paved yards, boundaries and vegetation enclosure are insufficiently represented.

Use this angle to test the length, orientation and separation of every replaced roof against R3. The road bend and access must join the same surfaces used by Pair 14. Rebuild low station gables, the canopy and the service office; do not merely reduce all scene buildings to one storey. Neighbouring blocks require their own roof outline and visible elevation evidence.

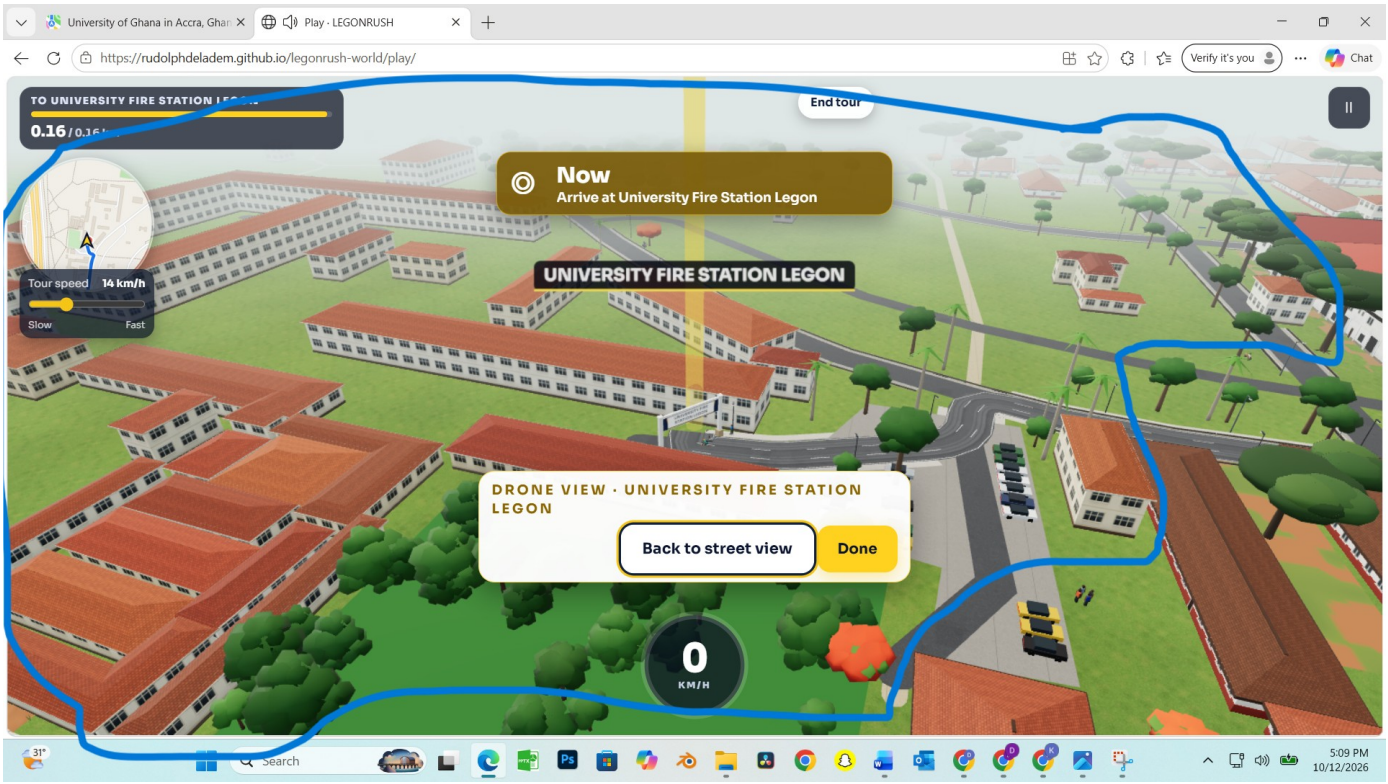
The oblique again shows repetitive long classroom bars, a large roof-and-court structure at the left and a broad paved car area near the road. A dense artificial tree patch and generic bright lawn stand in for distinct planted and service spaces. The annotation does not reveal which unlabelled game building corresponds to each real roof.

Compare repeated roof corners with G1 and G2 to identify the same assets. Test courtyard perimeter, inner openings and nearby trees against the appropriate real map after road alignment; do not assume the large game courtyard is R1 solely because both contain courts. Correct parking and ground surfaces from real evidence, keeping cars as removable props. Resolve identity before making global replacements.

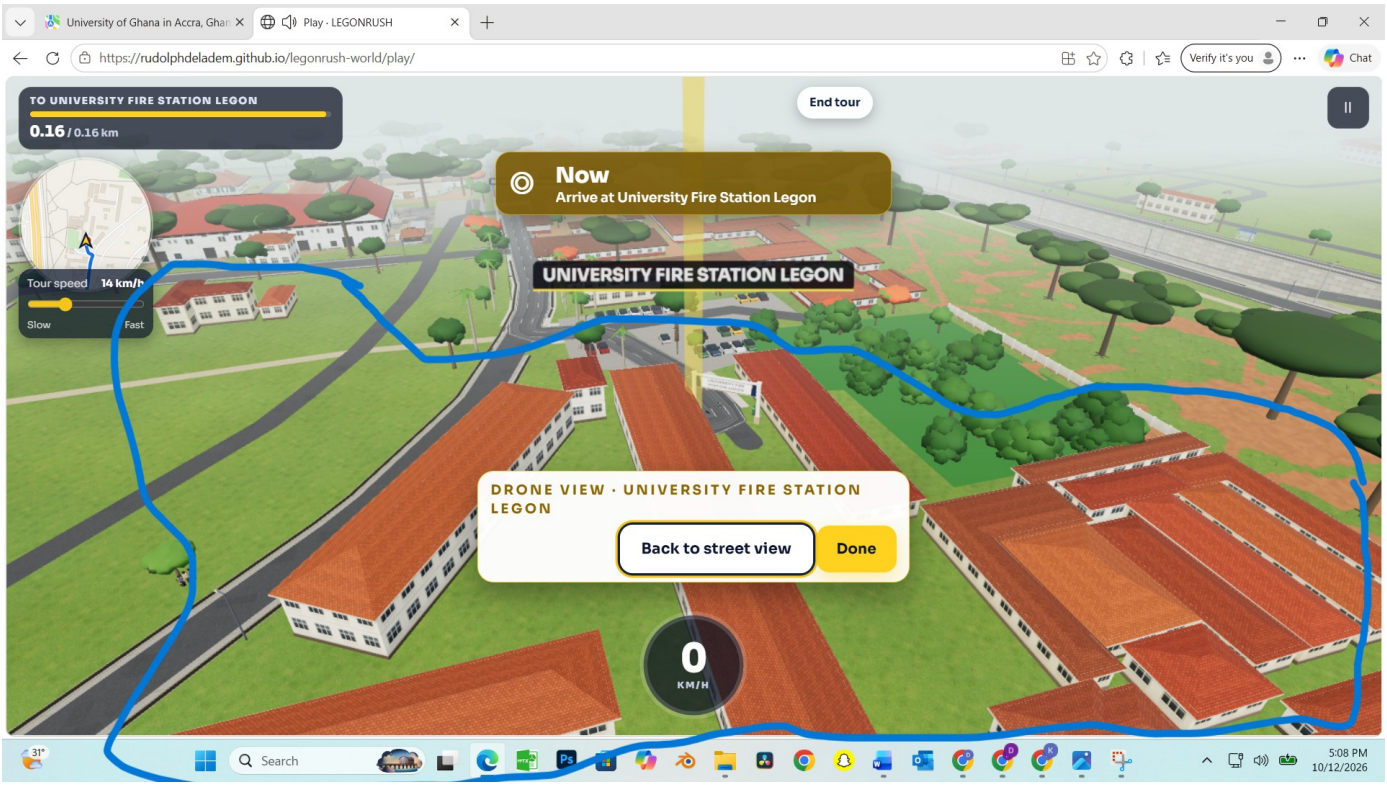
From this angle the selected area still reads as a generic institutional campus: elongated roof bars, almost identical white facades, broad lawn sheets and regularly placed palms. The road-mouth and parking apron dominate the foreground, while the real service architecture and irregular enclosure are missing.

Check road-mouth shape against R3 and Pair 14 before moving the adjacent buildings. Reconstruct separate low station volumes and practical service access. Adjust each roof length and orientation from the real outline rather than reusing one long bar. Replace the palm repetition with the mixed mature canopy supported by the street views, preserving verified neighbouring assets outside the selected work.
