UGMC reconstruction audit

In game aerial views and real world references

Correct the existing UGMC reconstruction in LEGONRUSH while preserving the portions that already match. This audit retains all 89 chronological game screenshots, registers the real references, and supplies a shared correction ledger and a complete implementation prompt for Claude.

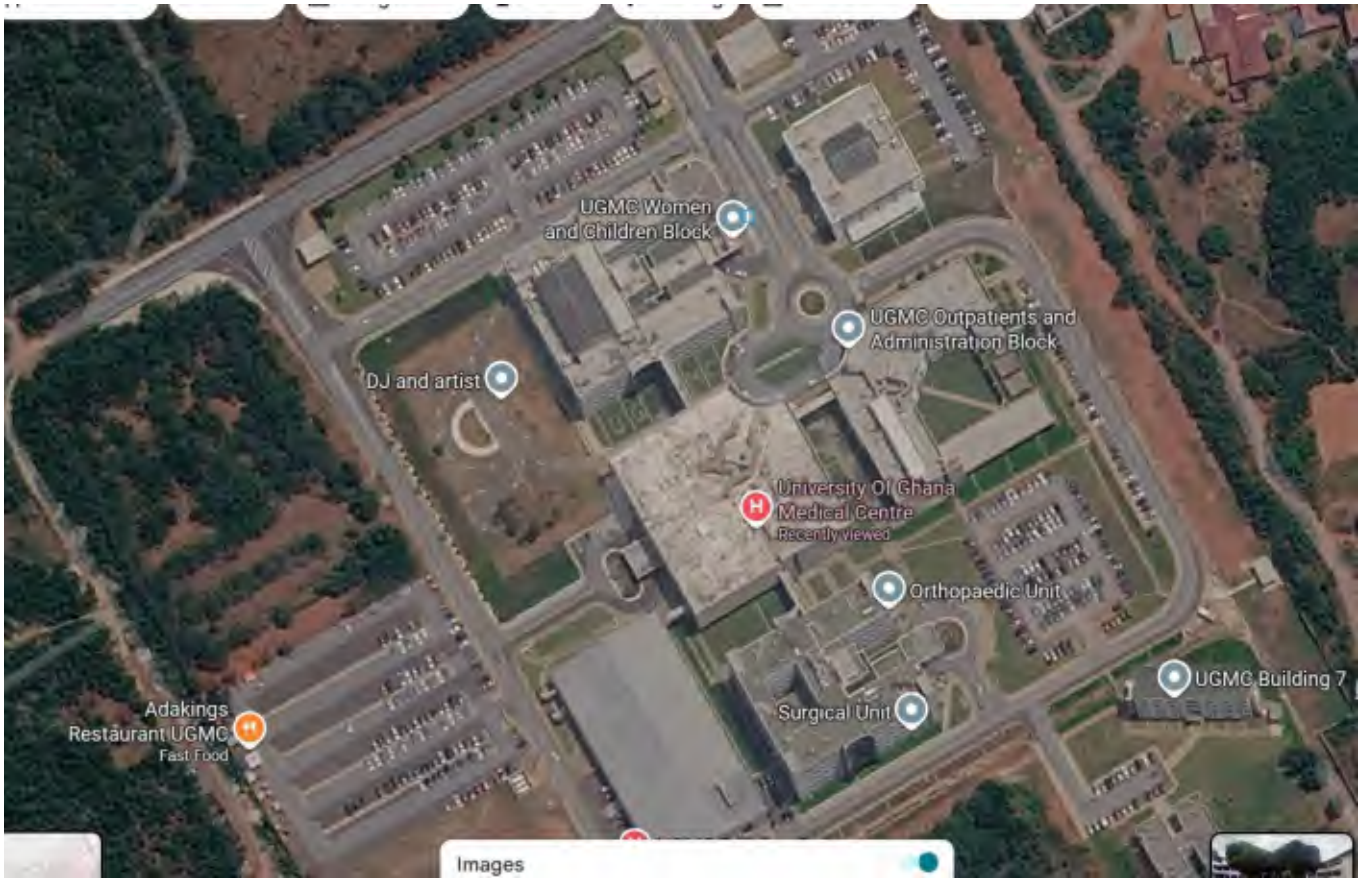
Satellite registration and block locations

1 C1 main roof; 2 W2; 3 O3 courtyard block; 4 T4; 5 P5; 6 L6 long low building; 7 main planted roundabout; 8 W2 crescent garden. Numbers are location annotations, not clinical department numbering.

Trace the true roof/ground boundaries, courtyard voids, road edges and planting separately. This is a satellite footprint record: it does not measure floor heights, door positions or hidden roof pitch.
