Rudy's Retro Intelligence

**NABU Personal Computer
Diagnostics and Repair Manual**

Version 1.8.1 Created April 2023. Updated Feb 2024

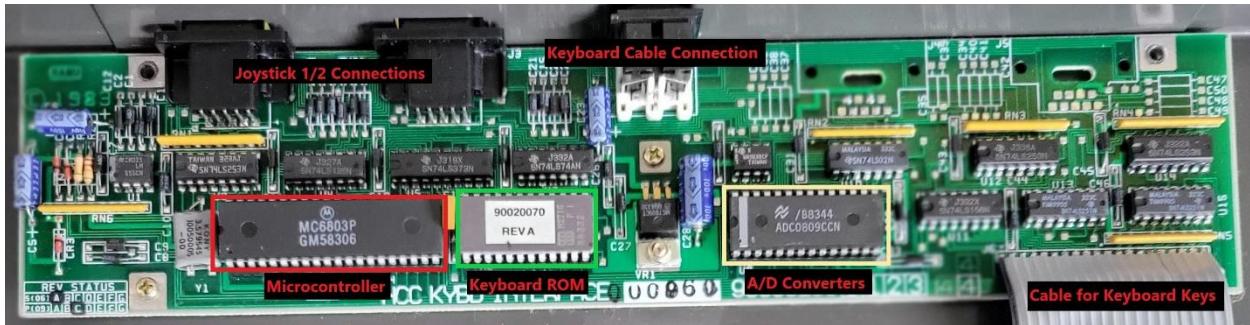
Keyboard Failures

Symptom: Keyboard not working.

Diagnoses: Check that the keyboard is connected to the NABU computer.

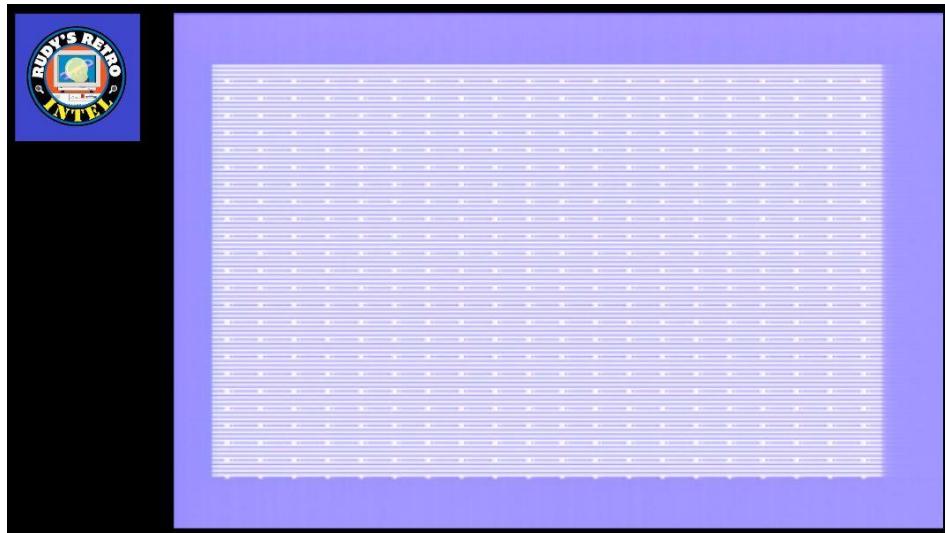
Symptom: Solid color, vertical green bars, scrambled colors and\or white screen.

Diagnoses: Replace **U44** with HM4864P – DRAM Chip DRAM 64Kbit 64Kx1 5V.

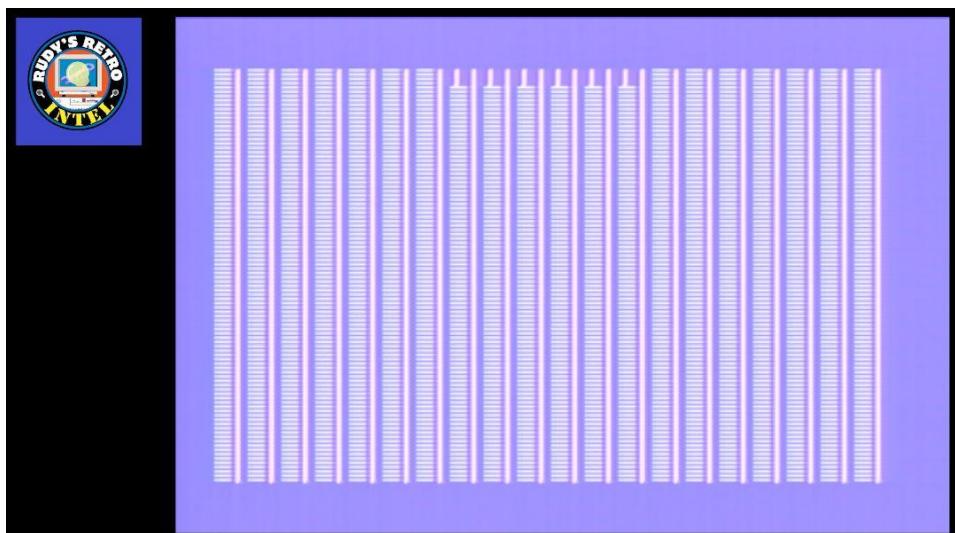
Symptom: Fine stripes with dots aligned vertically and horizontally.

Diagnoses: Replace **U46** - HM4864P – DRAM Chip DRAM 64Kbit 64Kx1 5V.

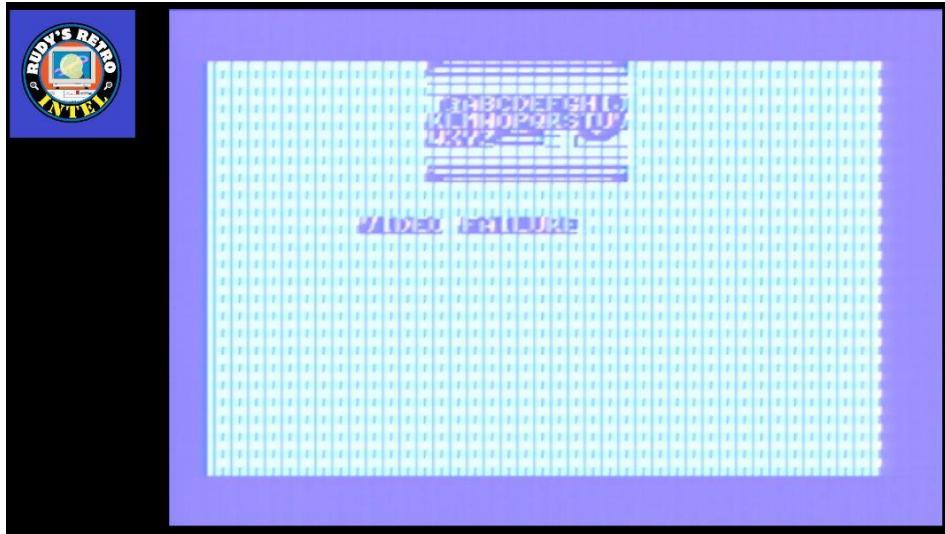
Symptom: NABU logo and text characters not shown correctly.

Diagnoses: Replace **U20** - TMS4116-15NL - DRAM 16,384-Bit (16Kx1) 150ns 5V.

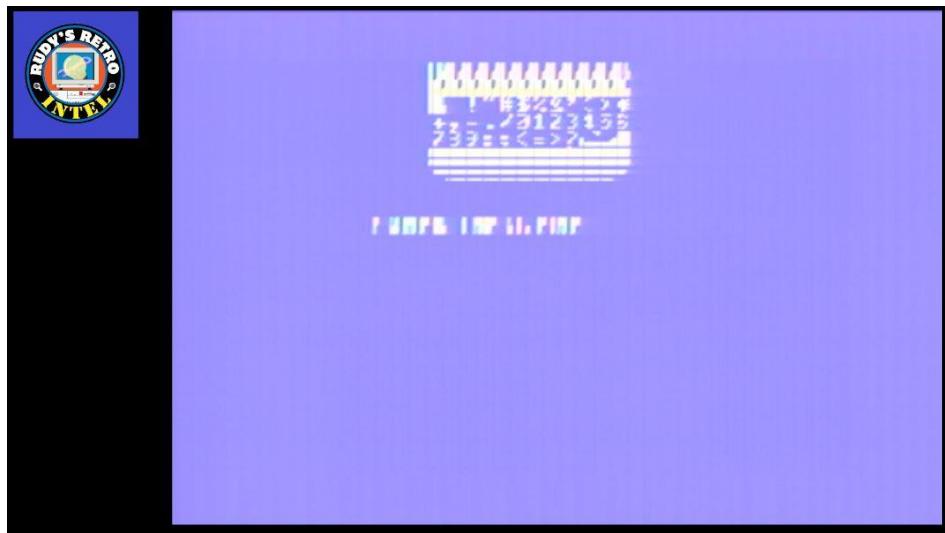
Symptom: NABU logo and text characters not shown correctly, inverse vertical bars displayed.

Diagnoses: Replace **U22** - TMS4116-15NL - DRAM 16,384-Bit (16Kx1) 150ns 5V.
