Rudy's Retro Intelligence

**NABU Personal Computer
Diagnostics and Repair Manual**

Version 1.8.1 Created April 2023. Updated Feb 2024

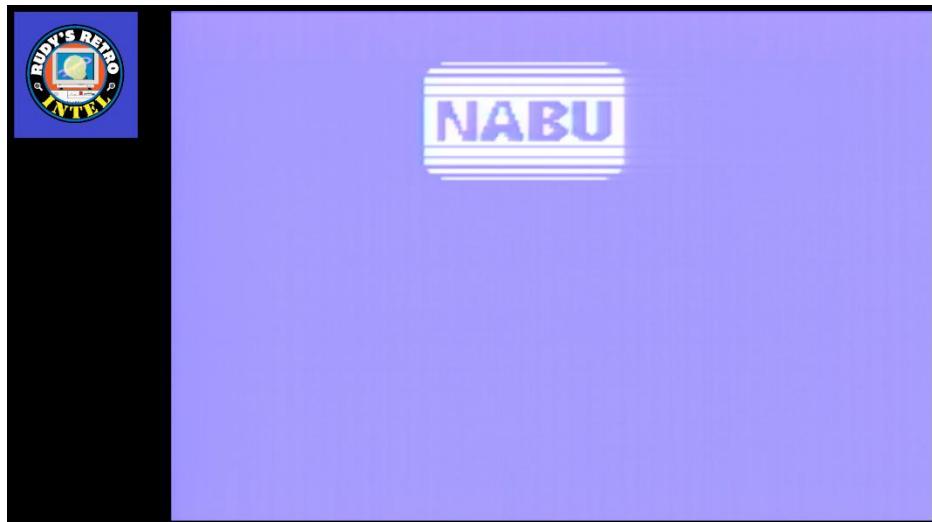
Symptom: Sound Failure message, no sound heard, Alert LED on.

Diagnoses: Replace **U25** - AY-3-8910 sound generation IC. **U15** - LM3900, **U35** - 74LS373, **U54** - Z80 processor, **U26** - 74LS153, **U27** - 74LS32, **U39** - 74LS00, **U36** - 74LS74, **U28** - 74LS38, **U34** - 74LS348, **U32** and **U33** - 74LS00, **U1** - 74LS14

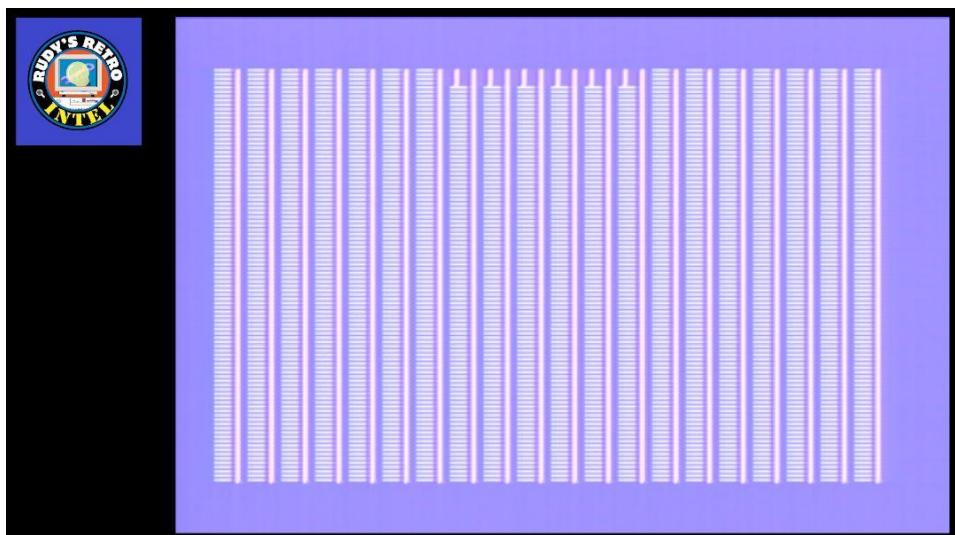
Symptom: Fine stripes with dots aligned vertically and horizontally.

Diagnoses: Replace **U46** - HM4864P – DRAM Chip DRAM 64Kbit 64Kx1 5V.

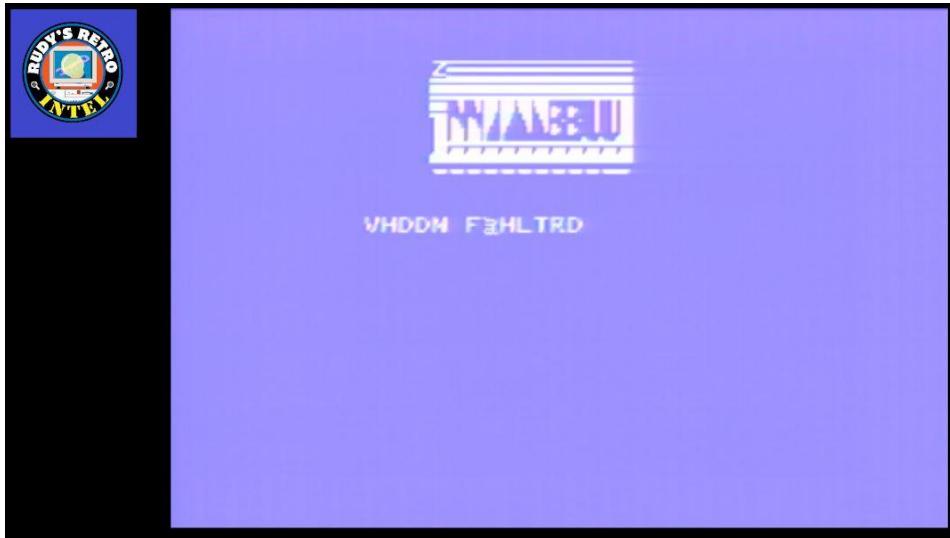
Symptom: Vertical bars (solid and non-solid bars), NABU logo tries to display.

Diagnoses: Replace **U47** - HM4864P – DRAM Chip DRAM 64Kbit 64Kx1 5V.

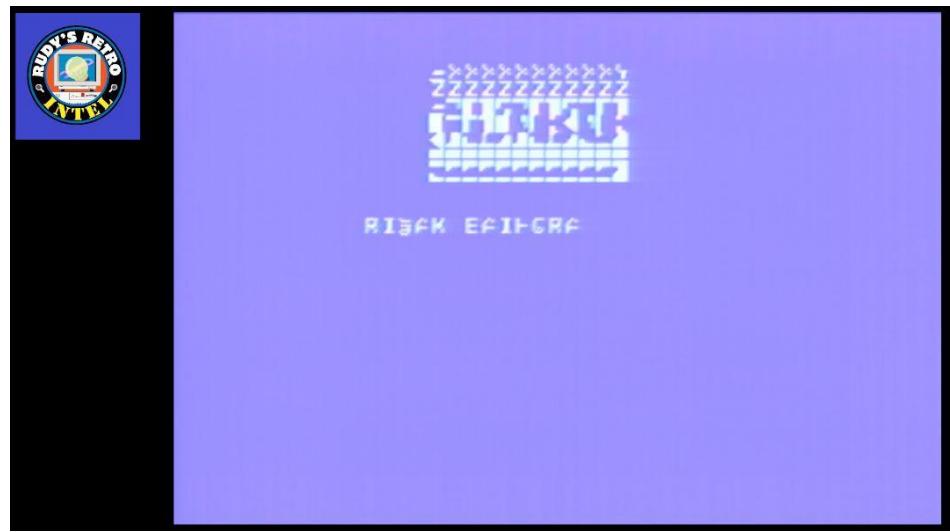
Symptom: NABU logo and text characters not shown correctly.

Diagnoses: Replace **U18** - TMS4116-15NL - DRAM 16,384-Bit (16Kx1) 150ns 5V.
