# NABU Computer Diagnostics

Version 1.7.3

This NABU computer diagnostics document was created to help diagnose issues with a NABU computer. My diagnostics and recommendations are based on the motherboard revision 01. Image below.

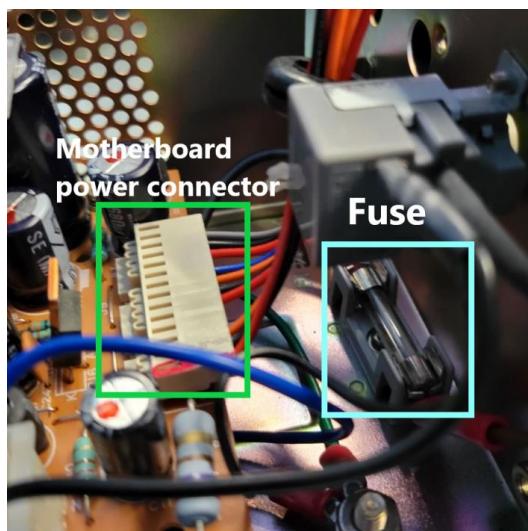
### Test\Replace Power supply

*Symptom:* Black screen, no sound. The Alert LED located on the front panel may be ON.

*Diagnoses:* This is a major fault and the following needs to be tested\replaced.

- Check power plug is connected and power is available from wall socket
- Check fuse located inside power supply. See image below
- Ensure motherboard connection to the power supply is connected and secure. See image below
- Press down all ICs in sockets, as they can have poor contact(s) due to heat
- Ensure that the lid side with the holes is on the side closest to the motherboard
- Other possible issues could be related to the power supply electronics. Future versions of this documentation may cover power supply repairs
- Inside power supply. Note the motherboard connector and fuse locations.

Test\Replace video cables and\or monitor\TV used.  
Test\Replace ROM – **U53** - 2732G EPROM: Burn new EPROM and replace  
Test\Replace Video processor – **U2** - TMS9919ANL. See pinout diagram on next page  
Test\Replace CPU – **U54** - Zilog Z80 processor. See pinout diagram on next page  
Test\Replace Transistors 2N3904

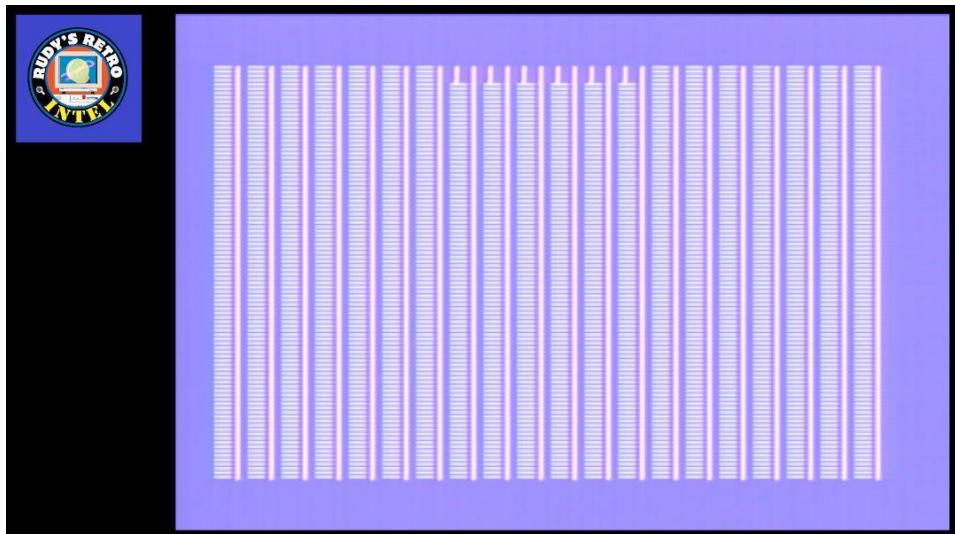
*Symptom:* Fine stripes with dots aligned vertically and horizontally.

*Diagnoses:* Replace **U46** - HM4864P – DRAM Chip DRAM 64Kbit 64Kx1 5V.

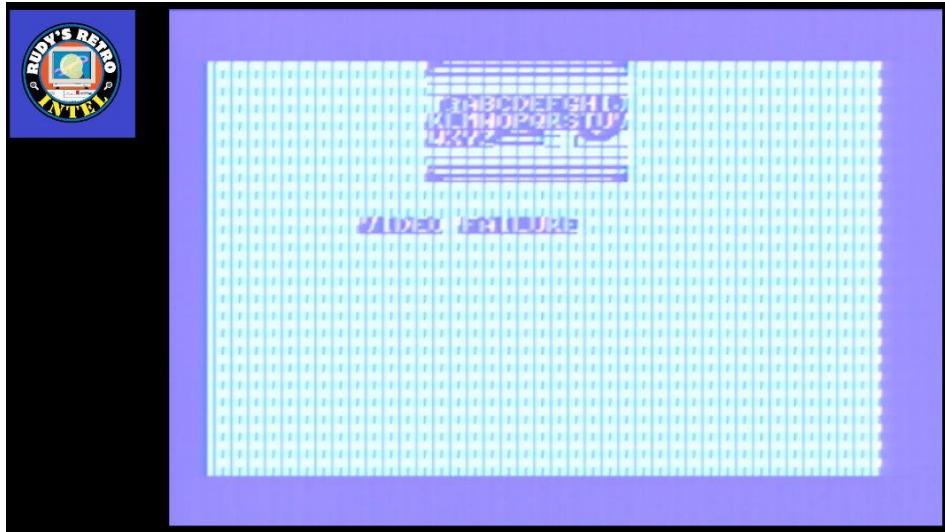
*Symptom:* NABU logo and text characters not shown correctly.

*Diagnoses:* Replace **U19** - TMS4116-15NL - DRAM 16,384-Bit (16Kx1) 150ns 5V.

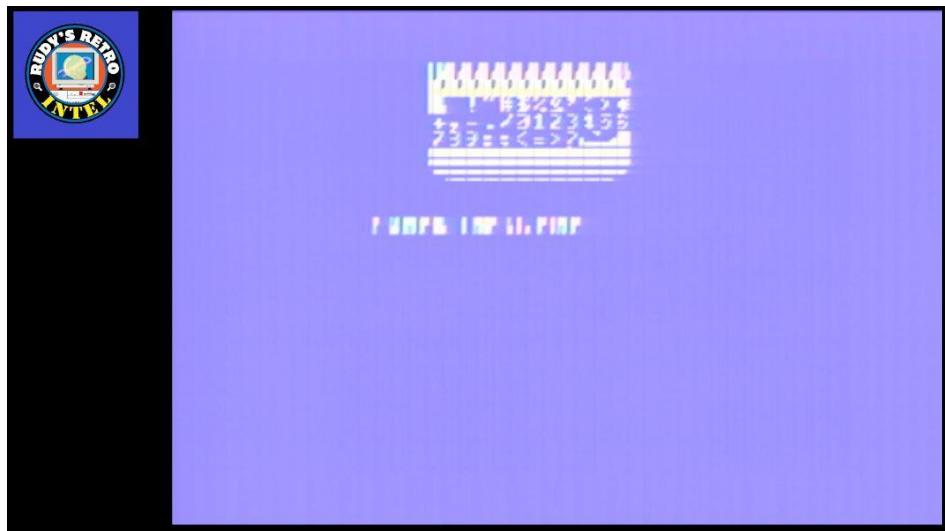
*Symptom:* NABU logo and text characters not shown correctly, inverse vertical bars displayed.

*Diagnoses:* Replace **U22** - TMS4116-15NL - DRAM 16,384-Bit (16Kx1) 150ns 5V.
