NABU Computer Diagnostics

Version 1.7.4

Created by Rudy's Retro Intel

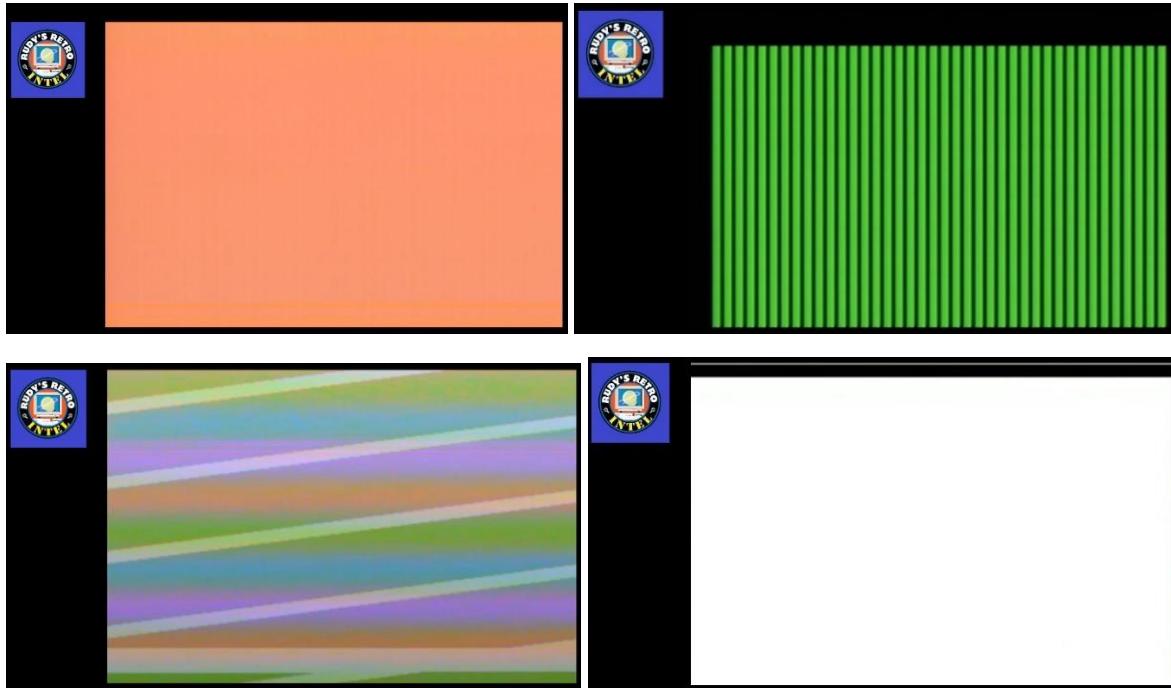
Symptom: No text, small\fine vertical bars.

Diagnoses: Replace **U42, U43, U45, and\or U49** - HM4864P DRAM, **U51 and U52** – 74LS157, **U54** -Z80 CPU, **U37, U9, U57** – 74LS32, **U39** – 74LS00, **U56** – 74LS04, **U36** – LP76-57, **U55** – 74LS260, **U28** – 74LS38
