DAILY WORK REPORT

PROJECT	SC 93 Widening, Phase 2	**CONTRACT NO.**	P-0293-24
LOCATION	Clemson, SC	**DATE**	Thursday, October 15, 2026
PRIME CONTRACTOR	Palmetto Site Works	**REPORT NO.**	42
INSPECTOR	Tyler Bowles	**WORKERS ON SITE**	10

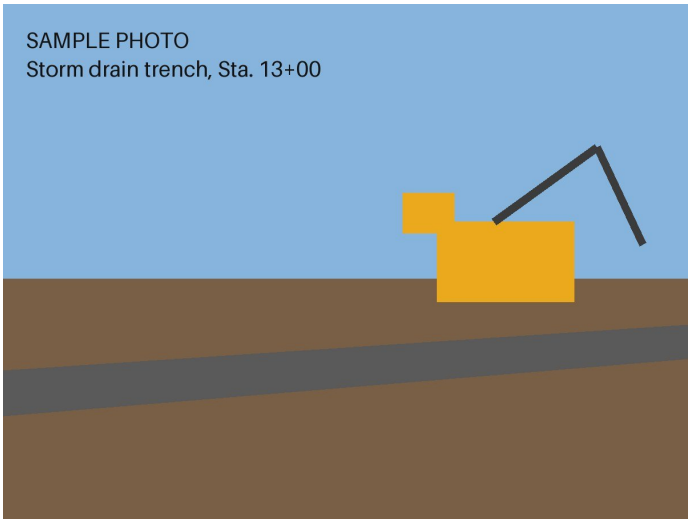
Photo 1. 10:42 AM. Open storm drain trench with trench box in place and excavator working near Sta. 13+00.

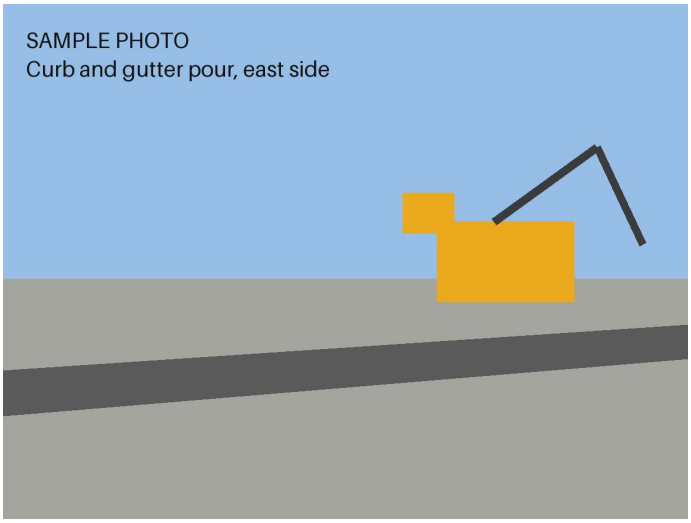
Photo 2. 2:18 PM. Fresh curb and gutter on the east side after the afternoon pour.
