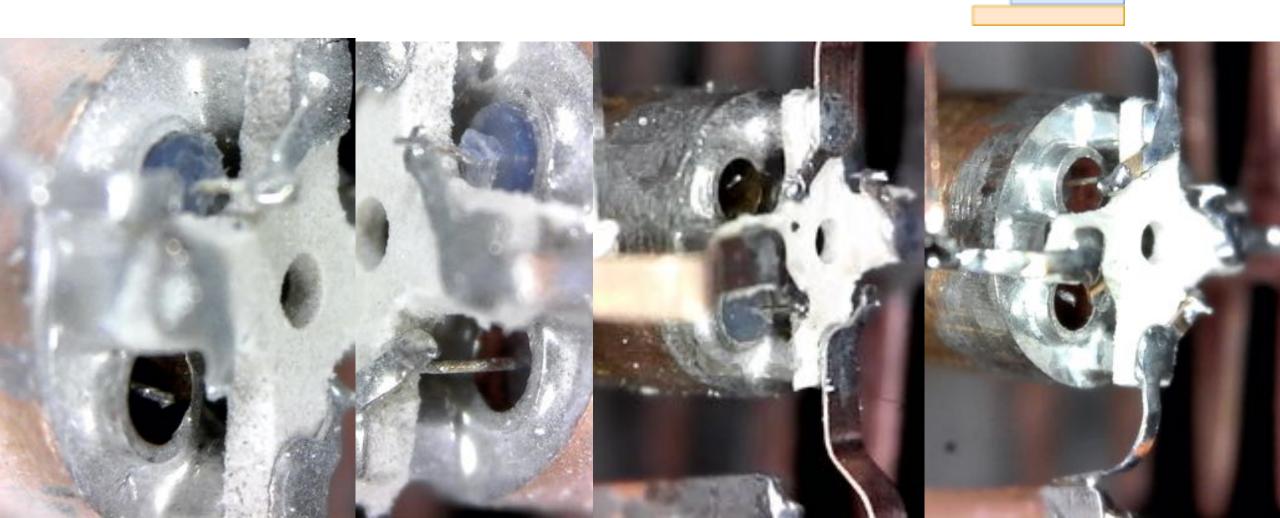
- In all these cases the center conductor seems to be moving with the PTFE.
- This indicates that there is a good mechanical connection / friction between the center core and the PTFE.

- Having a long straight section will allow the PTFE and center conductor to move freely within the outer conductor.
- By introducing a bend as close to the top as possible we might be able to accommodate the thermal expansion and could reduce the retraction of the PTFE and center conductor.
- This would also explain why the displacement is not visible at the LNA side (reduced), where we have bends fairly close to the LNA.
- Remove second point where the four coaxial cables are connected (*)
