Claim Management Panel

Supplier: **AVO Carbon France (NMAP551841)**

Problem description: **double DMC on brush card**

Claim reference: **NMAP/551841/2/2024/1666**

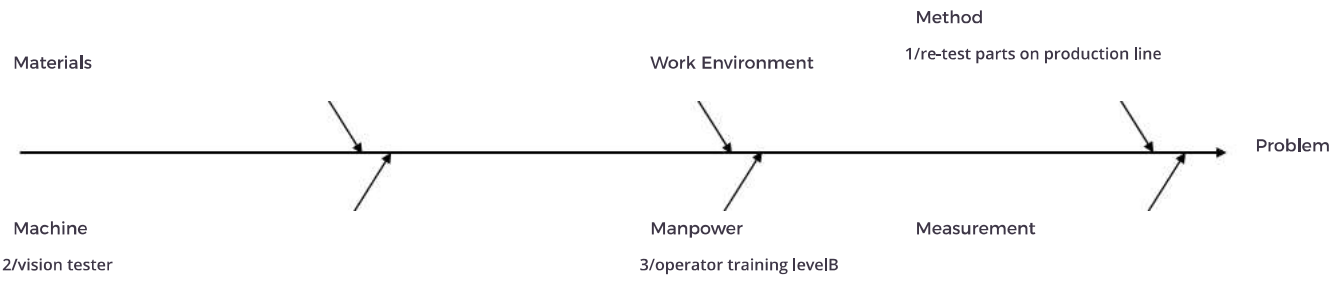
Ishikawa Diagram

standard not exist :
There is no specific standard for operation re-testing.

the setter mixed between the printer device and the reader device
