Quality Alert

N° of Alert:2024-mar-008	*Date 18/03/2024*	*update of Alert:*
Customer Plant: AVO/SCEET Fahs	Supplier: AVO GERMANY	
Customer Contact:bassem.benmallek@avocarbon.com	Editor: Belgacem Brika

1- Porblem Description :bush was manufactured with dimension 5,965 not conform in minimum
2- Why is it a problem: the height of this carbon brush is too small

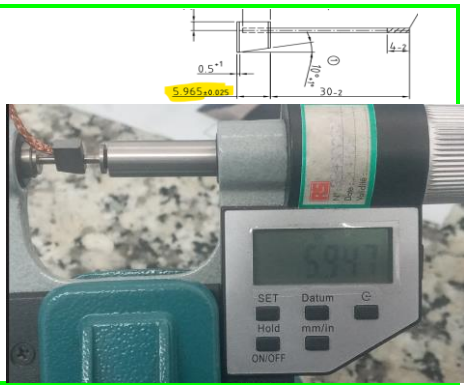
Part number:	A60101942(1026047)	When did it happened:	16/03/2024
Part name:	Carbon brush	Who detected it	technician
Batch number:	278419	Where was it detected	at incomming inspection
Recuerrence defect:	yes	How was it detected	by measures
Demerit:		How many parts:	4pcs

Moyen de contrôle utisé par la Tunisie différent de celui utilisé à Poitiers

5,908;5,898;5,928;5921,....
