Assymex Monterrey S.A. de C.V.

QUALITY CONTROL REPORT (10D)

- What happened? *Description of the Problem*	**Parts found with slot on wrong side of brush**	**- Why is it a problem?**	**Incorrect operation of parts**

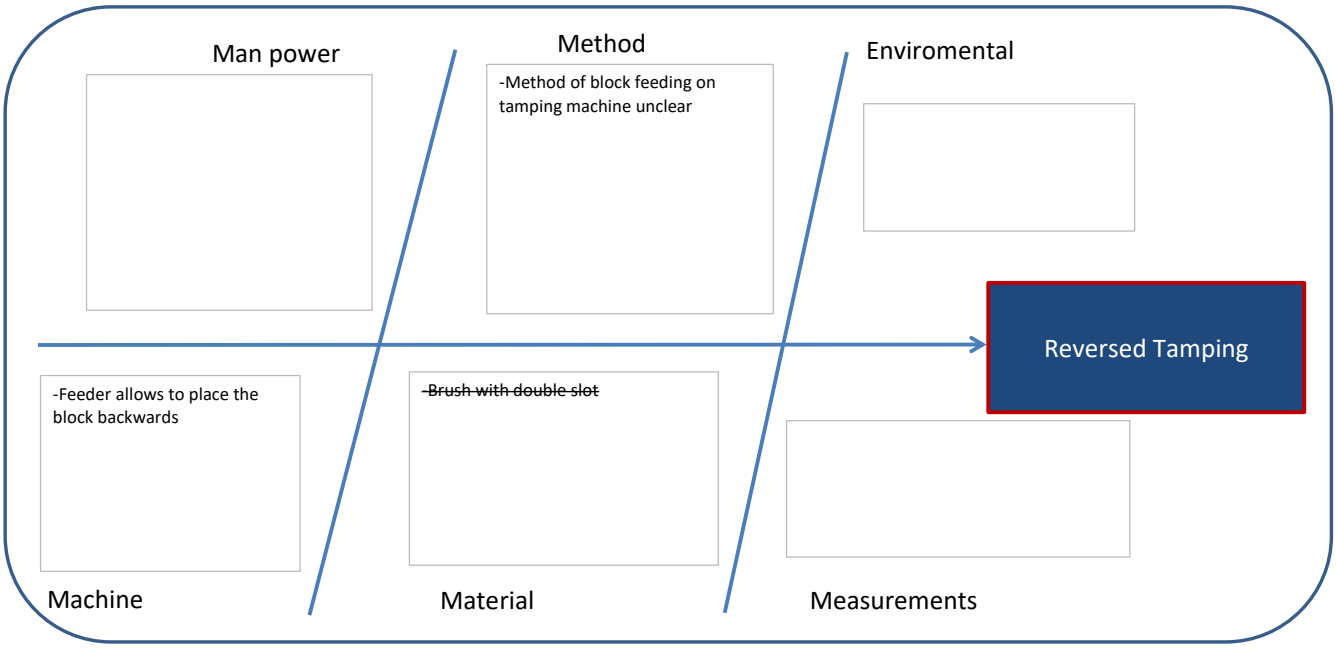
4,1.-	Analysis and Root Cause - Ocurrence

5 x Why Analysis Form - Ocurrences
Why did it happen?

1st Why?	Question:	Why were assemblies prduced with wrong finish on the face of the brush?
	Answer:	Because the slot of the brush is on the wrong side
2nd Why?	Question:	Why the slote of the brush is on the wrong side?
	Answer:	Because the block is tamped in backwards
3rd Why?	Question:	Why the block is tamped in backwards?
	Answer:	Beacuse the block was placed in the guide backwards
4th Why?	Question:	Why the block was placed in the guide backwards?
	Answer:	The guide feeder allows the block to be placed backwards
5th Why?	Question:	
	Answer:

Corrective Action	Expected result efficiency	Who	Due Date	Done Date
Place a sensor that detects the correct position of the block in the guide (stop machine when detecting a block backwards)	Eliminate the occurrence of placing the block backwards on the machine guide	Alicio F.	25-mar-25	Ongoing
Update work instruction with the correct feeding method on the machine	Eliminate the occurrence of placing the block backwards on the machine guide	Astrid L.	26-mar-25	Ongoing
Update work instruction with the reaction plan when the sensor stops the machine for a reverse block	Eliminate the occurrence of placing the block backwards on the machine guide	Astrid L.	26-mar-25	Ongoing
Update set-up sheet with the function of the sensor	Eliminate the occurrence of placing the block backwards on the machine guide	Ramses R.	26-mar-25	Ongoing

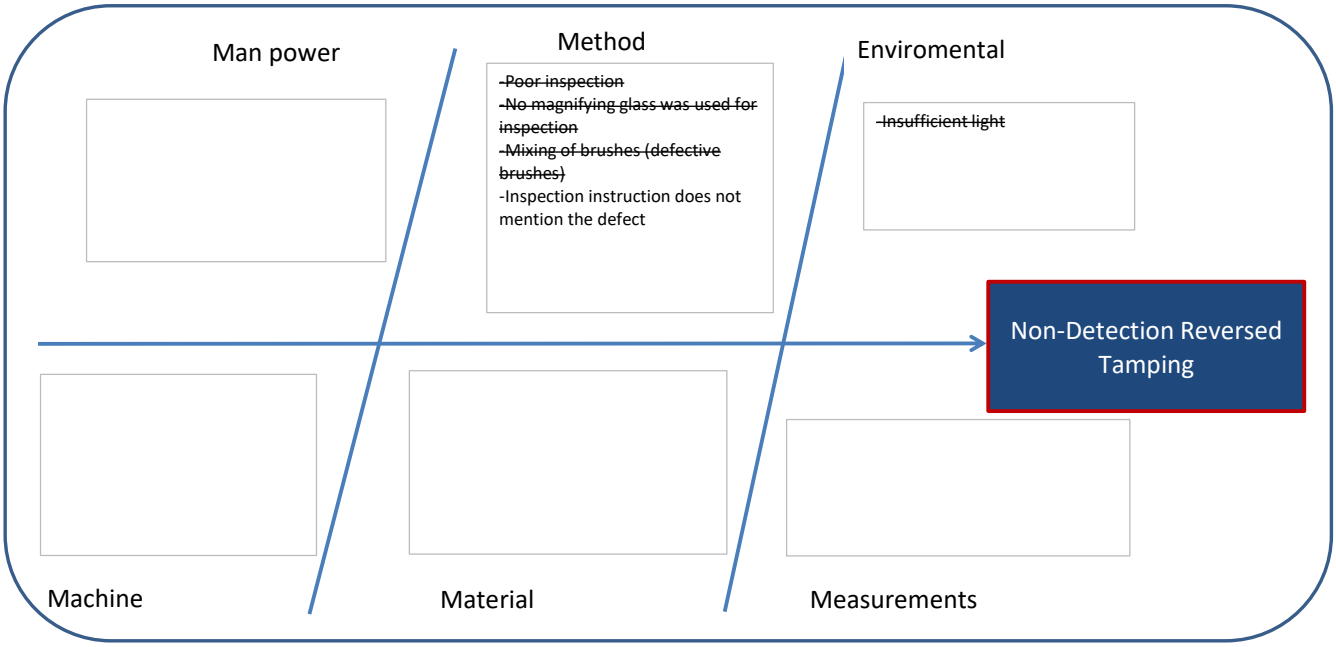
4,2 .-	Analysis and Root Cause - Non Detection

5 x Why Analysis Form - Non-Detection Why did the non-conformity escape?		
1st Why?	Question:	Why was brush with slot on the face not detected?
	Answer:	Because criterio was not established in inspection instruction
2nd Why?	Question:	Why wa criterio not established in inspection instruction?
	Answer:	Beacuse criterio was not established in control plan
3rd Why?	Question:	
	Answer:	
4th Why?	Question:	
	Answer:	
5th Why?	Question:	
	Answer:

Corrective Action	Expected result efficiency	Who	Due Date	Done Date
Update work instruction with correct criterio for reversed tamping on brush	Detect the defect on real time and correct the problem	Astrid L.	21-mar-25	Ongoing
Update control plan with correct criterio	Correctly document the defect in the production line	Astrid l.	28-mar-25	Ongoing
Update AMEF with correct criterio	Correctly document the defect in the production line	Astrid l.	28-mar-25	Ongoing
