8D REPORT

Customer Name : **M/s.Aditya Auto**

8D-no:	1	**Submit Date:**	18.08.2025
Status:	Open		
Title:	Brush Width side Serration	**Supplier:**	AVO Carbon India.
Part No:	500383-A	**Place:**	Chennai, India.
Reported Date:	09.08.2025		
Editor:	Suresh.A	**Supplier Agent:**	Mr.Ramkumar

Compliant Text: **Brush Width side Serration**

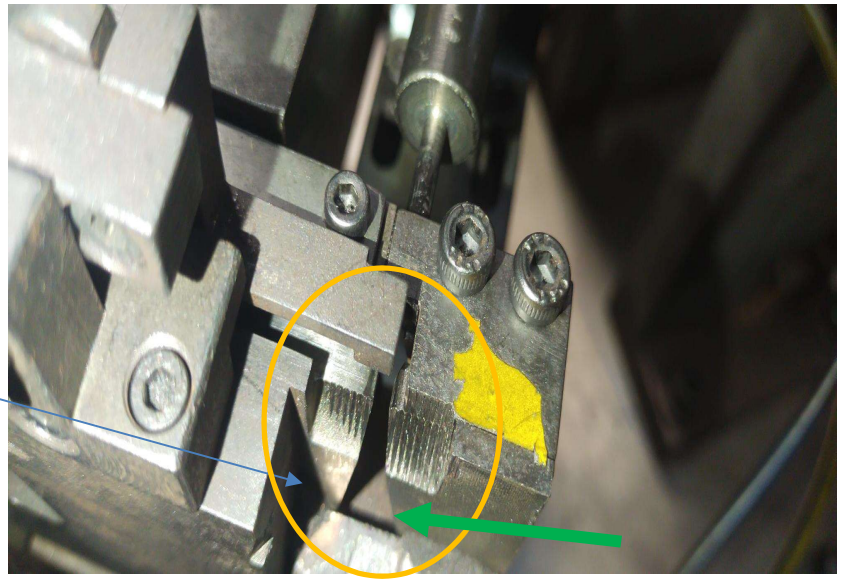
Occurrence causes:	Responsible	Plan End
Why? - Brush Damage Why? - Grinding mark on brush width side Why? - Brush flexible struck after serration operation Why? - Flexible Ejection gap was less Why? - Root cause: Based on picture shown, brush grinding(Serration) operation happen width side,while our further check with machine after completion of serration process part ejected and collected by bins, while ejection some parts are struck with ejection point due to flexible wire releasing less gap it leads to serration done again with width side of brush in next cycle of process.	Vasanth /Saravanan	13-Aug-25
Detection causes :		
Parts was moved along with next cycle of brush and it was missed with inspection	Senthil	13-Aug-25

Ejection Gap was less

The fixture gap was less, it leads to brush struck at the station

Brush Ejection fixture was modified, the flexible wire ejection point was cut and gap increased to move parts freely into collection chute, this wide gap was ensure flexible wire not struck with gap
