AVO Carbon INDIA	8D REPORT	Fromat no:F/QAD/8D/09 Rev no:00 Rev date:16.08.2022

Title: 46770009 Brush Thickness oversize found customer assy line **Supplier:** AVO Carbon india Pvt ltd

Part No: 16770009(46770009) Avo Part # 9227-01 **Place:** Chennai-98

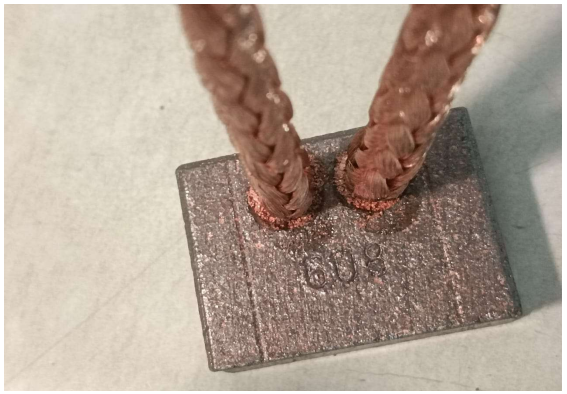
Root cause	Responsible	Plan End
Why? -Brush Thickness oversize Why? - Burr projection Why? - Tamping process create Why? - **Root cause:** Process flow of manufacturing of this parts, while manufacturing process marking (608) provided by stamping and subsequent operation tamping with flexible wire,it makes little burr projection and leads to thickness higher side. Various point of inspection with vernier and other insturment leads to parts flow out..	Saravanan	20.05.2024

Presently followed the above process for flex insertion we done drilling and tamping, it create little burr projection leads to thickness higher side

Title	Responsible	Plan End
For improvement we alert our process to minimize the burr level with stamping and tamping processes, However little projection of burr is state of process, So it is better we propose will make the brush with wire in the pilling process instead tamping, so that we will meet all the requirements in the pilling stage itself and finally we will grind the brush thickness with a nominal size. So please consider our proposal to come out of this situation permanently.

The above proposed process, flex insertion can be done with pilling operation itself, so we prevent the burr projection on tamping process
