8D report

Customer plant	AVO Tianjin	**Supplier**	AVO Carbon Germany	**Date of claim**	07.03.2024
Customer contact	Liyuan Ren	**AVO contact**	Joachim Gehl		
Customer reference	e-mail 07.03.2024	**AVO reference**	240304

Problem description	Copper wire falling of	What happened?	Copper wire falling of
Incident type	Customer claim	Why is it a problem?	Parts can not be assembled
PN customer/AVO	5000621	When did it happen?	07.03.2024
Part description	Carbon brush	Who detected it?	Production
AVO batch number	271796, 271797, 271798	Where was it detected?	NIIDEC Dalian
Recurrence	non reccurent	How was it detected?	CT-scan
Defect S/R	no	How many nOK parts ?	1
Standard process used	yes		
When was the part manufactured?	pressing machine => 6157 grinding machine => AVO Tianjin

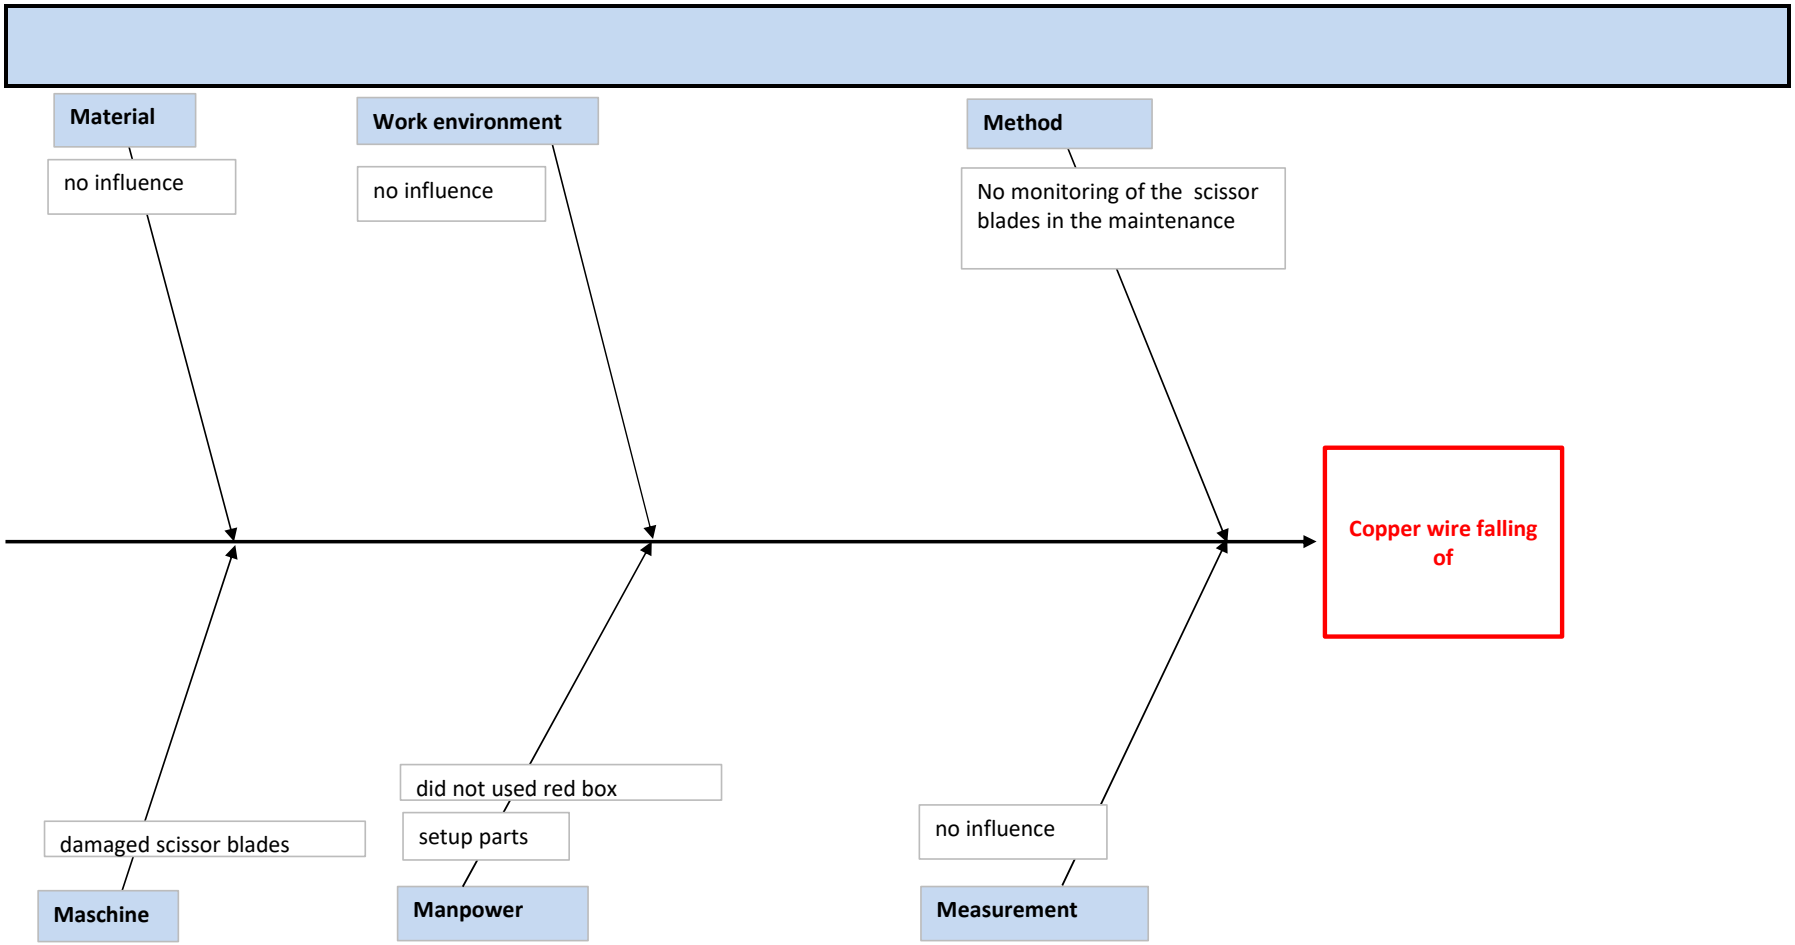
Ishikawa

During set-up the damaged scissor blade caused the wire to be pulled out of the carbon brush when it was cut.

Material
no influence
Work environment
no influence
Method
No monitoring of the scissor blades in the maintenance
Copper wire falling of
damaged scissor blades
Maschine
did not used red box
setup parts
Manpower
no influence
Measurement

Actions	Resp.	Date plan.	Date clos.
Replace the damaged sizzor blade	U. Walocha	07.03.2024	22.03.2024
Monitoring of the scissor blades in the maintenance plan	U. Walocha	08.03.2024	22.03.2024
