Supplier 8D report
供应商8D报告

Customer plant 客户工厂	Kelier	**Supplier** 供应商	AVO Anhui/Tianjin	**Date of claim** 投诉日期	2025/9/28
Customer contact 客户联系人	Tony	**SAP no.** SAP编号		**Date of QR** QR日期	2025/9/28
Claim reference 客诉编号	20250929	**Author** 审核者	Tim	**Update of QR** QR更新日期	2025/10/11

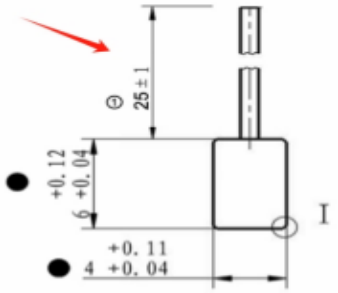
nok part picture / sketch 不良品照片/草图

Problem description 问题描述	碳刷铜线尺寸短 Short size of carbon brush copper wire	What happened? 发生了什么	Standard:: 25±1 Actual size:: 18.74
Incident level事故等级	C2 : Production claim	Why is it a problem? 为什么这是一个问题？	影响使用，碳刷无法正常工作 Affects usage, carbon brushes cannot function properly
Part number料号	UP28	When did it happen? 何时发生的？	2025/9/28
Part description名称	Brush	Who detected it? 何人发现的？	OAperator
Traceability of nok parts 不合格品追溯	20250822	Where was it detected? 在哪里被发现的？	Assembly line
Recurrence 事故再发？	no reccurent defect	How was it detected? 如何发现的？	visual inspection
Defect S/R 不良类型	no	How many parts ? 发现多少不良？	1/4000

碳刷成型加工过程中，由于滑道内调机品没有清理，造成混入正常加工产品

During the carbon brush forming process, due to the lack of cleaning of the adjusted products inside the slide, they were mixed into the normal processed products

铜线长度没有监测装置，超限产品无法识别

There is no monitoring device for the length of copper wire, and products exceeding the limit cannot be identified
