8D-Report

Claim no.	C_11787	**Version no.**	01
Date entered	13.08.2024	**Interim report**	13082024
Part No.	B130	**Customer claim**	yes
Date completed	open	**Final Decision for claim**	open

Symptom
Kohlen zu kurz

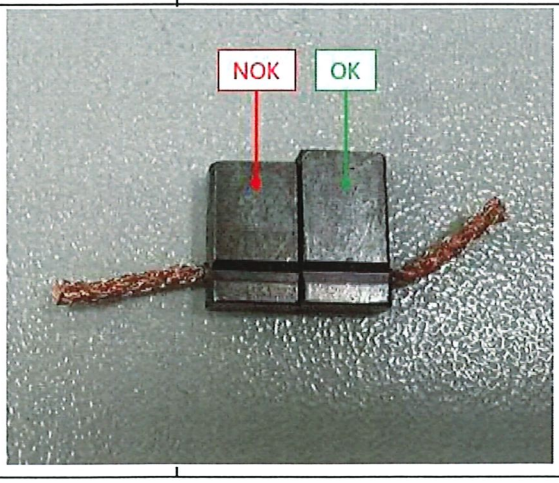
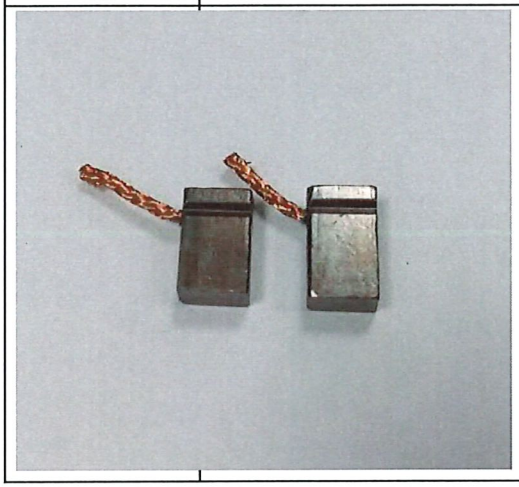
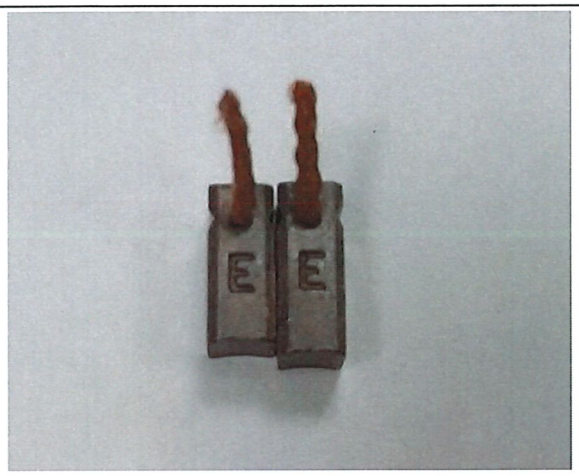
Position: 1			
Entered	13.08.2024	**Part no.**	B130, WE iBE batch 2347D1
Problem description	WE iBE Kunde hat Fertigteile reklamiert, bei welchen die Kohlen zu kurz sind Spezifikation: 10 +/-0,3 mm (**SPC Maß !**) NOK Teile: 9,21 - 9,22 mm Anteil: 78.000/15 = 0,019%

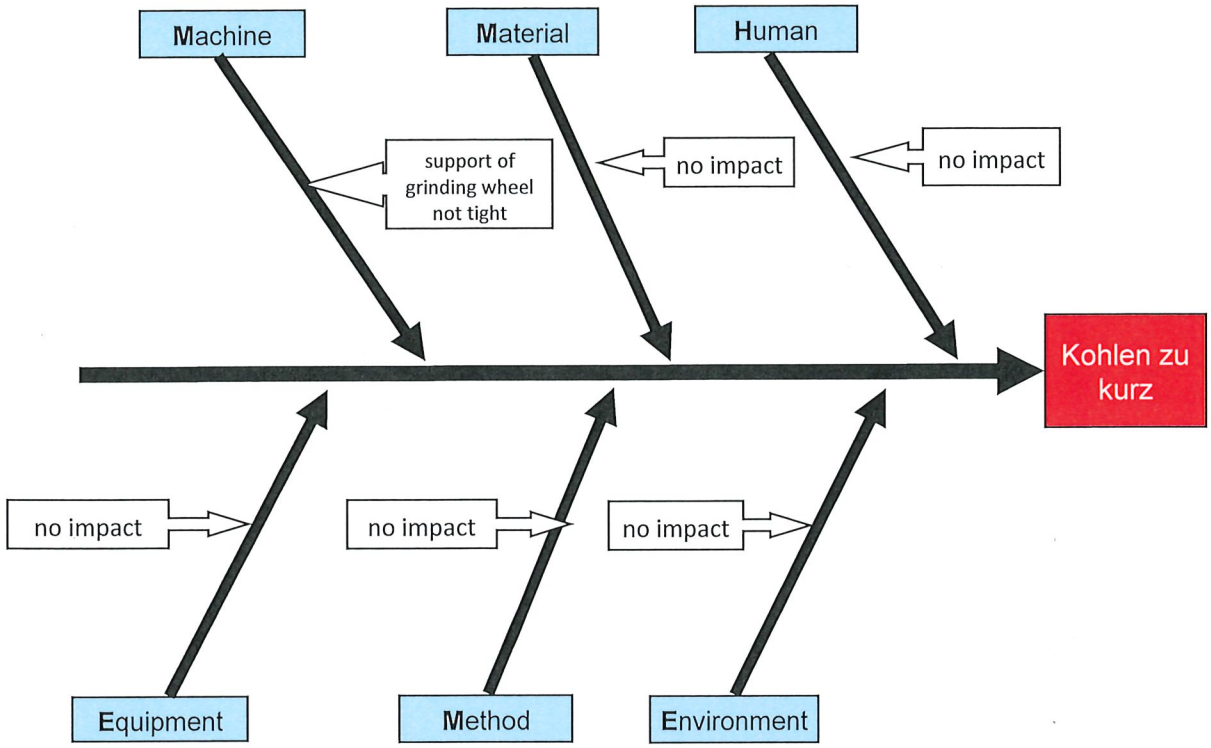
Cause Effect Diagram

Cause theory				
No.	Title	Confirmed on	Category	Excluded
1	wrong adjustment during setup	only 753 pcs found	man	excluded
2	wrong adjustment after wheel change	only 753 pcs found	man	excluded
3	support for grinding wheel movement was not tight	single parts where found in different card boxes	machine

Questions on the theory 1:	
Why happened?	
1	because screw of support was not tightened
2	because it was missed by technician
3	because technician was unattentive
4	because he was disturbed by operator
5	
Why not discovered?	
1	because the defect does not occur permanently
2	because the support is partially locked in his position
3	because during serial inspection the defect part was not detected
4	
5

Cause No.	Action title	Responsible employee	Start date	Planned end date
1	support - bearing was defect - grinding was not continuously	Maintenance / MR	18.09.2024	19.09.2024
Comment	support is working properly now			
2	check conditions of preventive maintenance	Gabriel Dohr	18.09.2024	18.09.2024
Comment	preventive maintenance was checked and added to the plan			
3				
Comment

Cause No.	Action title	Responsible employee	Planned start date	Planned end date
1	check conditions of preventive maintenance	Gabriel Dohr	18.09.2024	18.09.2024
Comment	preventive maintenance was checked and added to the plan			
2	check during work place audits	QM	18.09.2024	ongoing
Comment				
3				
Comment
