Assymex Monterrey S.A. de C.V.

QUALITY CONTROL REPORT (10D)

QCR	18799	*Date:*	24-09-2024
AssyMex Contact / Title:	Leticia Castillo	*Customer Contact / Title:*	Martin Sosa
Contact Phone:		*Contact Phone:*	8128607691
Email:	leticia.castillo@avocarbon.com	*Contact Email:*	martin.sosa@tricoproducts.com

- What happened? *Description of the Problem*	**Brushcard without ferrite on inductor**	**- Why is it a problem?**	**Low perfomance of motor (low inductance)**

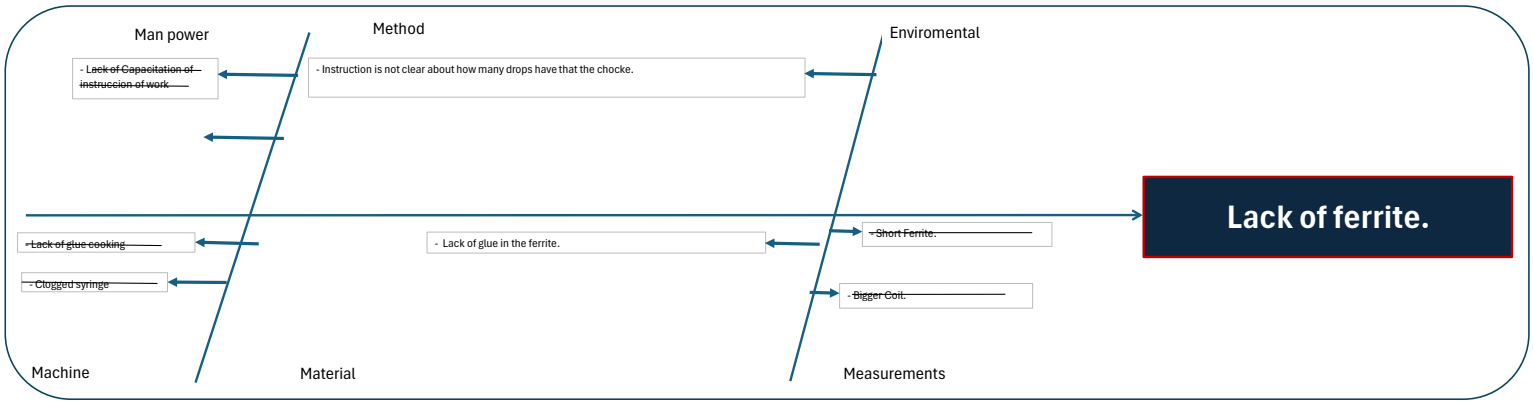
4,1.-	Analysis and Root Cause - Ocurrence

Cause: Instruction is not clear about how many drops have that the chocke.	
1st Why?	Question: Why lack ferrite in chocke?
	Answer: because the process was not executed correctly
2nd Why?	Question: Why the process was not executed correctly
	Answer: Because it does not mention the step by step of how many drops of glue the ferrite should have.
3rd Why?	Question: Why it does not mention the step by step of how many drops of glue the ferrite should have.?
	Answer: Because it changed the assembly process.
4th Why?	Question: Why Because it changed the assembly process?
	Answer: Because we sought to improve the efficiency of the process.
5th Why?	Question:
	Answer:

Cause: Lack of glue in the ferrite.	
1st Why?	Question: Why lack ferrite in chocke?
	Answer:Because it lacks glue.
2nd Why?	Question: Why it lacks glue?
	Answer: Because the drop of glue was not the right one.
3rd Why?	Question: Why the drop of glue was not the right one.?
	Answer: Because the glue did not have the correct temperature.
4th Why?	Question: Why the glue did not have the correct temperature?
	Answer: Because there was no preheating and temperature control of the glue
5th Why?	Question: Why there was no preheating and temperature control of the glue
	Answer: Work instructions did not consider preheating and temperature control of the glue.

Corrective Action	Expected result efficiency	Who	Due Date	Done Date
Preheat the glue before starting the operation.	Parts without loose ferrites.	Matilde Serrano	24-sep-24	24-sep-24
Update instruction with the number of drops of glue you should have.	Parts without loose ferrites.	Leticia Castillo	24-sep-24	27-sep-24
Add the preheating of the glue to the instructions.	Parts without loose ferrites.	Leticia Castillo	24-sep-24	27-sep-24

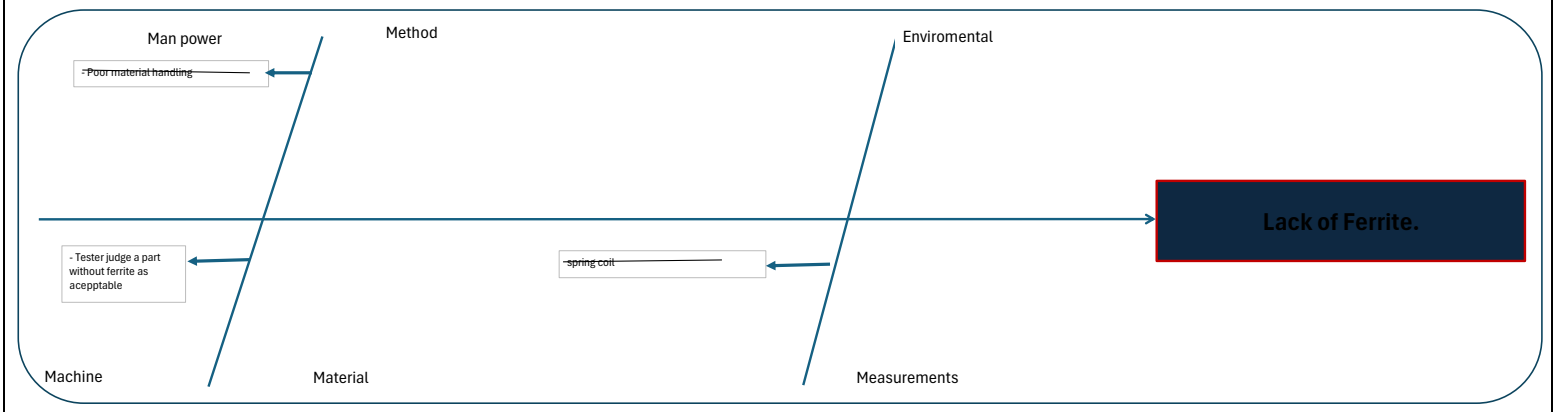
4,2 .-	Analysis and Root Cause - Non Detection

Cause: Tester judge a part without ferrite as acepptable	
1st Why?	Question: Why tester judge a part without ferrite as acepptable?
	Answer:Because it doesn't do the inductance test.
2nd Why?	Question: why it doesn't do the inductance test?
	Answer: Because the tester does not have inductance equipment.
3rd Why?	Question: Why the tester does not have inductance equipment.?
	Answer: Because it was not considered in the test of tester.
4th Why?	Question:
	Answer:
5th Why?	Question:
	Answer:

Corrective Action	Expected result efficiency	Who	Due Date	Done Date
Add inductance test on capacitance tester	Parts without loose ferrites.	Alicio Flores	02-dic-24
