Quality Alert

N° of Alert: 2024-JULY-018	*Date 17/07/2024*	*update of Alert:*
Customer Plant: AVO/SCEET Fahs	Supplier: AVO Poitiers	
Customer Contact:CharaabiLassaaad@avocarbon.com	Editor:Brika belgacem

Part number:	A60110821 '(1026647)	When did it happened:	16/07/2024
Part name:	brush SIM2	Who detected it	Technician
Batch number:	280504	Where was it detected	at incoming inspection
Recuerrence defect:	Yes	How was it detected	by measures
Demerit:		How many parts:	3 pcs

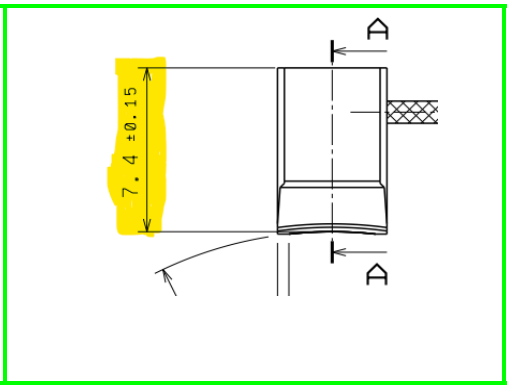
nok Part (Sketch - Picture)

1- Porblem Description :the brush was manufactured with nok length (dimension 7,4+/-0,15 not conform in min)
2- Why is it a problem:the brush was too short (the dimension 7,4 is not in specification measured values 7,15mm;6,95mm…)
