Supplier 8D report
供应商8D报告

Problem description 问题描述	碳刷铜线尺寸短 Short size of carbon brush copper wire	What happened? 发生了什么	Standard:: 25±1 Actual size:: 18.74
Incident level事故等级	C2 : Production claim	Why is it a problem? 为什么这是一个问题？	影响使用，碳刷无法正常工作 Affects usage, carbon brushes cannot function properly
Part number料号	UP28	When did it happen? 何时发生的？	2025/9/28
Part description名称	Brush	Who detected it? 何人发现的？	OAperator
Traceability of nok parts 不合格品追溯	20250822	Where was it detected? 在哪里被发现的？	Assembly line
Recurrence 事故再发？	no reccurent defect	How was it detected? 如何发现的？	visual inspection
Defect S/R 不良类型	no	How many parts ? 发现多少不良？	1/4000

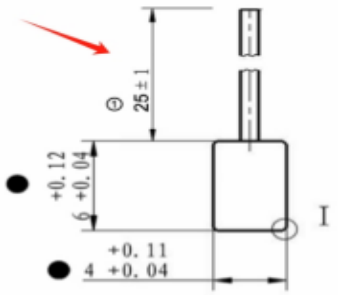
nok part picture / sketch 不良品照片/草图

At present, the cause of the failure cannot be determined from the pictures. Further investigation and analysis of the manufacturing process and production records are required.
