Claim Management Panel

Supplier: **AVO Carbon France (NMAS609128)**

Problem description: **Trimmed Sheet Not Punched**

Claim reference: **NMAS/609128/3/2024/1696**

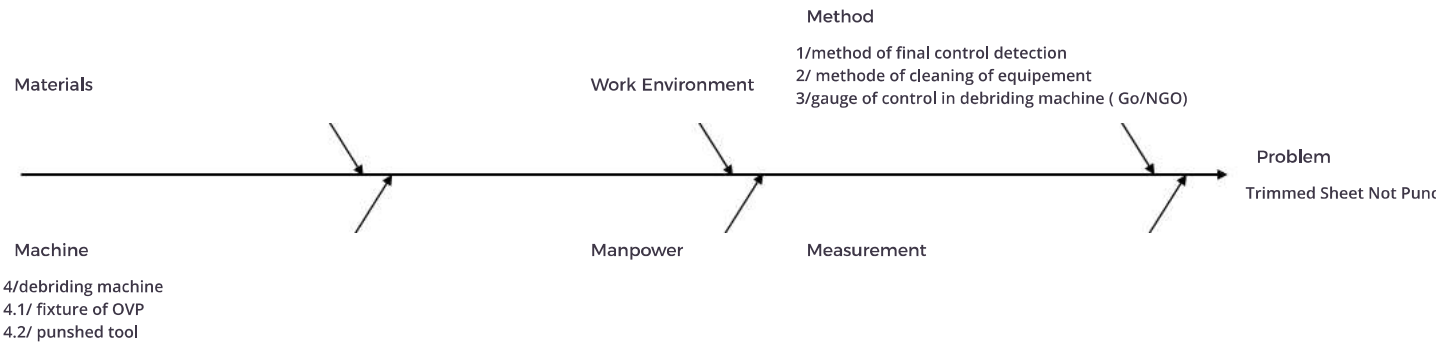
Ishikawa Diagram

standard is not enough :
the frequency of cleaning the debreding station is not well defined , that's mean cleaning each shift is not enought to eliminate the burr and the risk of punshed point not done
