IGARASHI MOTORS INDIA PVT.LTD.
MEPZ -SEZ, TAMBARAM, CHENNAI -45

8D SUMMARY REPORT

Part Name	Part Number	Supplier / Customer
EPB CARBON BRUSH	**CB-VA08-1001**	**Supplier**

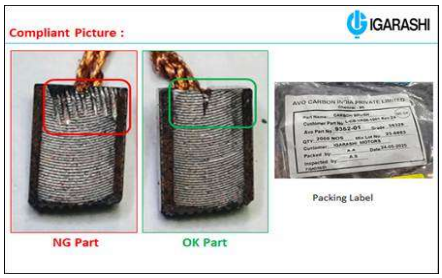
Grooving issue on the Shunt wire side

Occurrence Failure Cuases	Detection Failure Causes	System Updation failure Cause
while verfication, after serration operation some ejected parts are struck in the fixture due to powder accumulation, when serration wheel moves it touch with this part and make wheel imperssion on the part, some parts hit into serration wheel when ejecting the parts from fixture.	This defect flow out with visual inspection and defect was not included in the SOP	Visual standard (SOP) not covered this defect.

Occurrence failure Actions	Detection Failure Actions	System Updation failure Actions
As immediate measure we clean the powder accumulation ever hour and place the powder suction close to the griding, also we placed air jet near to powder accumulation, so blowing air to avoid accumulation of powder and it was suck by suction pipe. it ensure powder accumulation. also we adjust grinding wheel travelling to avoid parts hitting back into grinding wheel while ejecting.	Visual inpsector alerted through Q alert and re taining and awareness created through one point lesson.	SOP to be update and followed
