1. Root cause Analysis

DYAUTO

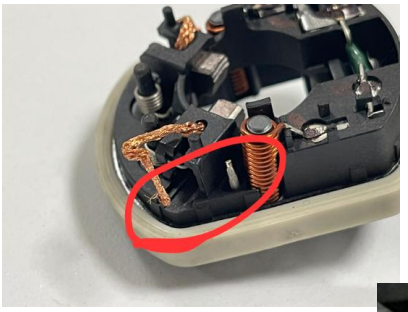
Description	**Bad Part:** Detached joint between brush wire-inductor **Good Part:** Brush wire correctly joined to inductor

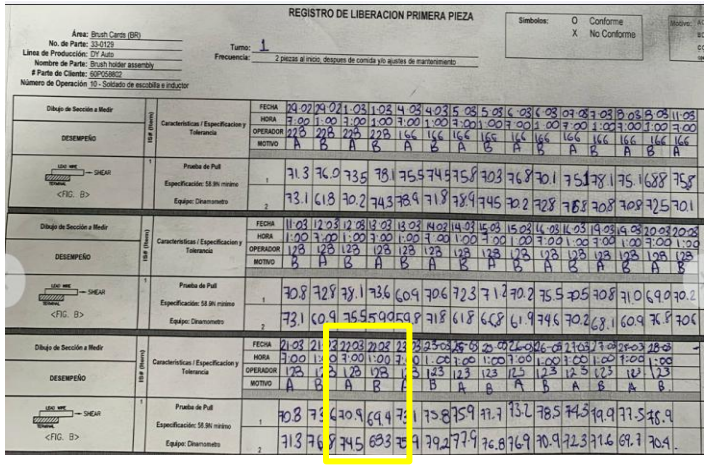
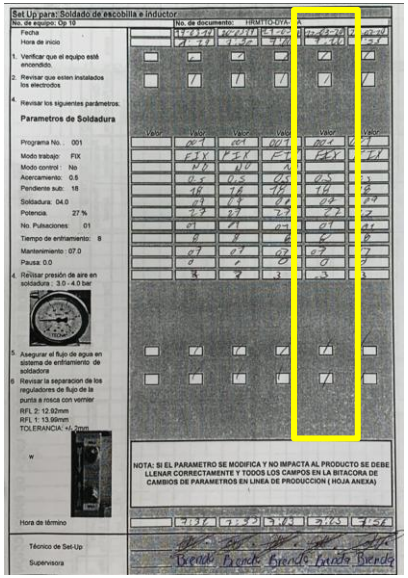
High quality
Picture	Pull test register Specification 58.9N min Frecuency: Start shift and after lunch

Pull test results 22-3-24: 70.9,74.5, 69.4,68.3 Set up register sheet

Description	The set up register sheet and pull test register shows datas in specification

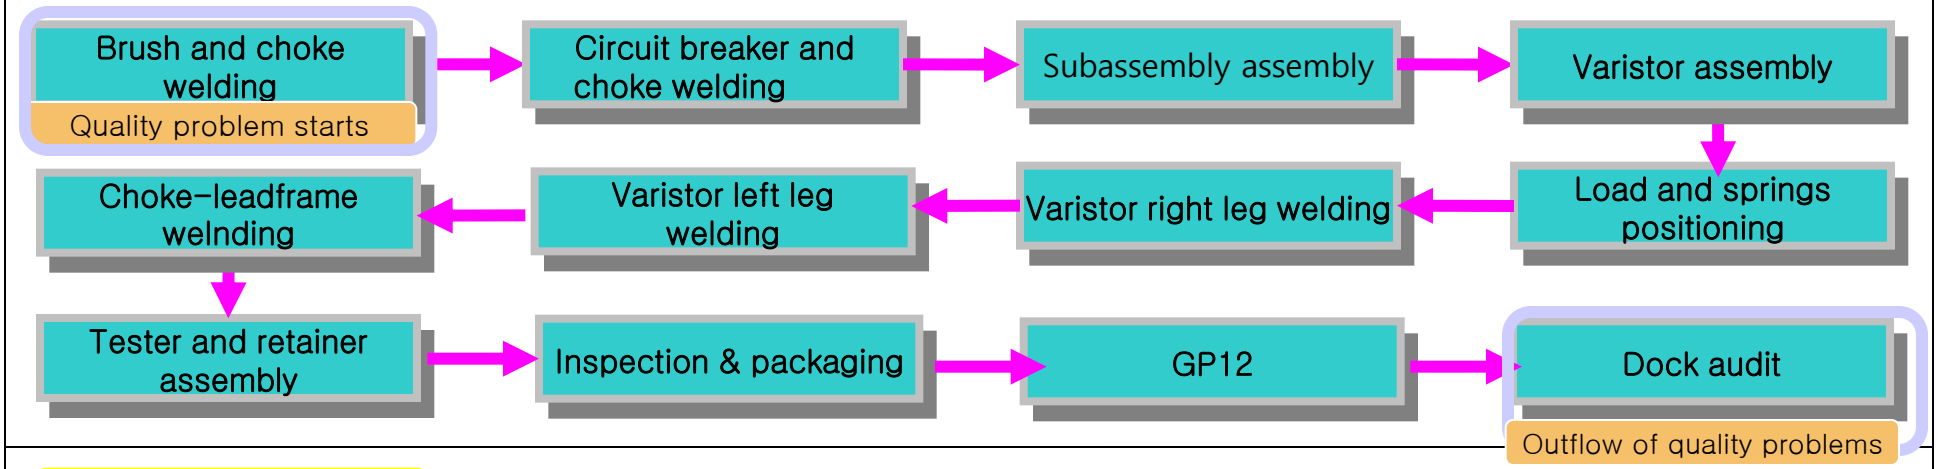
Lay - Out

fair		
Picture		
Contents	**Brush wire not combed to the moment to be welded to inductor**
