8D report

Customer plant:	Eurotec	**Supplier:**	AVO Carbon Germany	**Date of claim:**	01.07.2025
Customer contact:	Anna Strnatkova	**AVO contact:**	Gunther Luschtinetz		
Customer reference:	25039	**AVO reference:**	250605

Problem description	Damaged wires of the carbonbrush	What happened	Damaged wires of the carbonbrush
		Why is it a problem	•Potentional functional issue •Potentional customer complaint
Incident type	Customer claim		
Part number AVO	1026151	When did it happen	30.06.2025
Part number Customer	3 134 320 622	Who detected it	Operator
Batch number	285173	Where was it detected	Production
Recurrence	Non-recurrent	How was it detected	Visually
Defect S/R	No	How many bad parts	3 NOK pcs+ 3146 suspicious
Standard process used	Yes

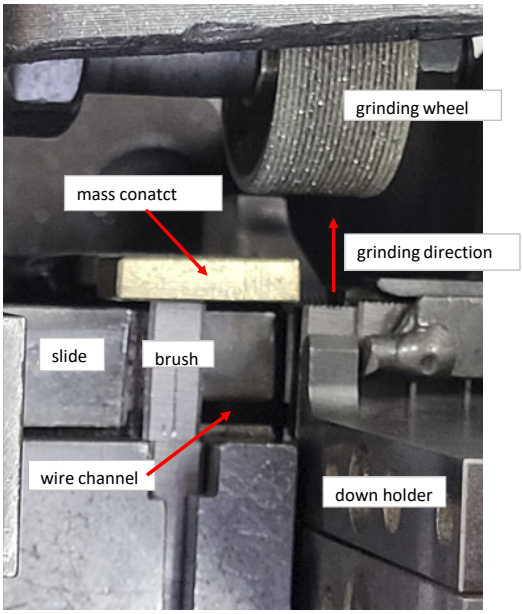
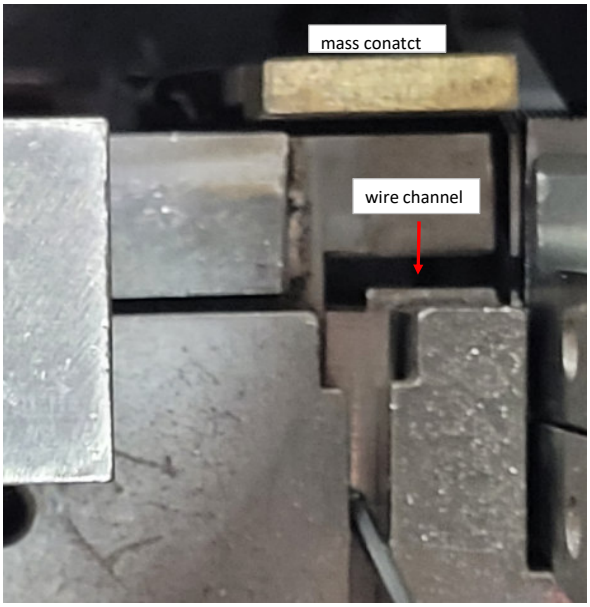
D 4. Root cause of occurrence

The mass contact on the grinding machine was contaminated. This caused the contact for the carbon brush feed to move the brush came too early and the cable became jammed in the cable guide and damaged.

Problem	N°	1st WHY?	1st ANSWER	2nd WHY?	2nd ANSWER	3rd WHY?	3rd ANSWER	4th WHY?	4th ANSWER	5th WHY?	5th ANSWER
	1	Why was the wire damaged?	Because the cable became jammed in the cable guide and damaged.	Why the cable became jammed in the cable guide and damaged ?	Because the contact for the carbon brush feed to move the brush came the too early.	Why did the contact for the carbon brush feed to move the brush came the too early.	Because the mass contact was contaminated.

Corrective actions	Responsible	Date planned	Date closed
Instruction of employees with special attention to cleaning the mass contact.	M. Yorulmaz	05.09.2025	
Check whether it is possible that, if there is continuous contact due to contamination at the mass contact, the slider does not pass on the carbon brush and the cycle is interrupted.	G. Dohr	05.09.2025
