8D report

Customer plant:	Igarashi SZ	**Supplier:**	AVO Carbon Germany	**Date of claim:**	10.01.2025
Customer contact:	MM Wang	**AVO contact:**	Gunther Luschtinetz		
Customer reference:	E-Mail 10.01.2025	**AVO reference:**	250102

Problem description	Carbon brush crack	What happened	Carbon brush crack
Incident type	Customer claim	Why is it a problem	•Interruption of the production •Decreased outputs from the line •Producing defective parts
Part number AVO	1023501	When did it happen	23.04.2024
Part number Customer	CB-C036-0032-06	Who detected it	Inspector
Batch number	278979	Where was it detected	Production
Recurrence	Non-recurrent	How was it detected	Visually
Defect S/R	No	How many bad parts	27/ 2000
Standard process used	Yes		
When was the part produced?	Pressing machine => 6125: 11.03.24-20.03.24 Grinding machine => SSS 3220: 25.03.24-27.03.24

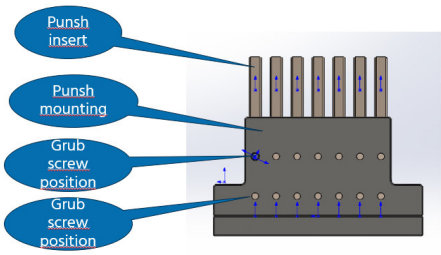
Upper punch

The punch has different single parts, the mounting and five punch inserts. Every punch insert is fixed with a single grub screw. One of the grub screw has loose and the punch lost his fixing. As the result, the punch insert has been pushed upwards and the wire has not been pressed in deep enough. Based on the fewer inseration deepth of the wire, the wire come loose.

Change the fixing grub screw to self secure grub screws
