Claim Management Panel

Supplier: **AVO Carbon France (NMAS609128)**

Problem description: **Fuse Choke Leg Height NOK**

Claim reference: **NMAS/609128/2/2024/1673**

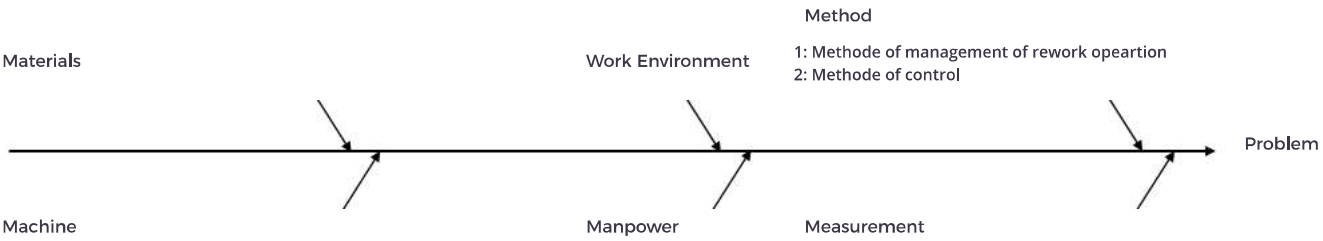
Ishikawa Diagram

lack of standard : there is no standard of rework operation
Our Production team receive this palettes to checked and change the spring NOK and passed again in Electrical test.
After the rework, the pallet was still waiting for the availability of the electrical test, and due to the miscommunication between the production team and warehouse, the agent of the warehouse entered the pallet to be delivered

3: EOL electrical test : test the height of fuse choke
