Claim Management Panel

Problem description: **Intermittent Hall function - unwelded fork**

Claim reference: **NMAP/551841/10/2024/1879**

Part Number & Description: Brush mounting plate assy (503-773-99-99)

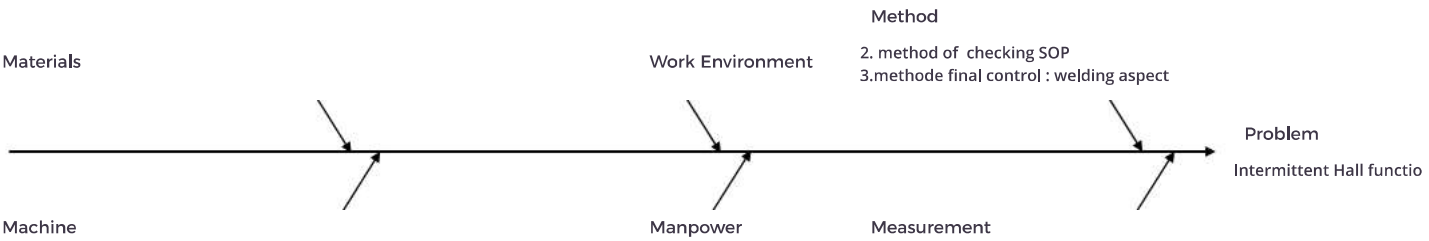
Ishikawa Diagram

1-Pressure controller not locked and setter can change the program manually
2-No sensor implemented to launch new cycle in the machine

1.welding machine of Hall Ic fork : pressure parameters during welding.
4.welding machine of Hall Ic fork : current parameters during welding.

1.welding machine of Hall Ic fork : pressure parameters during welding.	During SOP the quality Agent control the value of Pressure	according to the work instruction */ min 2.5 bar */ Max 3.5 bar if the pressure out tolrance the weling machin stop immediatly	the OK parts produced with pressure = 3 bar	the NOK parts produced with pressure = 2 bar machin not stopped and part skipped	No	Yes	Make the welding with pressure 2 bar (out of tolerance Min) --> defect was created	11/18/2024	Yes

4.welding machine of Hall Ic fork : current parameters during welding.	During SOP the quality Agent control the value of Current	according to the work instruction */ min 1.9 KA */ Max 2.6 KA if the Welding current out of tolerance the welding machine stopped automatically	2.3 KA	1.8 KA minimum 2.7 KA maximum	Yes	Yes	Make the welding with current 1.6 KA (out of tolerance Min) and 2.7 KA (Out of tolerence maximum)	11/28/2024	No

Action	Responsible	Date Plan	Date Clos.	Attachments Please click 'Save' to activate attachment field
Automatisation of the pressure controller	Hafedh	12/2/2024	12/20/2024	
Add a sensor to detect the position of the piston	Kamel	12/4/2024	12/20/2024	
Update the process rules guideline: Add the requirement of sensor for each Piston installation	Kamel	12/4/2024	12/20/2024
