8D report

Customer plant	Eurotec	**Supplier**	AVO Carbon Germany	**Date of claim**	01.02.2024
Customer contact	Anna Strnátková	**AVO contact**	Joachim Gehl		
Customer reference	24006	**AVO reference**	240207

Problem description	Broken edge on the back side of carbon brush	What happened?	Broken edge on the back side of carbon brush
		Why is it a problem?	Brush can`t used in assembly
Incident type	Customer claim		
PN customer/AVO	3 134 320 663 / 1026299	When did it happen?	No information
Part description	Carbon brush	Who detected it?	No information
AVO batch number	276503/ 276608	Where was it detected?	No information
Recurrence	non reccurent	How was it detected?	No information
Defect S/R	no	How many nOK parts ?	9 NOK assembled+ 2 NOK single/ 5 nok
Standard process used	yes		
When was the part manufactured?	pressing machine: K50-2: Batch-nb.:276503: 13.11.23-15.11.23 pressing machine: 6157: Batch-nb.: 276608: 28.11.23-01.12.23

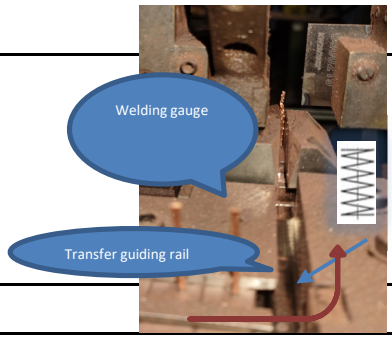
The downholder spring was broken and during the brush was pushed through the transfer guiding rail, the brush was not positioned and pushed against the sharp edge of the welding gauge.

Manipulation of the downholder spring of the welding gauge.

Actions	Resp.	Date plan.	Date clos.
Sensiblization of the workers	J. Gehl	27.02.2024	17.04.2024
Add the spring to the preventive maintenance with monthly cycle	P. Balenzano	26.02.2024	17.04.2024
Re-design of the gauge with slighty chamfers to avoid bad adjustment	U. Wallocha	27.02.2024	17.04.2024

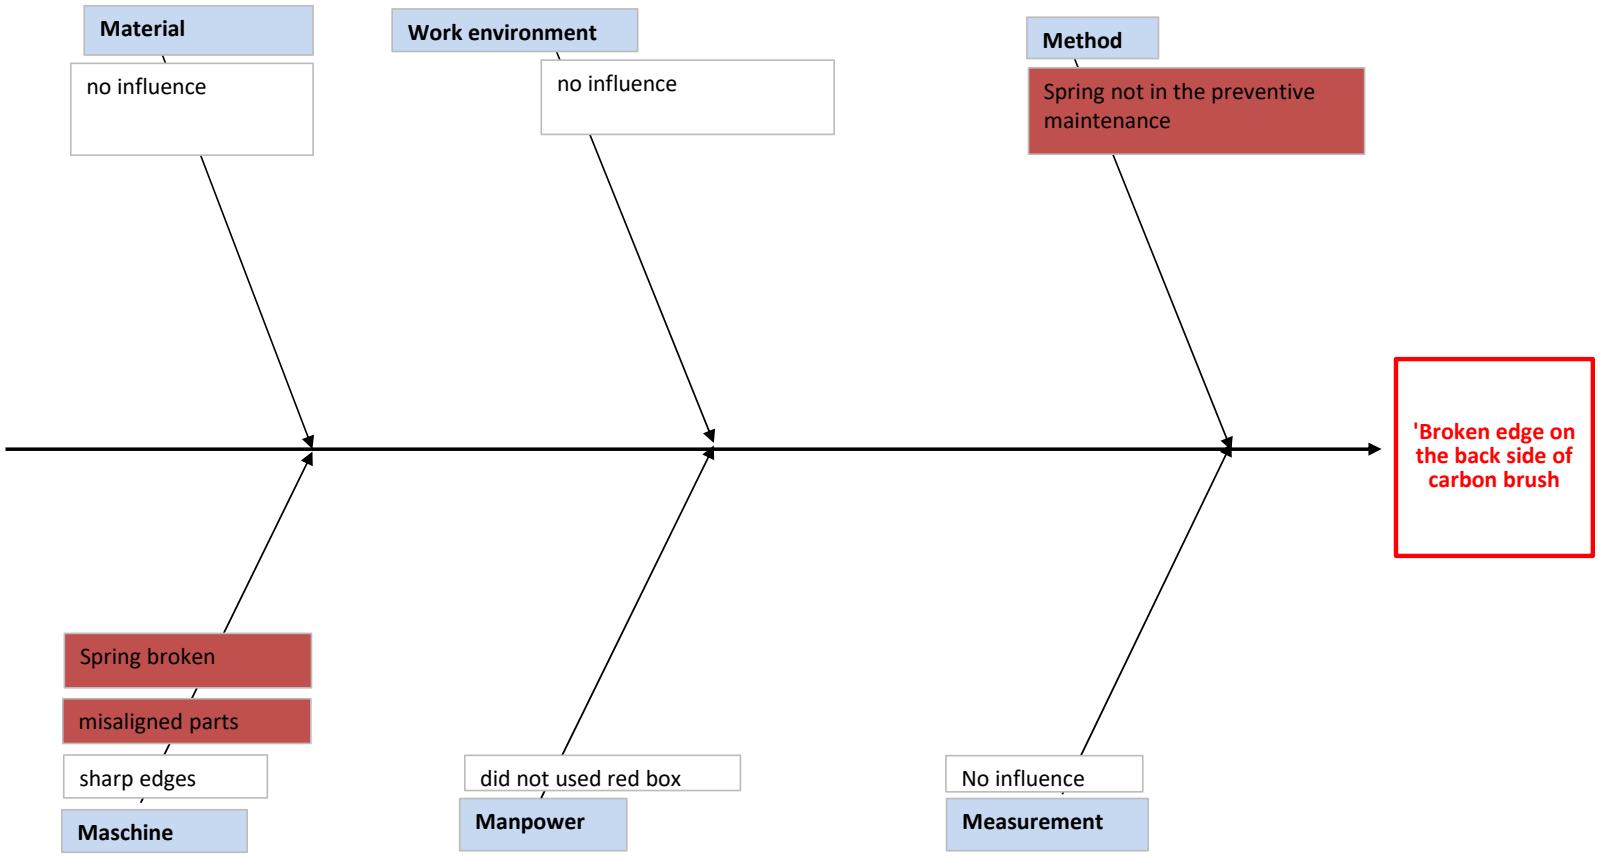
Ishikawa

Material
no influence
Work environment
no influence
Method
Spring not in the preventive maintenance
'Broken edge on the back side of carbon brush
Spring broken
misaligned parts
sharp edges
Maschine
did not used red box
Manpower
No influence
Measurement
