Claim Management Panel

Supplier: **AVO Carbon France (NMAP551841)**

Problem description: **pin of tin on the soldering pad, risk of contamination**

Claim reference: **NMAP/551841/2/2024/1662**

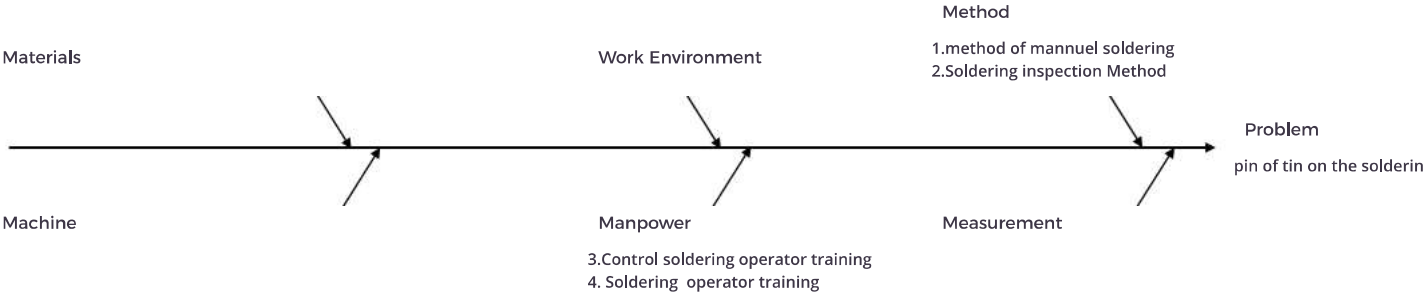
Ishikawa Diagram

At the end of soldering, the operator passes the soldering iron (with the tin remaining on the nozzle of the soldering iron) to be cleanned and the smal burr stick and drop in the sector of PCBA

The operator didn't have the clear information to control the point.control point is unclear because The control instruction doesn't specify the control point of not having tin in sector of PCBA

Action	Responsible	Date Plan	Date Clos.	Attachments Please click 'Save' to activate attachment field
switch to automatique soldering with robot	Hafedh	2/1/2024	2/1/2024	Automatic soldering with Robots.pptx

Updated the Control instuction of station control & inspection soldering points	marwan	5/21/2024	5/21/2024	IC700 Control soldering station updated.pdf
training opeartor of control& inspection of soldering point regarding the new issue	training departement	5/21/2024	5/21/2024	20240628122945192.pdf
