Assymex Monterrey S.A. de C.V.

QUALITY CONTROL REPORT (10D)

QCR	**112787**	*Date:*	**06-02-2025**
AssyMex Contact / Title:	**Astrid López**	*Customer Contact / Title:*	**Gregory Festian**
Contact Phone:	**+528181272830**	*Contact Phone:*	**+989-672-8400**
Email:	astrid.lopez@avocarbon.com	*Contact Email:*	GFestian@tifs.com

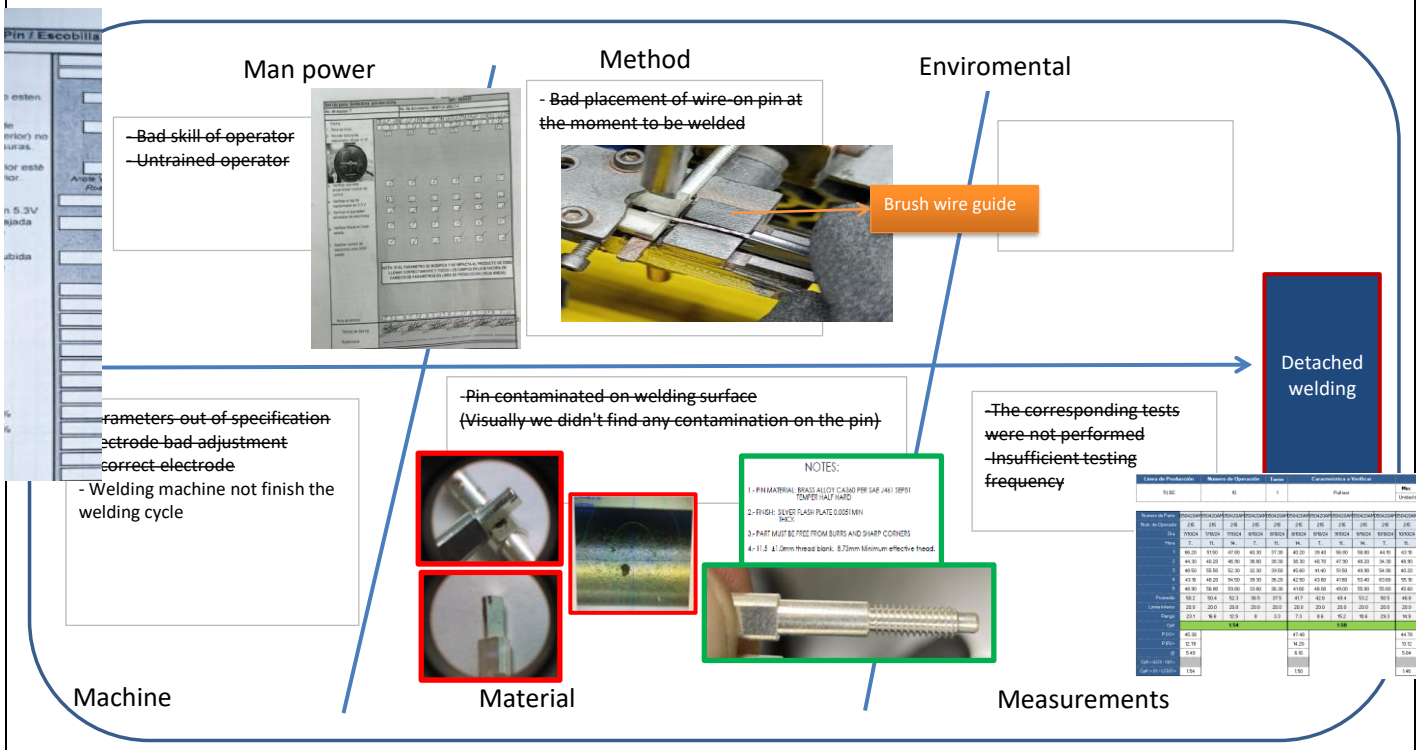
4,1.-	Analysis and Root Cause - Ocurrence

5 x Why Analysis Form - Ocurrences
Why did it happen?

1st Why?	Question:	Why the welding machine not finish the welding cycle
	Answer:	Pedal than active the welding cycle did not guarantee completion of the welding cycle
2nd Why?	Question:	Why the Pedal than active the welding cycle did not guarantee completion of the welding cycle
	Answer:	Cycle card of welding machine module was damage
3rd Why?	Question:	Why cycle card of welding machine module was damage?
	Answer:	system overcurrent due to a general power outage
4th Why?	Question:	
	Answer:	
5th Why?	Question:	
	Answer:
