Claim Management Panel

Problem description: **Lack Of Capacitor**

Claim reference: **NMAS/609128/8/2024/1822**

Problem description: **Lack Of Capacitor**
What happened?: **NOK Motors due to lack of capacitor**
Part Number & Description: **BRUSH CARD HOLDER 11TA (A18116507G)**
Why is it a problem?: **Motor malfunction**
Traceability of nok parts: **2402191-01**
When did it happen? : **8/7/2024** 11:00:00 PM (your local time)
Recurrence: **No reccurent defect**
Who detected it?: **11TA Assembly Operator**
Defect S/R: **Yes (S/security)**
Where was it detected? : **Assembly Line Electrical Test**
How was it detected?: **Electrical Test Stops**
How many parts ?: **7.00**

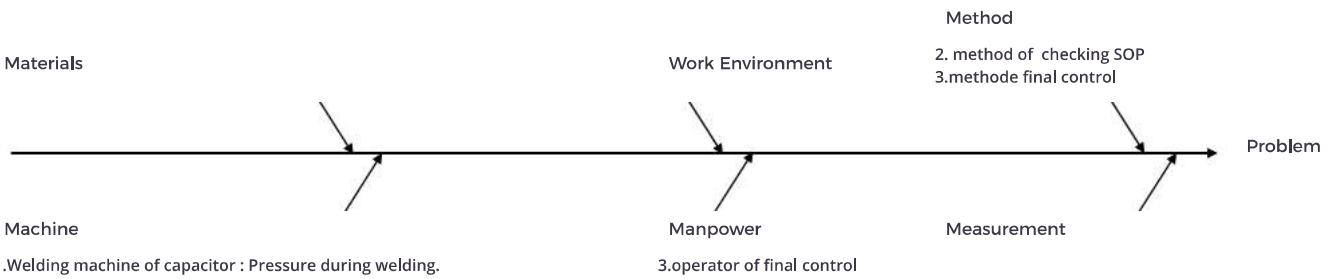
Ishikawa Diagram

There is no pressure stability inside the welding machine

For occurence
*/No pressure control in welding machine
For Non detection
*/In control instruction there is no Indication to avoid any manipulation of composants

For occurrence
*/ Implementation, a pressure control to stop the welding machine if the value of pressure out the tolerance
For non detection
*/ Update the Final control instruction with adding the indication to do not manipulate the components during the visual control
