Claim Management Panel

Supplier: **AVO Carbon France (NMAP551841)**

Problem description: **lack of DMC**

Claim reference: **NMAP/551841/1/2024/1659**

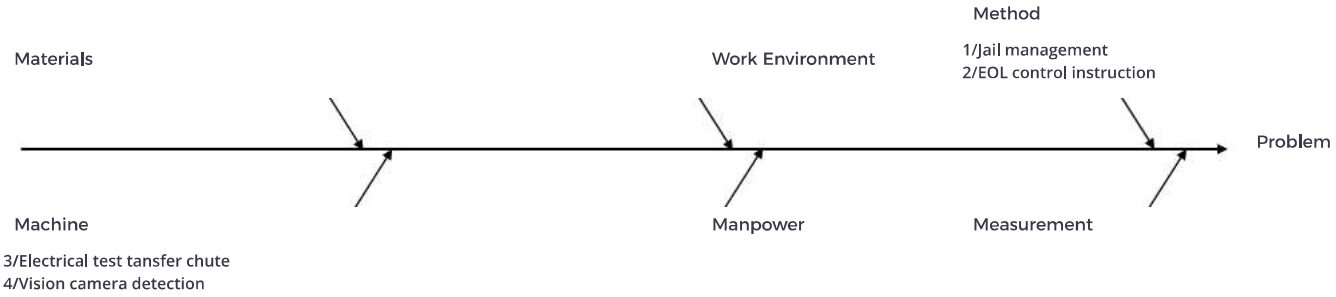
Ishikawa Diagram

Method : Jail management : Part with missing DMC mixed with good parts due to that part was escaped from the jail (NOK Vision test) and mixed with good parts because :
1-the transfet chute of nok part from the unloading clamp to the jail is not fixed and allow to drop NOK parts oustside the jail
2- the is lack training of opeartor due the management of parts on floor

'Re-integration of evacuated parts in the electrical test once no visual problem is detected in the parts(Parts missing DMC) --> the control vision reject these parts --> rejection takes place in the prison --> the prison is damaged (upper side of transfer chute)--> the parts are thrown on the floor

Action	Responsible	Date Plan	Date Clos.	Attachments Please click 'Save' to activate
update the design of the tansfer chute in the eletrical test to be tottaly cover and don't allow drop the NOK parts	hamza jbelli	2/19/2024	2/19/2024	
training session for all opeartor with mention forbidding to pick up all dropped parts on the flow and each dropped parts will be traited by quality agent	training departement	2/5/2024	2/5/2024
