Claim Management Panel

Supplier: **AVO Carbon France (NMAP551841)**

Problem description: **choke wire not welded**

Claim reference: **NMAP/551841/7/2024/1798**

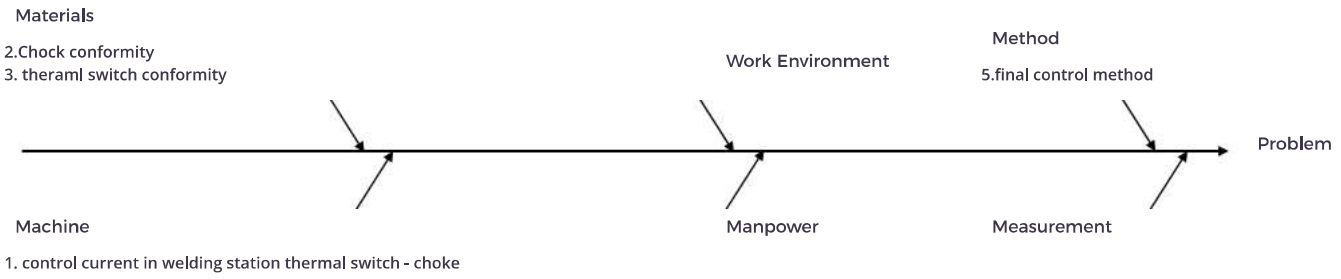
Ishikawa Diagram

the current was controlled but not efficient , the intervall were not well defined , the claimed parts were welded with lack current

Action	Responsible	Date Plan	Date Clos.	Attachments Please click 'Save' to activate attachment fiel
Implement control current in welding station to avoid any welding operation with lack of power	hajer	7/19/2024	7/19/2024	PH 3.75 Soudure Self sur PTH.pdf
