Quick fix for sales sample rotation seats

iZi Turn and iZi Twist

Cap.:	Rev.: 01	Date: 2019-11-01	Pages.: 1 of 2	Name: Options to reduce scratches in sales samples 2019 11 01.docx
Done by: Erik van der veer	Sign:	Saved:

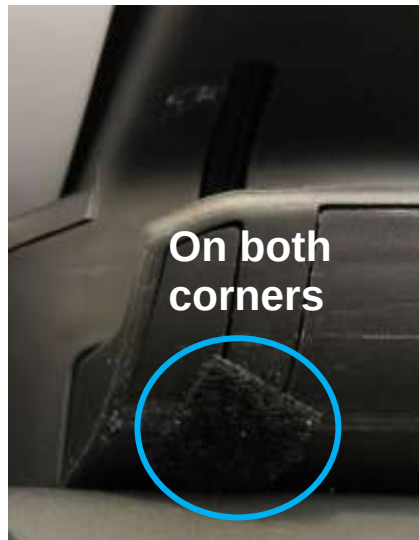
The rotation of the iZi Twist and iZi Turn seat can cause visible scratches on the plastic covers. This is unavoidable especially when dirt will get on the seat.

To avoid that seats used for demonstration will lose their mint condition appearance self-adhesive soft velcro might be applied. It is still important to keep the surfaces clean to avoid scratches.

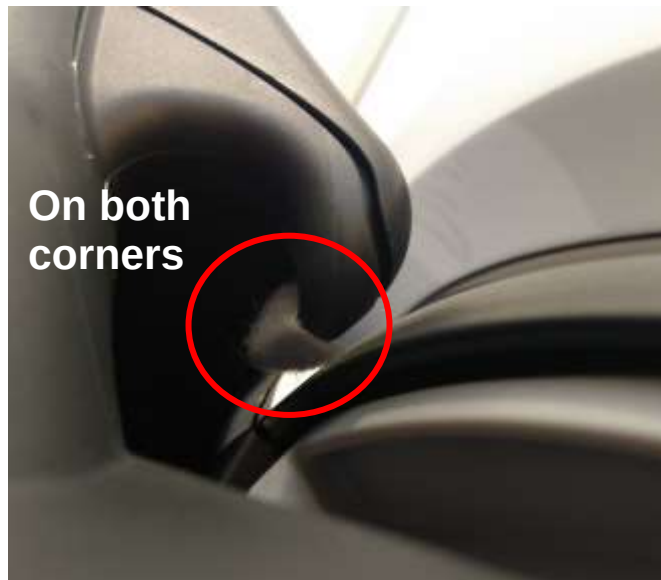
Scratch mark location 1

Scratch mark location 2

Self adhesive soft velcro

Colour: black (white is used in this manual to make position better visible)
