ROADSENSE | Infrastructure Intelligence

DATE: November 09, 2026
STANDARDS: ASTM D6433 | IRC:SP:77 / IRC:82

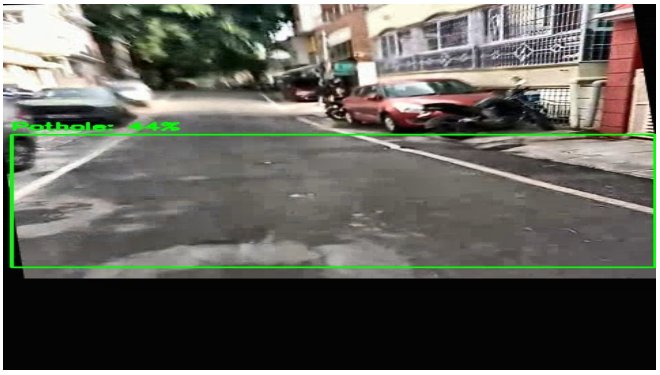
#01	**Pothole** Severe	**Cat Category C (Structural Base / Sub-base Failure)** IRC:82-Clause 6.4	12.91964, 77.55478	25000cm² depth 3.4cm	**99.9 kg**	Rs.4795	Deep milling, granular sub-base recompaction & DBM overlay
#02	**Pothole** Severe	**Cat Category C (Structural Base / Sub-base Failure)** IRC:82-Clause 6.4	12.91964, 77.55478	25000cm² depth 3.4cm	**99.9 kg**	Rs.4795	Deep milling, granular sub-base recompaction & DBM overlay
#03	**Pothole** Low	**Cat Category B (Standard Pothole Cavity)** IRC:SP:77-Clause 4.1	12.91943, 77.55473	3231cm² depth 3.4cm	**12.9 kg**	Rs.880	Square cut, edge priming & Cold-Mix Bituminous Patching
#04	**Pothole** Low	**Cat Category B (Standard Pothole Cavity)** IRC:SP:77-Clause 4.1	12.91933, 77.55472	6626cm² depth 3.4cm	**26.5 kg**	Rs.1491	Square cut, edge priming & Cold-Mix Bituminous Patching

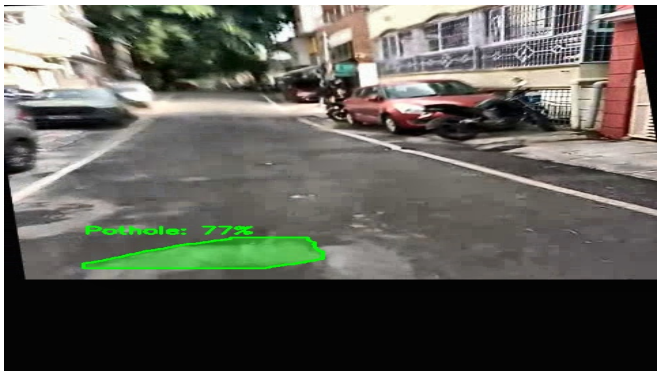
#05	**Pothole** Severe	**Cat Category C (Structural Base / Sub-base Failure)** IRC:82-Clause 6.4	12.91932, 77.55472	25000cm² depth 3.4cm	**99.9 kg**	Rs.4795	Deep milling, granular sub-base recompaction & DBM overlay
