Fabric Defect Inspection Report

Company Name:	ijo	**Date:**	2026-08-08 10:42:43
Operator Name:	akjdk	**Inspection ID:**	INSP-CE588B94
Roll ID:	7898	**Batch ID:**	8484
Fabric Type:	coja	**Final Verdict:**	REWORK

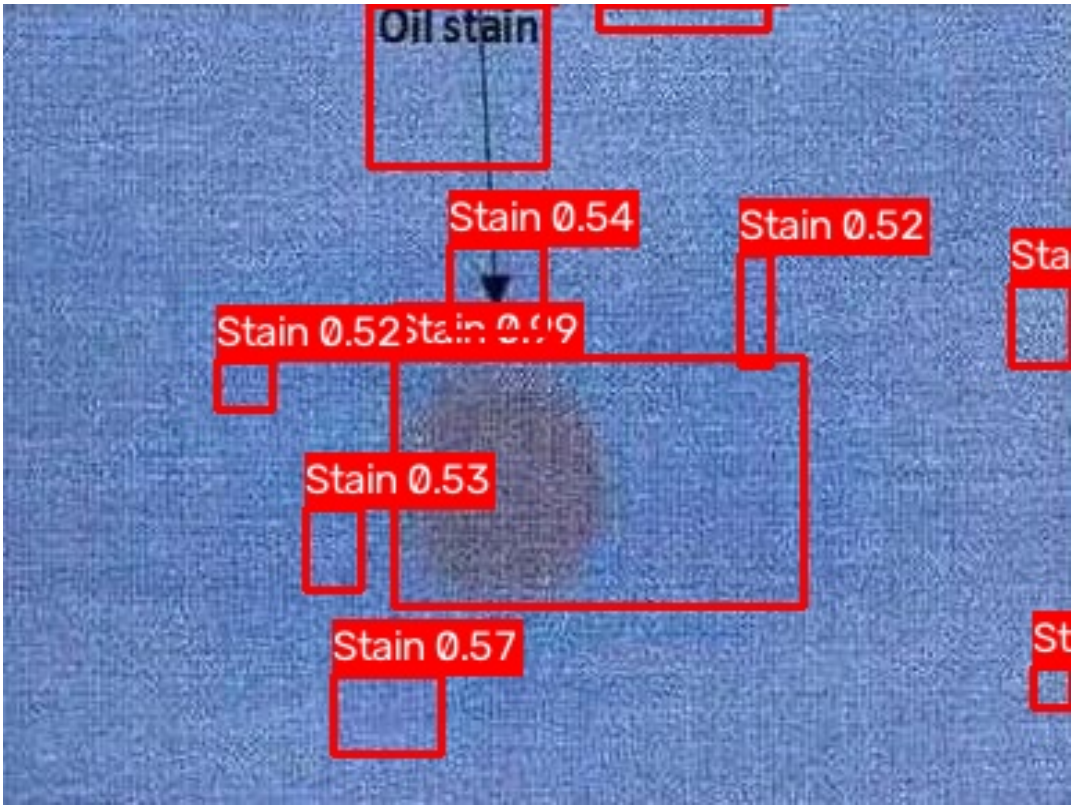
Inspection Image:

Quality Score: 57.0/100

Type	Confidence	Dimensions (cm)	Area (cm2)	Severity	Suggestion
Stain	0.99	7.4 x 4.55	33.67	Moderate	Spot Clean and Reprocess
Stain	0.63	3.2 x 2.95	9.44	Minor	Chemical Wash
Stain	0.57	1.95 x 1.45	2.83	Minor	Chemical Wash
Stain	0.55	1.1 x 1.5	1.65	Minor	Chemical Wash
Stain	0.54	1.7 x 1.6	2.72	Minor	Chemical Wash
Stain	0.53	1.0 x 1.5	1.5	Minor	Chemical Wash
Stain	0.53	3.05 x 0.45	1.37	Minor	Chemical Wash
Stain	0.52	1.0 x 0.9	0.9	Minor	Chemical Wash
Stain	0.52	0.55 x 2.05	1.13	Minor	Chemical Wash

Stain	0.51	0.7 x 0.75	0.53	Minor	Chemical Wash
