SMART MANUFACTURING AI

Visual Quality Inspection & Automated Defect Intelligence Platform

FAILED QUALITY AUDIT

Inspection ID:	INSP-1793369894-CB4FFC	**Timestamp:**	2026-10-30 19:48:17
Component Name:	Gearbox casing	**Similarity Score (SSIM):**	99.38%
Total Defect Regions:	2	**Affected Surface Area:**	1.046%
High-Severity Defects:	0	**Processing Duration:**	3585.4 ms

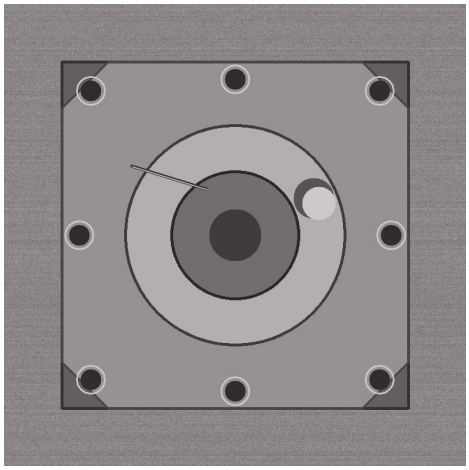
Figure B: Inspected Component

DEF-01	**Dent**	**MEDIUM**	0.87	(498, 298) 79x79	0.75% (4823px)	Localized plastic deformation / depression (0.75% surface area).
DEF-02	**Scratch**	**LOW**	0.95	(215, 274) 141x53	0.29% (1872px)	Superficial hairline scratch on component surface.

- Verify whether surface dent impacts critical mating face sealing or bolt seat flatness.
- Check material handling conveyors and robotic gripper pad pressure to prevent impact indentation.
- Inspect if scratch depth exceeds allowable paint/protective primer specification (e.g., > 25 microns).
- Route to rework station for deburring, light polishing, and primer re-touch.
