AquaSmart AI System

Comprehensive Water Quality Analysis Report

Target: Pond 2 | Date: 2026-02-20

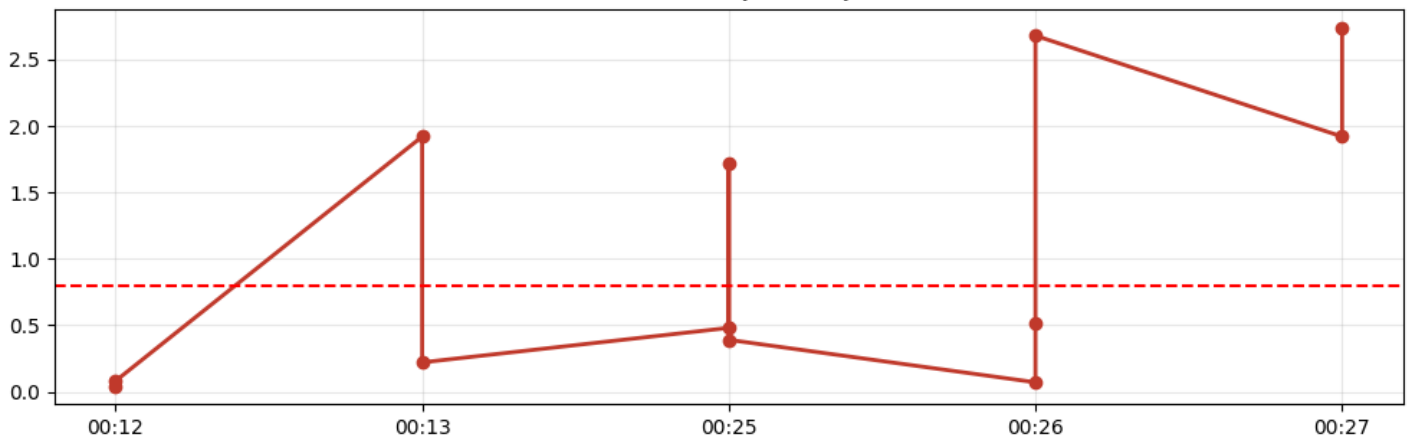
Ammonia (Pond 2)

CRITICAL: The system detected unsafe conditions. High Ammonia or Low Oxygen levels were recorded. Immediate corrective action (Aeration/Water Exchange) is recommended.
