# COLUMBIA

## ACCIDENT INVESTIGATION BOARD

## VOLUME III

<b>OTHER TECHNICAL DOCUMENTS</b>	
Appendix E.1	Reader's Guide to Volume III .....	5
Appendix E.2	CoFR Endorsements .....	7
Appendix E.3	STS-107 Image Analysis Team Final Report .....	27
Appendix E.4	An Assessment of Potential Material Candidates for the "Flight Day 2" Radar Object Observed during the NASA Mission STS-107 .....	139
	<i>Columbia Early Sighting Assessment Team Final Report.....</i>	171

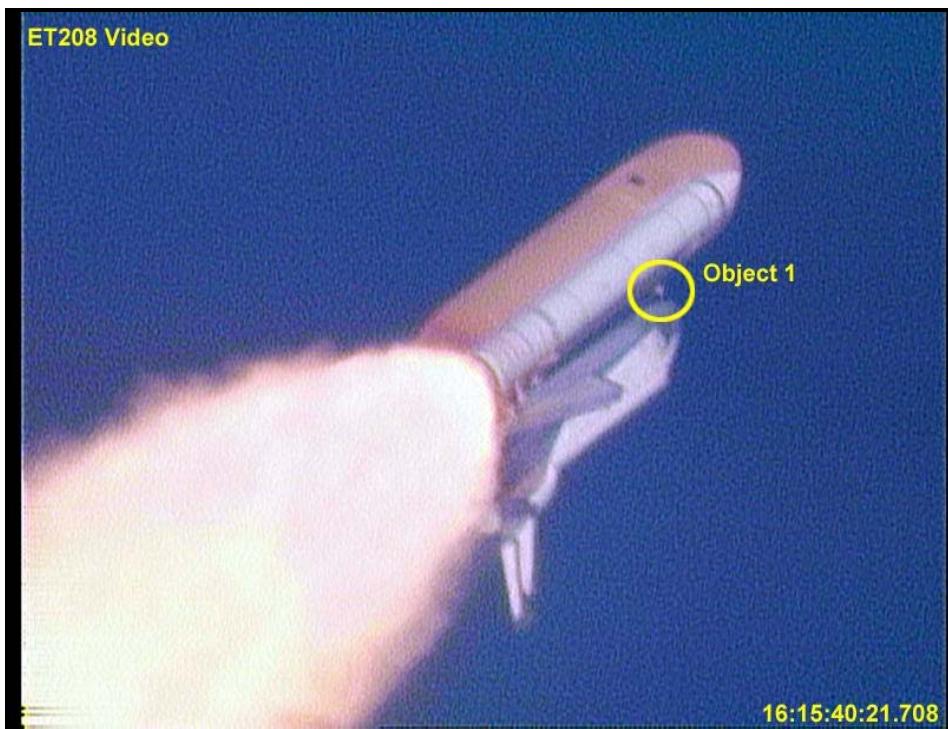
Figure 4.3.2.1a ET-208 View of the debris near point of origin

A single piece of light-colored debris was first seen on ET-208 imagery near the ET/Orbiter -Y bipod attach area at 016:15:40:21.674 UTC. Figure 4.3.2.1a is a good view of the debris after it becomes more clearly visible. The debris traveled outboard in a -Y direction (Orbiter structural coordinate system) before falling aft. Figure 4.3.2.1b shows the debris just after it struck the wing (the moment of impact was between video images). The location of the debris was mapped from frame to frame to build a trajectory from the approximate source to impact as viewed by Camera ET-208, shown in Figure 4.3.2.1c.

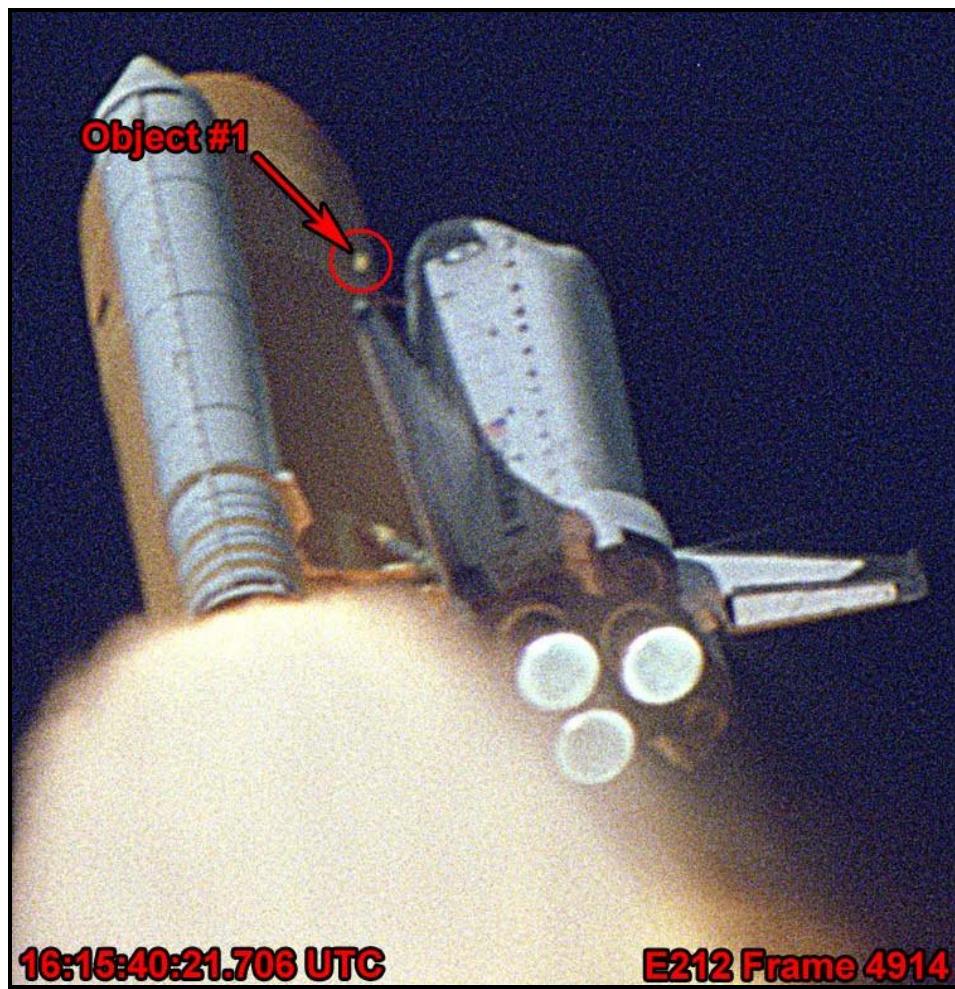
Only Object 1 was confirmed to impact the left wing. There is no conclusive evidence of more than one debris impact to the Orbiter. A large, light-colored cloud, which emanated from the underside of the left wing due to debris impact (Figure 4.3.2.1f), was first observed at 016:15:40:21.863 UTC. Within the post-impact cloud, at least two large pieces of debris were observed and measured (see Section 4.3.2.6). There is no conclusive visual evidence of post-impact debris flowing over the top of the wing.

Figure 4.3.2.1d Debris object in full illumination (E-212, Frame 4914)

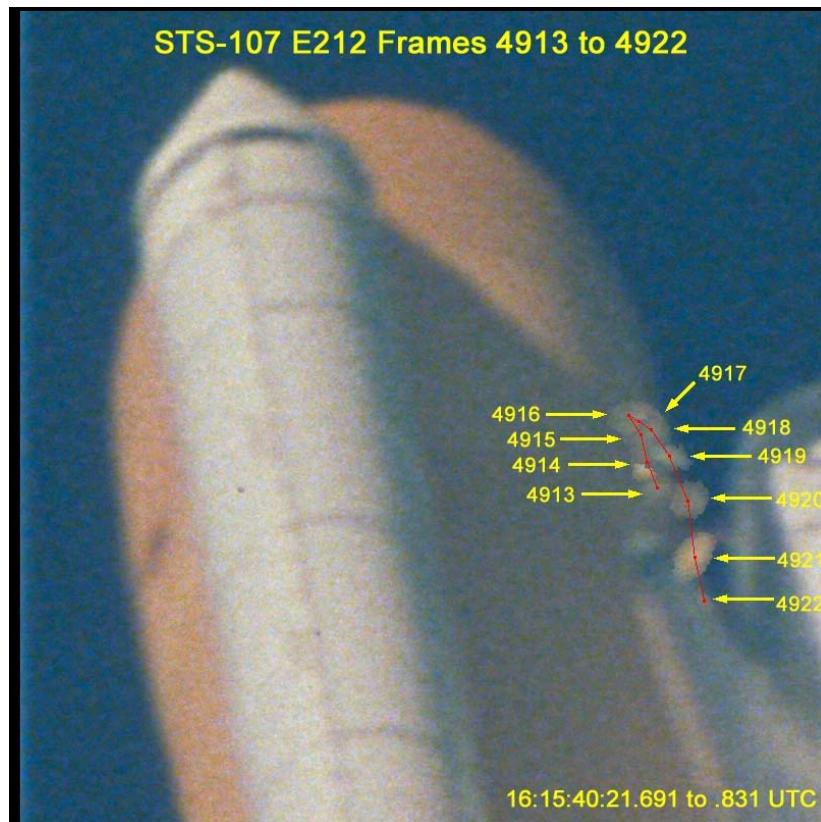
**Figure 4.3.2.1e Composite image showing the trajectory of the major piece of debris (Object 1) mapped from camera E-212, frames 4913 through 4922.**

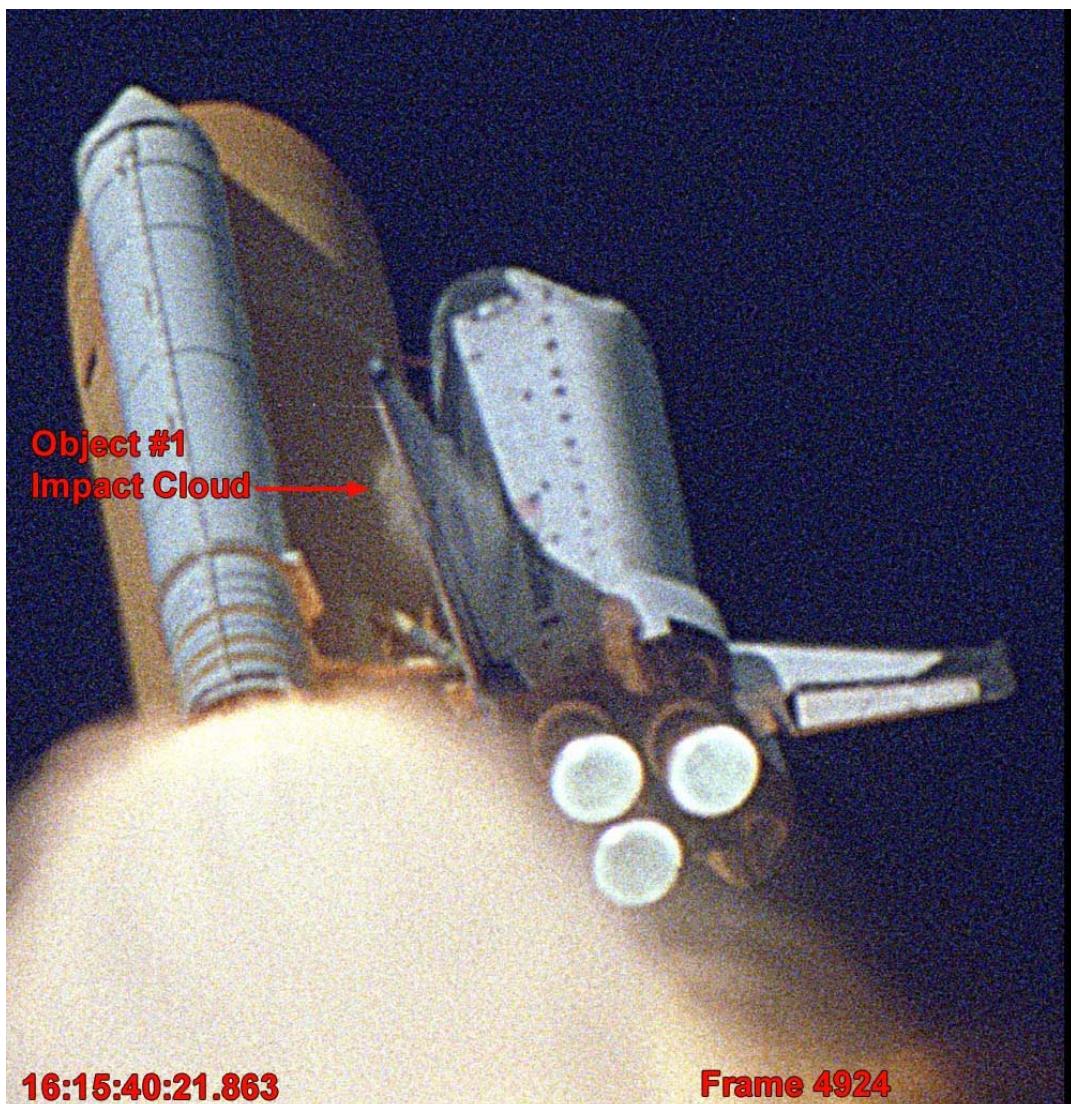
Figure 4.3.2.1f Debris impact cloud seen on E-212 (Frame 4924)

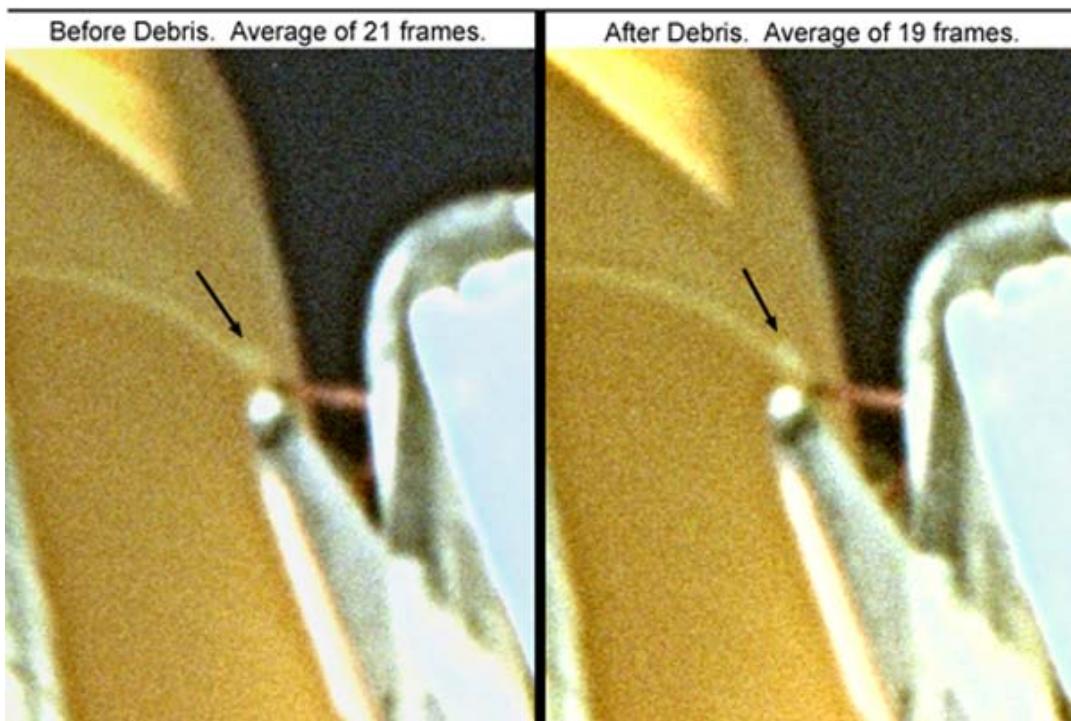
**Figure 4.3.2.2a Enhanced images of the ET forward bipod ramp area before and after the debris shedding event**

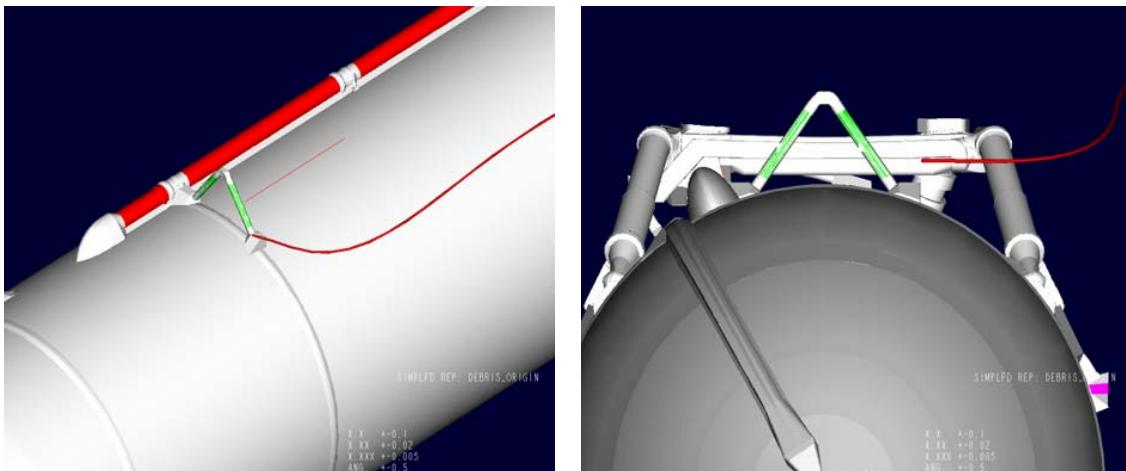
**Figure 4.3.2.2b 3-D model of the debris trajectory (red curve) relative to the external tank, based upon ET-208 and E-212 camera imagery**

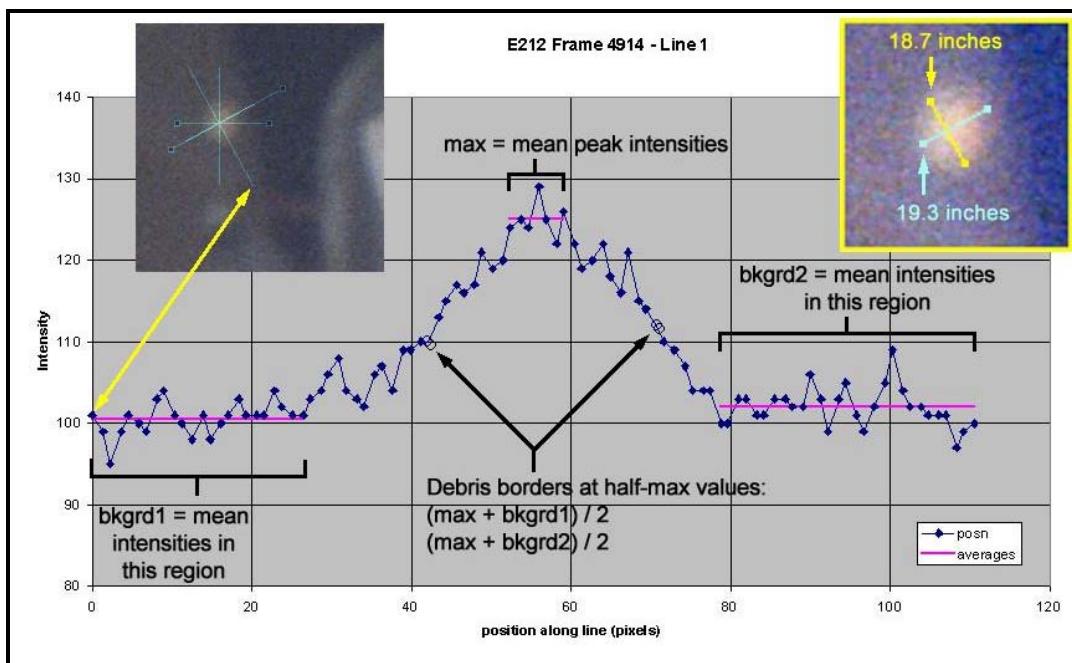
The uncertainty in the debris size measurements of approximately +/- 3 inches was derived from a +/- 2-pixel uncertainty in locating the debris borders at half-maximum values.

**Figure 4.3.2.3 Debris size measurement methodology full width at half maximum intensity profile.**  
The curve represents the image intensity values for a transect across the debris in one frame 4914, illustrated in the upper left image.

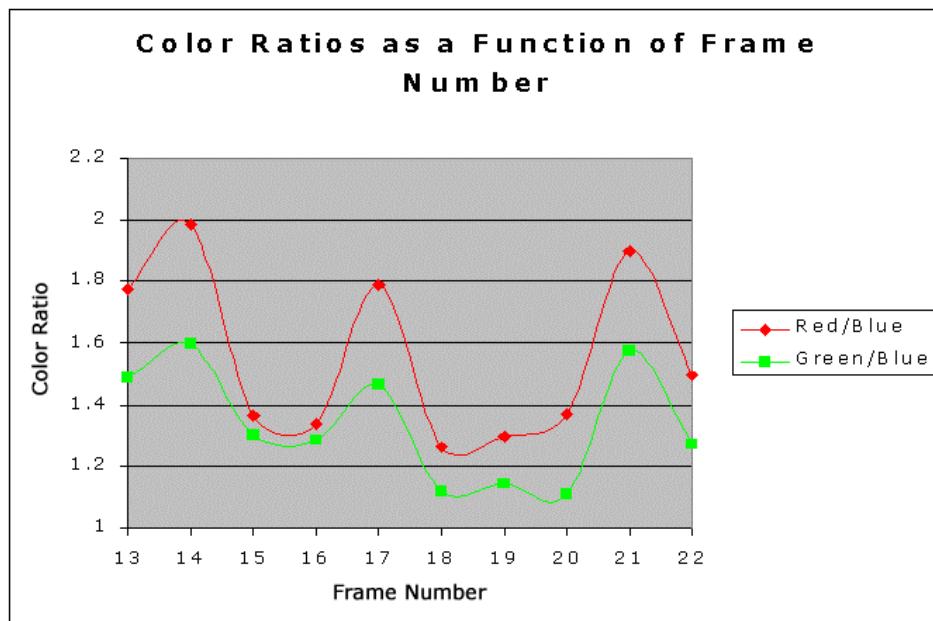
To begin the analysis, the red, green, and blue color channels of the debris were recorded for each frame on E-212 in which the debris was observed prior to impact. Ratios of the green to blue and red to blue were then calculated and plotted as a function of time (see Figure 4.3.2.4). The use of color ratios reduces the effect of variations in illumination and makes the analysis more sensitive to color change. The plot shows a definite sinusoidal pattern with a frequency of approximately 18 Hz. Details of this analysis are given in Appendix 4.3.2D. In the absence of any other data for measuring rotation, the best estimate of the debris rotation rate based upon the imagery is approximately 18 Hz.

Figure 4.3.2.4 Color ratio analysis of debris from E-212 frames

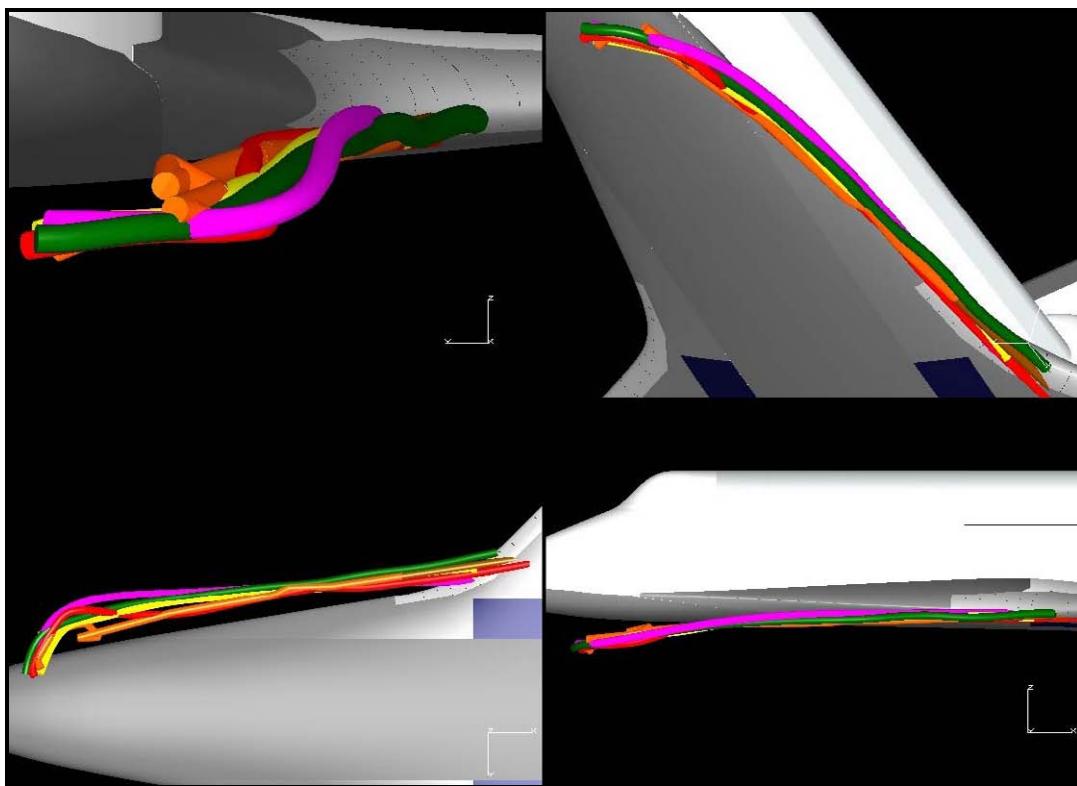
Figure 4.3.2.5a Debris trajectories derived by separate independent analyses.

- not seeing the debris on E-212 as it passed behind the wing just prior to impact;
- uncertainty in timing offsets between E-212 and ET-208. This was less of a concern for the CAD surface intersection methods, but a major issue for the methods that relied on intersecting vectors from multiple cameras extending from each camera to the debris at discrete points in time.

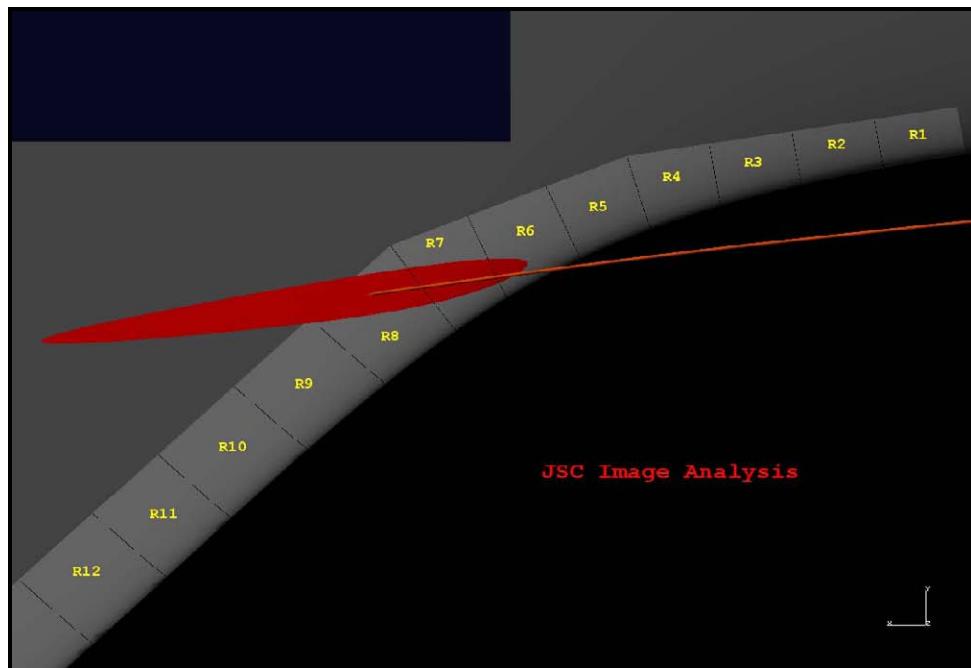
acreage aft of the leading edge panels, no damage to the tiles was observed in the imagery (see Section 4.3.2.7). Figure 4.3.2.5b shows the impact area on the Orbiter left wing as predicted by one example trajectory analysis.

**Figure 4.3.2.5b Debris trajectory analysis — impact area on Orbiter left wing. A 1-foot-radius, trajectory tube projected onto the left wing, showing probable impact to the panel 6, 7, 8 area.**

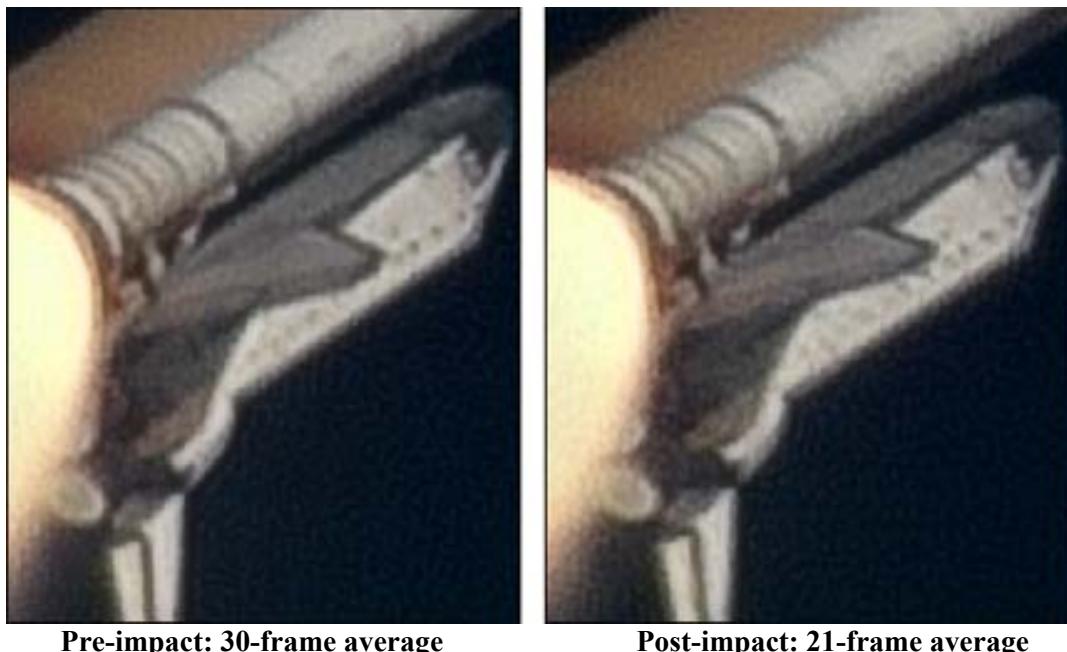
No visible damage to the left wing was detected in the imagery from camera ET-208, which was determined to be the camera with the best view of the debris impact. Figure 4.3.2.6a shows frame-averaged image enhancements of the underside of the left wing from before and after the impact event. There is no conclusive, detectable change in the impact area. In the “before” image, a relatively bright area on the wing is observed just aft of the leading edge, which is attributed to an area of lighter-colored tile acreage, as verified in the Orbiter close-out photos. The “after” image shows a slight brightening to this area, but in the noise level of the image. The brightening may be attributed to a lighting effect caused by slight changes in the Orbiter orientation, or is simply an artifact of the image processing.

A constraint to this analysis is the low resolution of the ET-208 imagery; a damage area smaller than an area of approximately 2 feet by 1 foot (in Orbiter X and Y respectively) would be undetectable in the imagery.

Figure 4.3.2.6a Comparison of images from before and after the debris impact

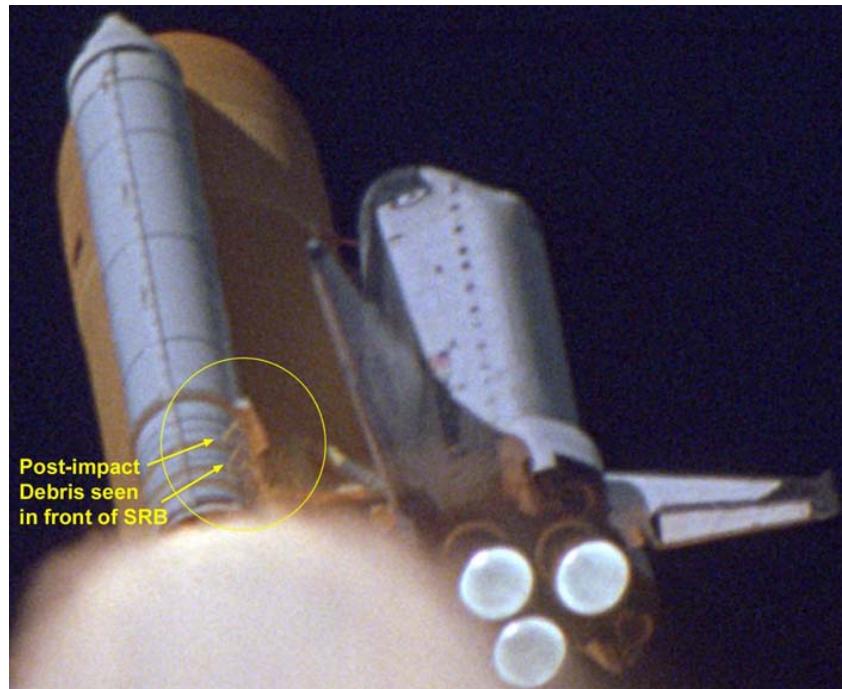
Figure 4.3.2.6b Post-impact debris fragments (E-212 frame 4927)

Imagery of the post-impact debris cloud shows at least two distinct, sizeable objects emanating from the location of the debris impact on the wing (Figure 4.3.2.6b, from E-212). Identification of these objects is not possible from the imagery, but they are presumed to be remnant fragments of the debris that struck the wing. The objects are visible in only two image frames and are badly motion-blurred. Compensating for the motion blur, the estimated sizes of these objects are 12 inches by 11 inches, and 7 inches by 7 inches, respectively (Figure 4.3.2.6c). See Appendix 4.3.2G for details of these post-impact debris size measurements. Note that these dimensions are based on an estimated velocity of approximately 900 ft/sec, which is used to compensate for the motion blur. No other distinct particles were observed in the post-impact debris cloud.

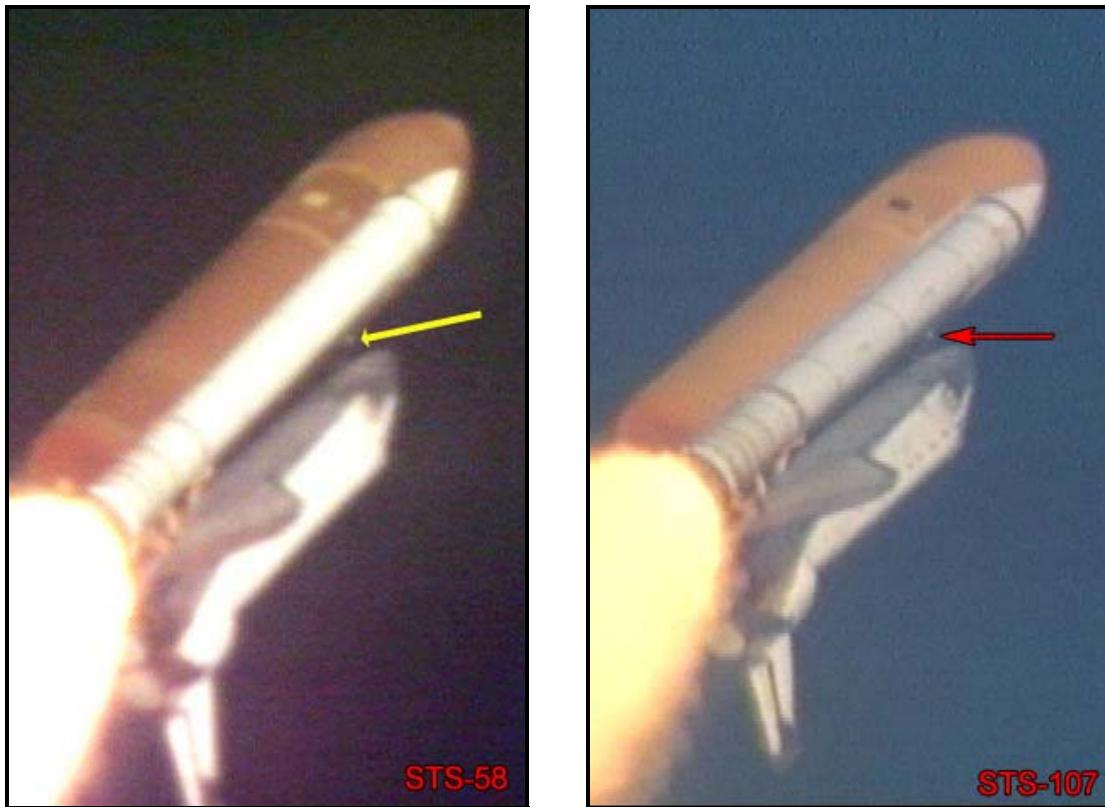
Figure 4.4.1 Comparison of bright spot near bipod on STS-58 and STS-107

A bright spot was seen near the ET/Orbiter -Y bipod attach area on the STS-107 camera ET-208 video approximately nine seconds prior to the debris strike to the Orbiter left wing (Figure 4.4.1). There was a concern that this white area may be related to the debris that struck the left wing — it is very close to where the debris appeared to originate. The white-colored mark is visible for about two seconds prior to fading away. It is most apparent on either side of some horizontal video noise that runs across the frame. As part of this analysis, the STS-58 ET-208 video was reviewed due to its similarity in lighting conditions at launch. Figure 4.4.1 is a comparison of the STS-58 and STS-107 ET-208 views. A similar bright spot was also seen near the ET/Orbiter -Y bipod attach area on the STS-58 video. Because of the similarity of the lighting and the appearance of similar

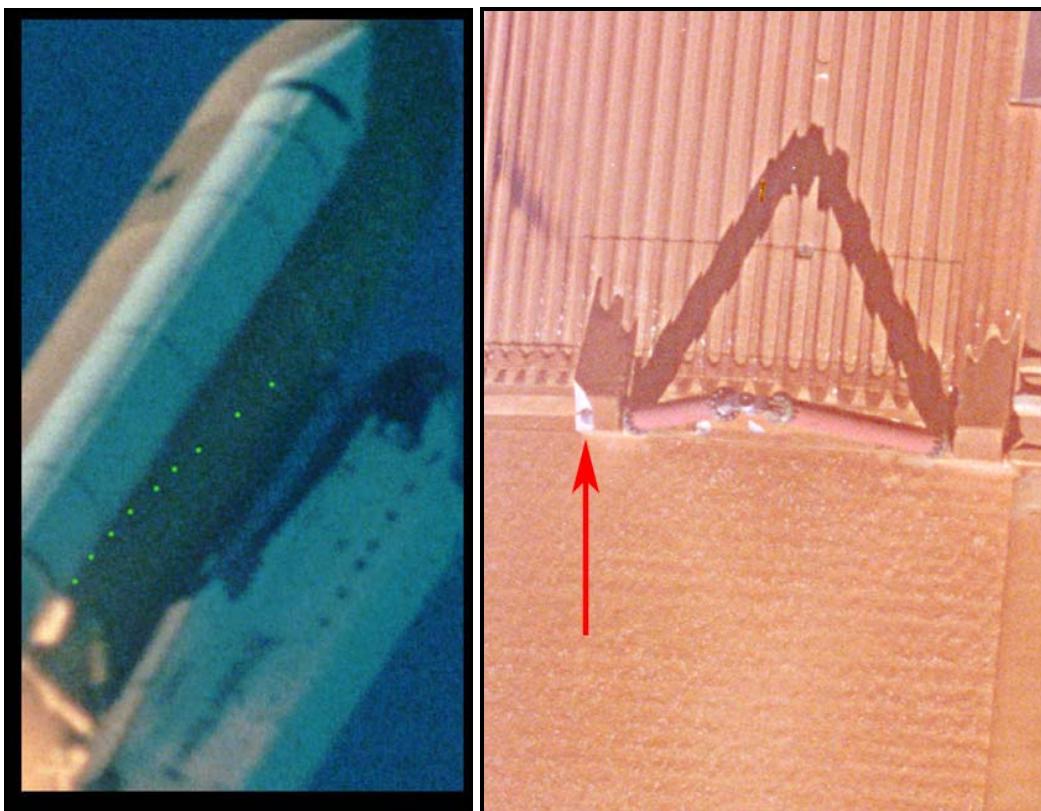
When the ET imagery from the on-board umbilical well camera was examined after landing, it revealed that a large portion of the ramp adjacent to the ET/Orbiter -Y bipod attach was missing and bipod substrate material was visible. The damaged area was measured on the film to be approximately 6 x 12 inches (Figure 4.4.5.1).

**Figure 4.4.5.1 STS-112 debris trajectory and umbilical well image of damage near ET bipod ramp**

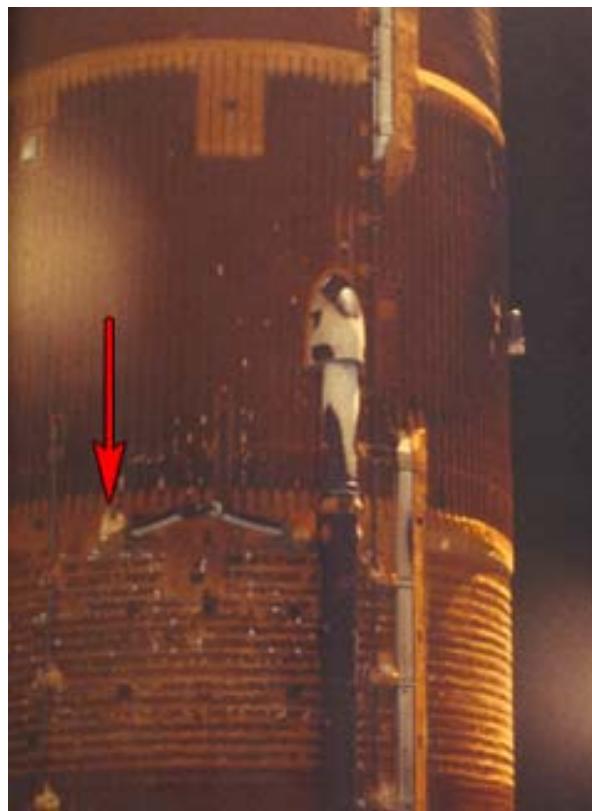
Figure 4.4.5.4 Image from STS-7 On-board Umbilical Well Camera Film Showing Damage to ET –Y Bipod Ramp

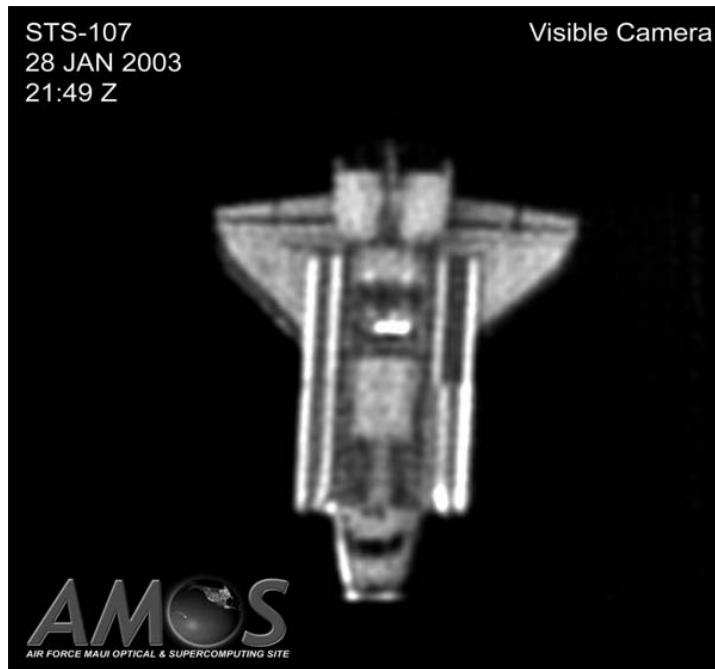
Figure 5.3.2.1 AMOS image of Columbia (taken January 28, 2003)

The Air Force Maui Optical and Supercomputing Site (AMOS) acquired photographs of Columbia while on-orbit during the STS-107 mission (Figure 5.3.2.1). The pictures were taken at approximately 21:49 UTC on January 28, 2003. All of the AMOS views are grainy and only major features of the Orbiter upper (+Z) surface are visible.

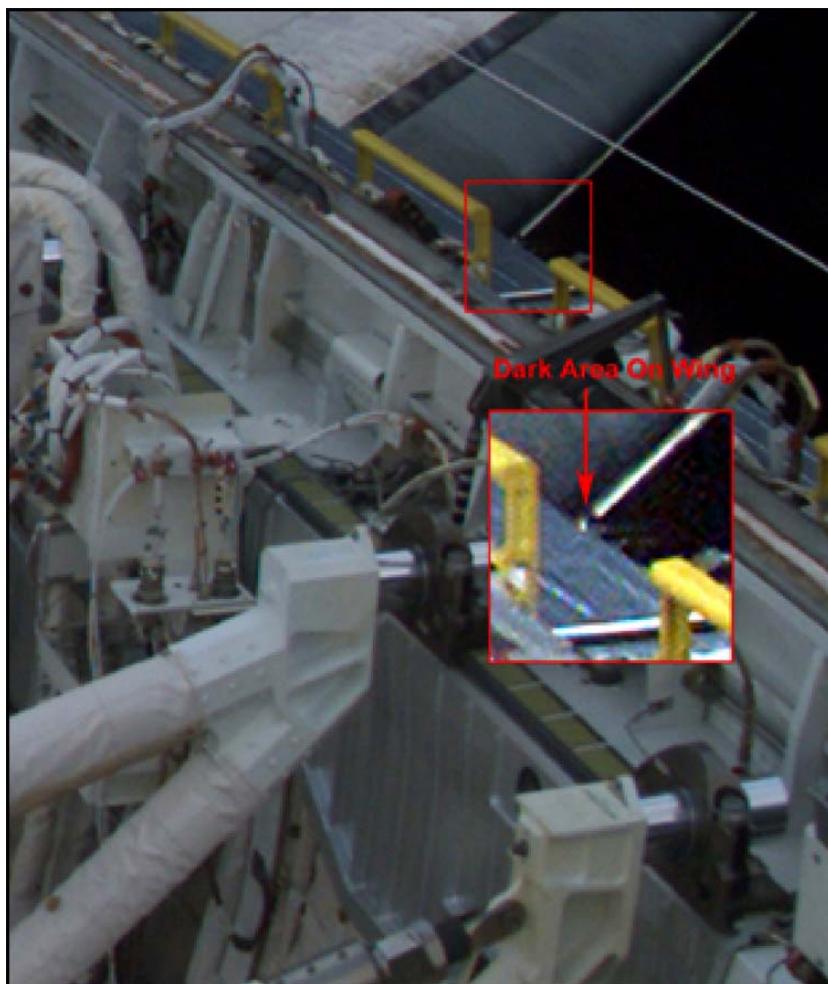
Figure 5.3.2.3a Dark spot seen on Columbia's left wing

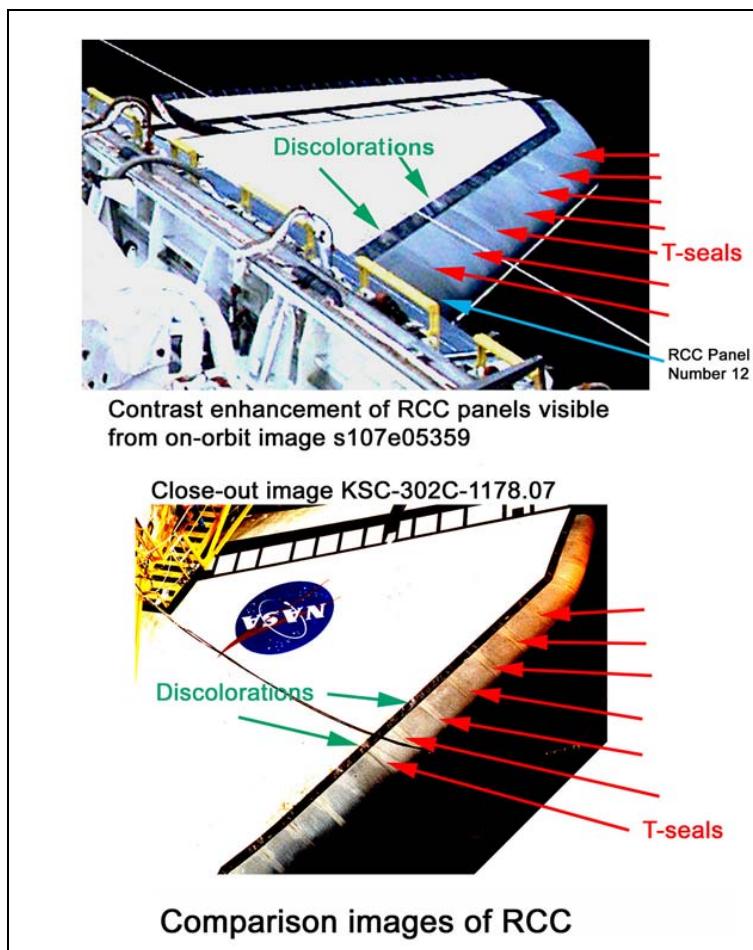
**Figure 5.3.2.4b No detectable changes on left wing RCC panels, T-seals**

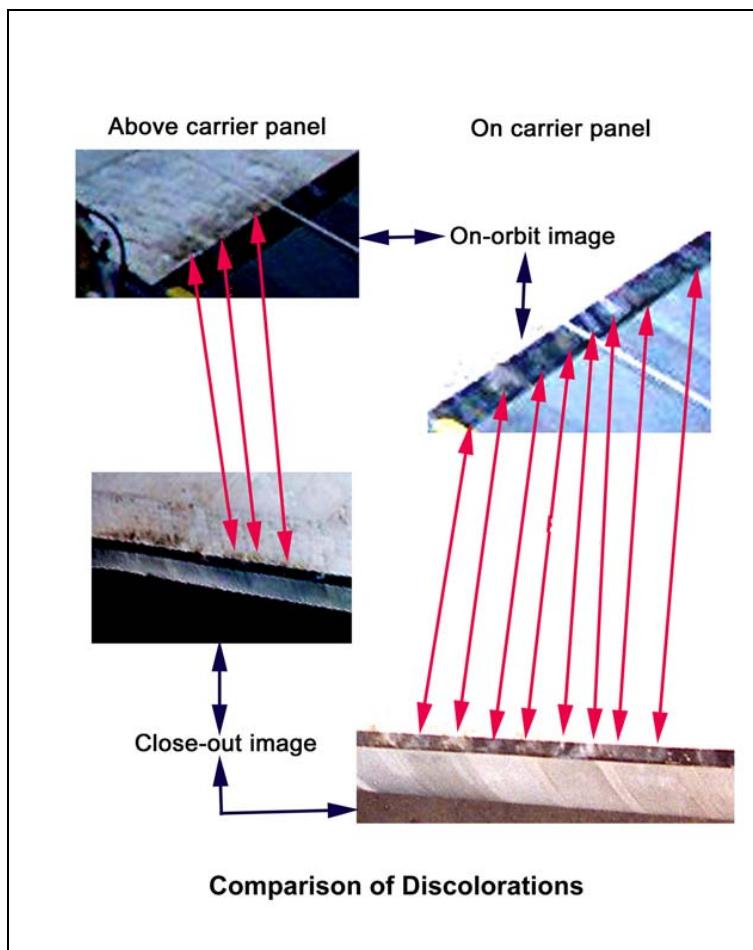
**Figure 5.3.2.4c Discolorations on Columbia's left wing carrier panels and adjacent tile surfaces**

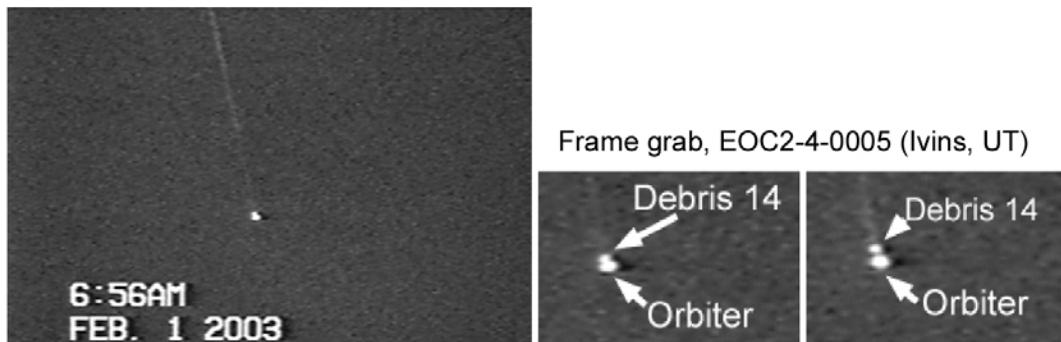
Figure 6.1 Example of full frame grab of a typical re-entry video, and an enhancement showing the separation of debris 14 at 13:55:58 UTC.

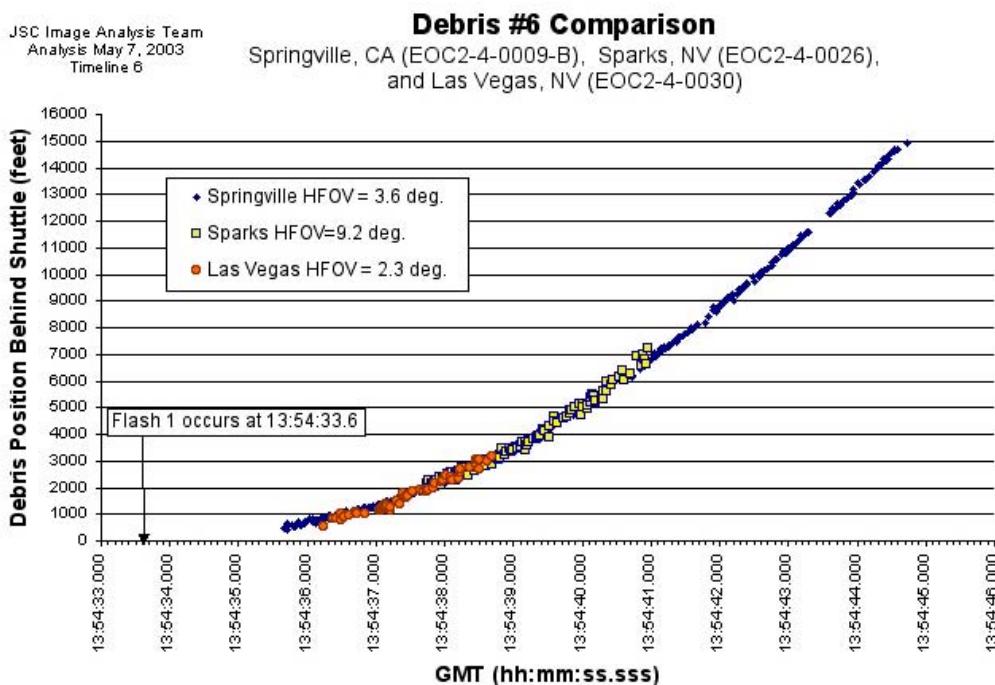
the debris, and the ballistic coefficient of the debris (which is directly related to its deceleration). The debris decelerations were then used by the Image Analysis Team's Luminosity Working Group to calculate debris mass. While Figure 6.3.4a shows very good agreement in the relative motion for Debris 6 for the three separate videos analyzed for this event, there was some disagreement for the motion of Debris 14 (Figure 6.3.4b) for the four videos analyzed for this event. Possible explanations for the Debris 14 discrepancy include the following: errors in the assumed focal lengths (fields-of-view) for some observers; errors in the precise timing of the videos; significant motion of the debris out of the Orbiter trajectory path causing an unmeasured component of its motion to be missed by observers in Utah. The last explanation is based on the fact that observers from Utah were directly under the Columbia flight path and were looking eastward, so if the debris dropped enough in altitude, it might appear to move away more slowly relative to observations from Flagstaff. Details about the relative motion analyses including determination of the camera fields-of-view are discussed in Section 6.2, Methods.

**Figure 6.3.4.a Debris 6 position relative to Orbiter as measured from three videos, identified by their EOC number.**

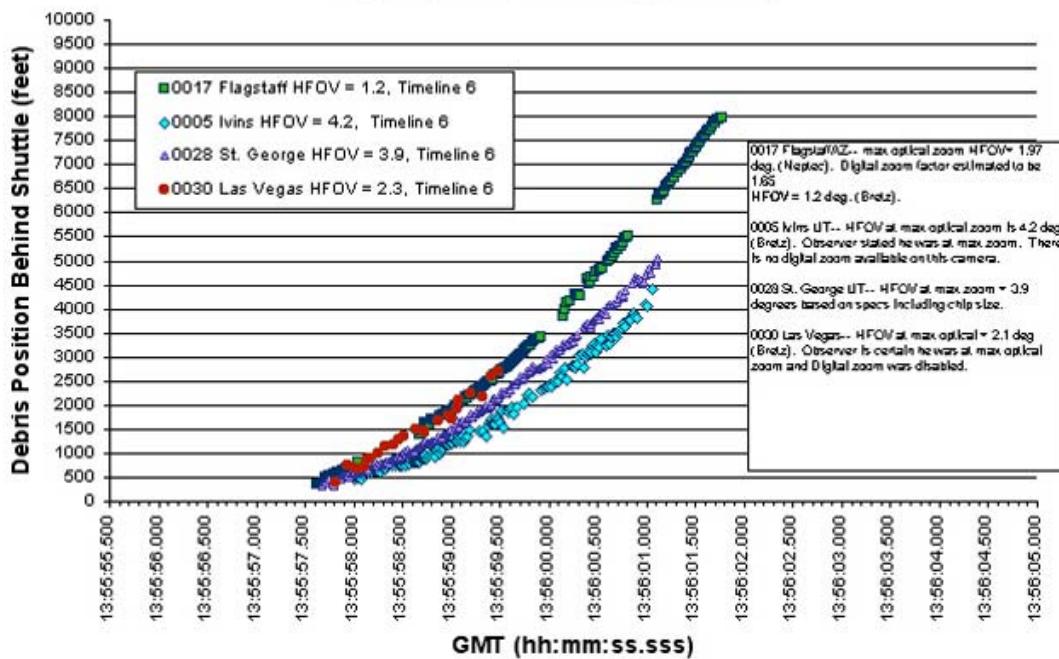
Figure 6.3.4b Debris 14 position relative to Orbiter, measured from four videos, identified by their EOC number.

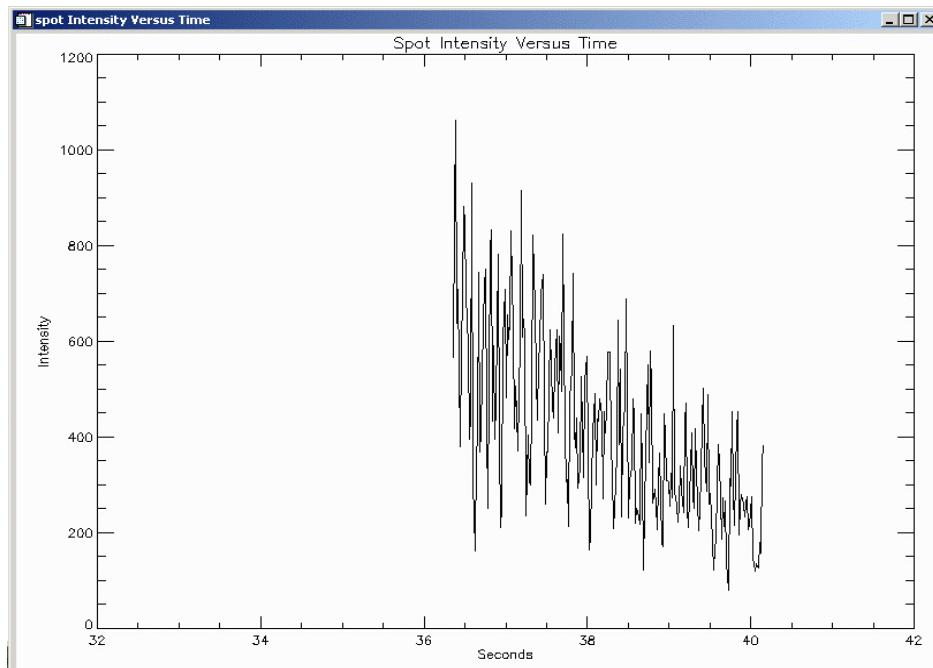
**Figure 6.3.5a Debris 6 intensity versus time (seconds after 13:54:00 UTC). The debris intensity decreased over the measurement interval. The light curve suggests that the debris was ablating by approximately 2% per second.**

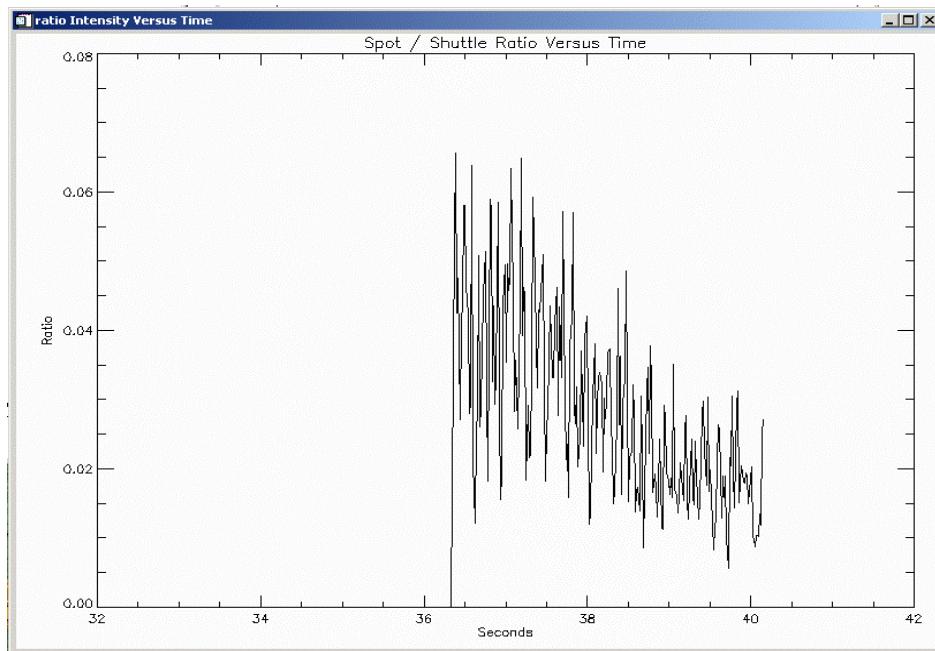
**Figure 6.3.5b Field-by-field Debris 6/Shuttle intensity ratio versus times (seconds after 13:54:00 UTC)**

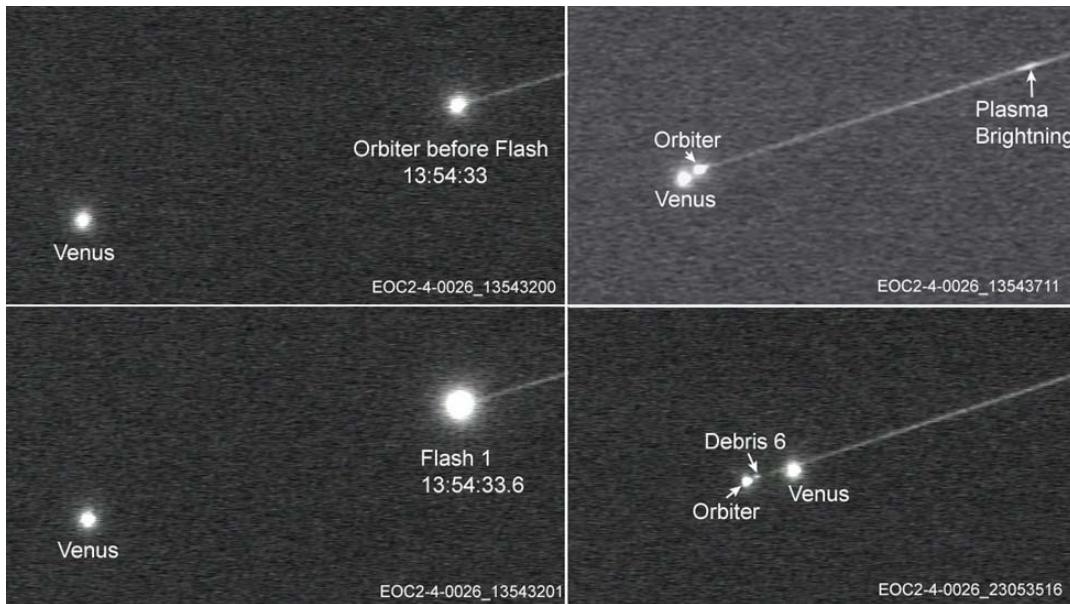
**Figure 6.3.6a Frame grabs from the Sparks, NV video illustrating the Flash 1 event and the separation of Debris 6 from the luminous envelope of the Orbiter as it crosses Venus**

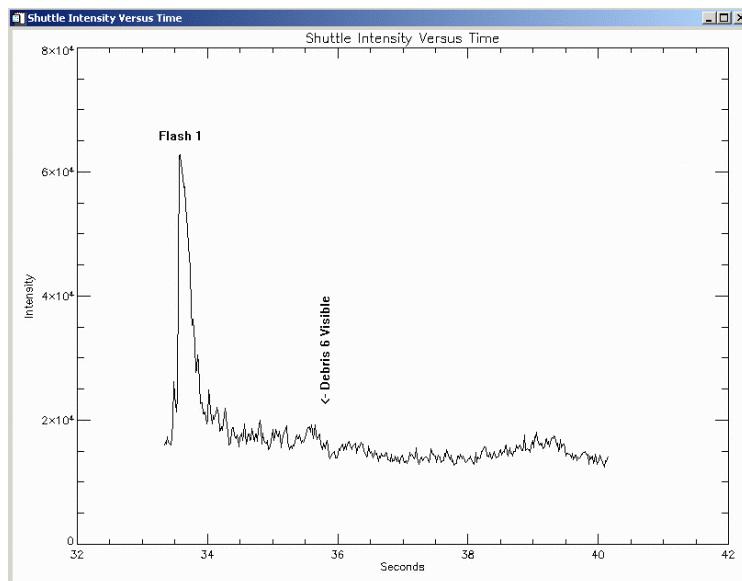
**Figure 6.3.6b Preliminary Orbiter light curve from the Springville, CA video. The Orbiter signature remains bright after the flash, until Debris 6 is observed to separate from the Orbiter.**

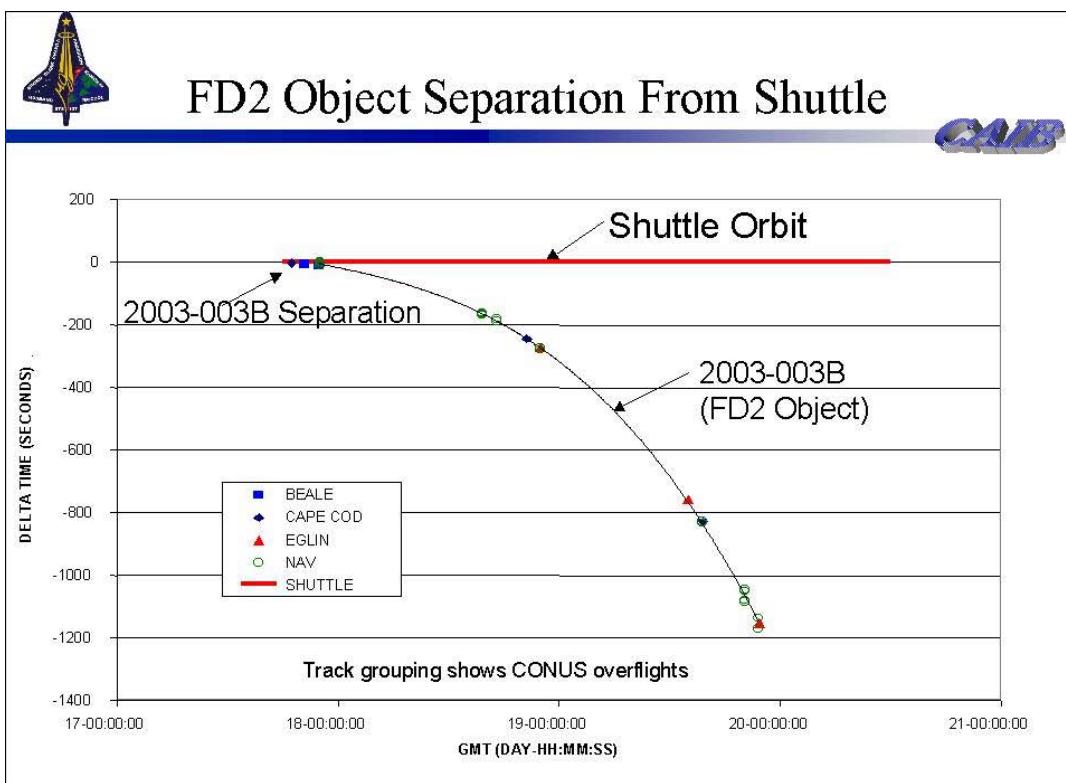
Though the part was never visually "observed departing the Shuttle", the radar data unequivocally shows the object originated from the Shuttle on the 17<sup>th</sup> of January, and departed the Shuttle at a very low exit velocity of under 1 meter per second. In addition, the radars tracked the object until it reentered the atmosphere approximately 60 hours after it originated from the Shuttle and the object was subsequently destroyed on re-entry. In order to simplify nomenclature, from this point forward, the author will refer to object "2003-003B" simply as the "flight day 2 object", or FD2 for short.

Figure 1 – Flight Day 2 (FD2) Object Orbit Relative to Shuttle

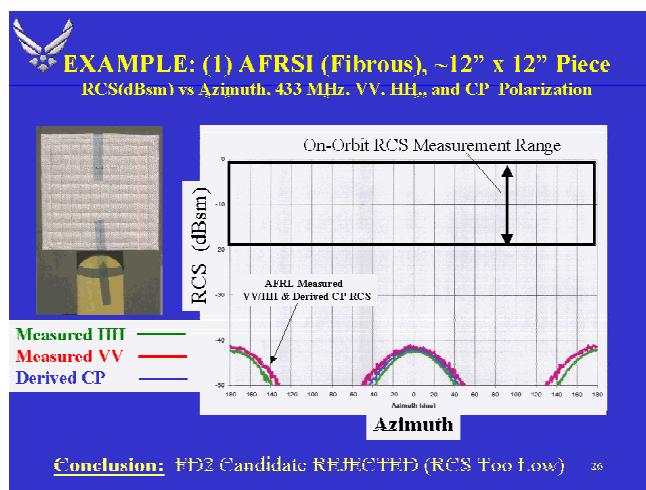
in detail. Figure 12 shows the measured linear and CP UHF RCS results for the AFRSI example. The sample plot shows the item tested photographically, the actual linear and circular RCS data, and a square “box” that represents the range of the on-orbit RCS measurements of the FD2 object. Remember, in this data display, the RCS in blue must exceed or “break” the top of the observed on-orbit RCS limits to be a viable candidate. RCS values that are several decibels below the peak are not viable candidates for the FD2 object. Since this is a decibel scale, it is clear that the RCS of AFRSI is 2 or more orders of magnitude too small. This object would be quickly rejected as a potential candidate for the FD2 object based solely on the RCS data. If we perform the same measurement of one of the payload bay TCS blankets, namely MLI-004, the UHF RCS results are shown in Figure 13. Based solely on RCS test results alone, one would have to consider the MLI-004 a very viable candidate for the FD2 piece.

Figure 12 – AFRSI CP UHF RCS Measurement of a 12" by 12" Sample

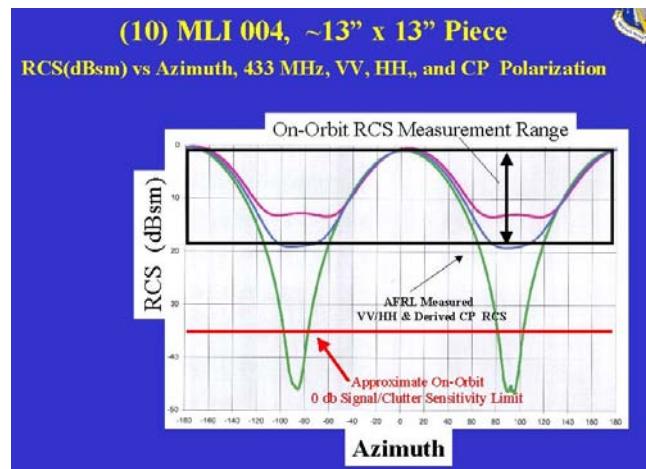
Figure 13 – MLI-004 TPS UHF RCS Measurement of a 13" by 13" Sample

Looking at the results of Figures 12 and 13 the RCS test and elimination process looks fairly straightforward. When we combine our knowledge of the ballistic coefficient or “B-term” for these cases, the situation becomes much clearer. A “B-term” analysis shows the MLI-004 (and other similar thermal blankets of the TPS system) are a factor of 7 or more too light to exhibit the B-term properties of the FD2 object. The MLI-004 object above, for instance, was rejected as a FD2 candidate based on the exclusionary B-term analysis. The AFRSI blanket failed both the “B-term” test, and the RCS test, and therefore was also rejected as the FD2 candidate. In a similar fashion, the team methodically proceeded through all the configurations and materials NASA identified as potential candidates.
