# COLUMBIA

## ACCIDENT INVESTIGATION BOARD

## VOLUME III

<b>OTHER TECHNICAL DOCUMENTS</b>	
Appendix E.1	Reader's Guide to Volume III .....	5
Appendix E.2	CoFR Endorsements .....	7
Appendix E.3	STS-107 Image Analysis Team Final Report .....	27
Appendix E.4	An Assessment of Potential Material Candidates for the "Flight Day 2" Radar Object Observed during the NASA Mission STS-107 .....	139
	<i>Columbia Early Sighting Assessment Team Final Report.....</i>	171

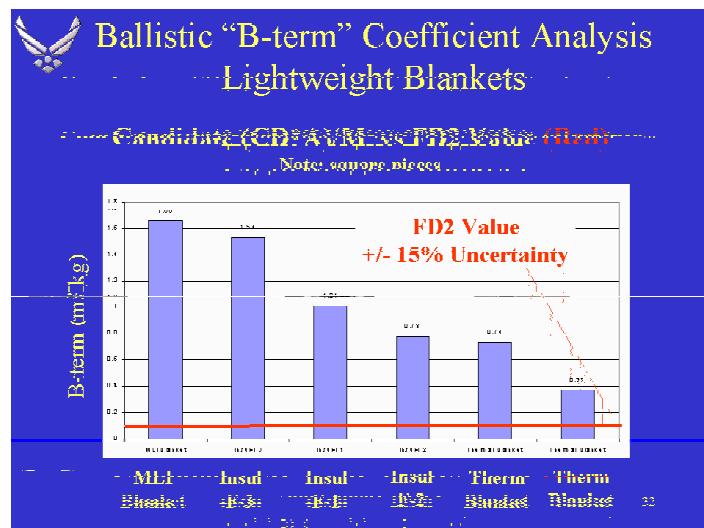
Table 1 shows the complete list of candidate materials evaluated by the FD2 assessment process. Glancing over the table, it is evident the RCS tests eliminated 14 of the tested components, while the B-term analysis eliminated 18 candidates. The thermal protective materials making up the TPS system are generally lightweight and are very inefficient scattering devices. Most of the results exhibited exceptionally low RCS, especially the Shuttle thermal tiles, FRSI, and AFRSI materials. Looking over many of the Thermal Control System (TCS) samples, many of them exhibited good RCS levels at UHF frequencies. This should be no surprise since most of the TCS systems consist of metalized Mylar or Kapton, so many of these samples scattered similar to the 12" by 12" flat plate test case presented earlier. However, these classes of objects are very lightweight, so their area to mass "B-term" calculations were far above the observed on-orbit quantity of  $0.1 \text{ m}^2/\text{kg}$ . Figure 14 shows representative values for the area-to mass for some of the components listed in Table 1 as "excluded" under the B-term analysis. Specifically, it is seen that the TCS samples are generally too light to meet the observed B-term value for the FD2 object.

Figure 14 – B-term Calculation for 6 of the TCS Samples  
Note that other TCS samples behaved similarly.

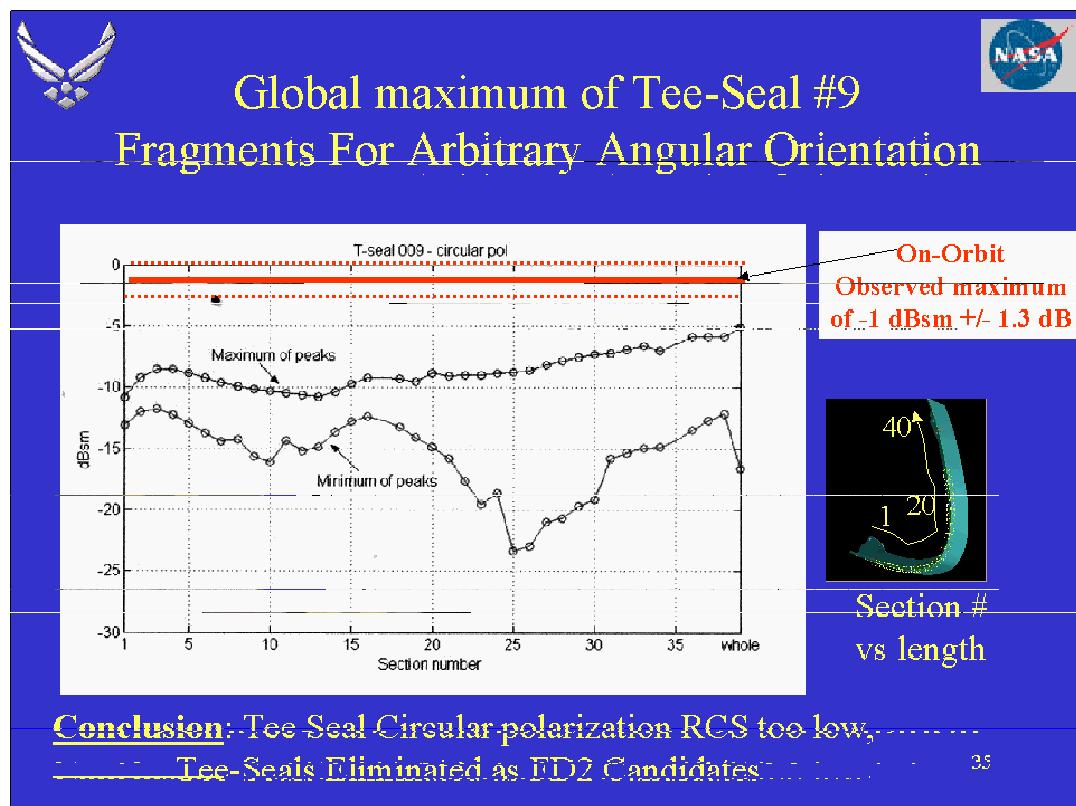
The Tee-Seal #9 is shown in Figure 15 as it is incrementally “cut up” on the computer, and Figure 15 also shows the global maximum RCS calculated by Carlos for nearly  $4\pi$  steradian coverage. This analysis, along with the correction of the original RCC Station 21 Tee-Seal RCS data from the 6 May 03 testimony now ***eliminates the Tee-Seal as a possible candidate for the FD2 object.***

Figure 15 - Global RCS maximum and minimum of peaks of Tee-seal 009 versus incremental length. The highest possible RCS occurs for the whole Tee-seal.

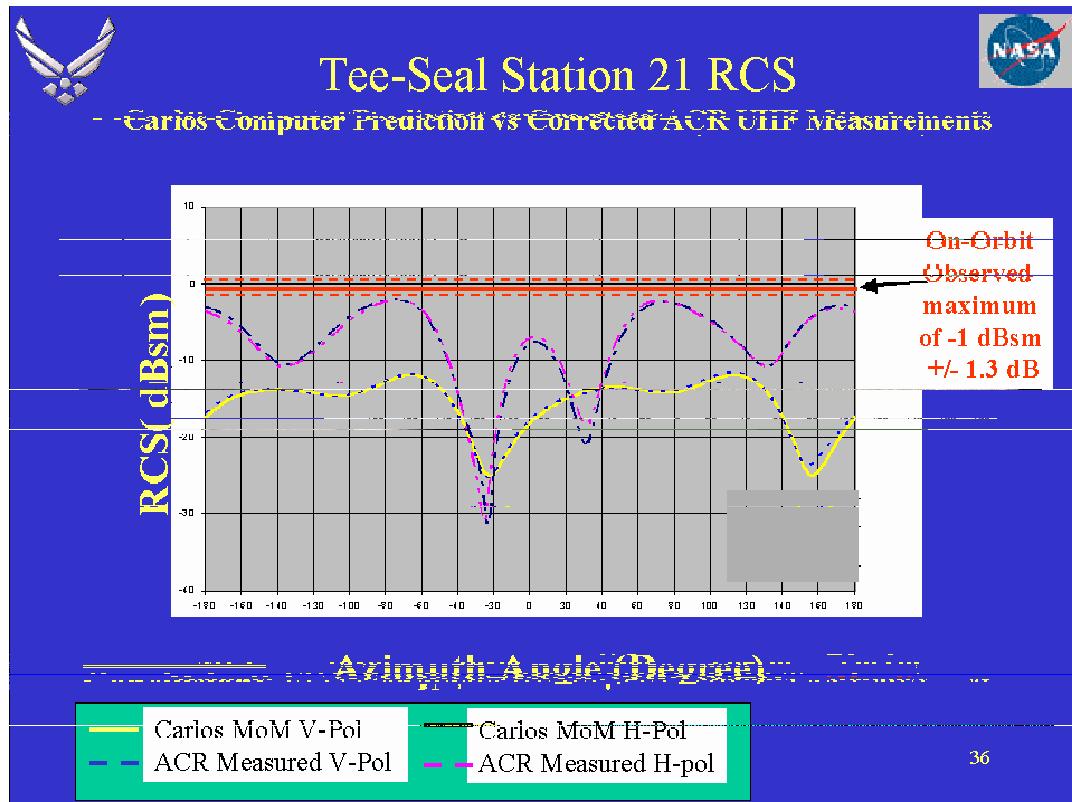
reported. Once we made the correction for the station 21 Tee-seal RCS results, we found that the resultant measurements and predictions were in outstanding agreement, giving our team confidence that the tool was working properly. A sample of the comparisons between theory and measurements of Tee-Seal #21 is shown in Figure 16 below. Note that Figure 16 shows the two linear polarization components. The circular polarization would lie somewhat between the two curves, clearly lower than the on-orbit circular polarized RCS maximum of  $-1 \text{ dBsm} \pm 1.3 \text{ dB}$ .

Figure 16 – Predicted CARLOS 3D RCS Vs AFRL/SN ACR UHF RCS Measurements at Linear VV and HH Polarizations. Note Tee Seal 21 is now below on-orbit observed maximum RCS for the FD2 Object. (From Appendix I)

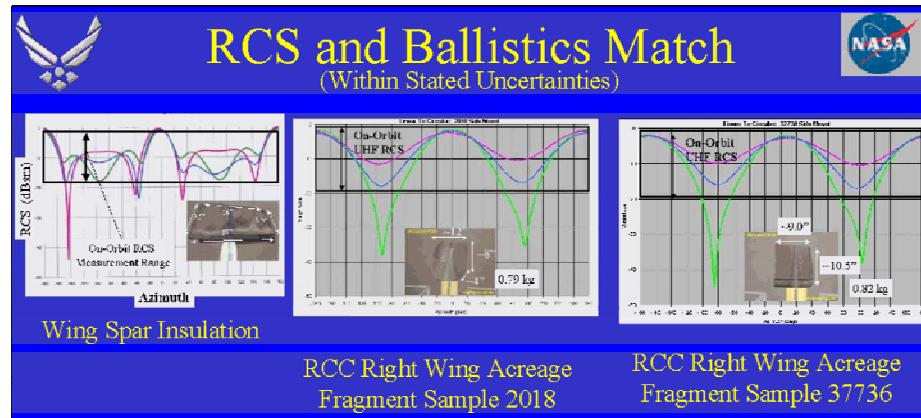
Subsequent RCS testing of the other RCC debris fragments showed their UHF RCS was consistent with on-orbit measurements, showing that fragments of RCC “acreage” could not be rejected as a class as the FD2 object. Figure 18 shows the RCS test results, while Figure 19 shows the B-term ballistic analysis.

Figure 18- UHF RCS Test Results for RCC Acreage Pieces

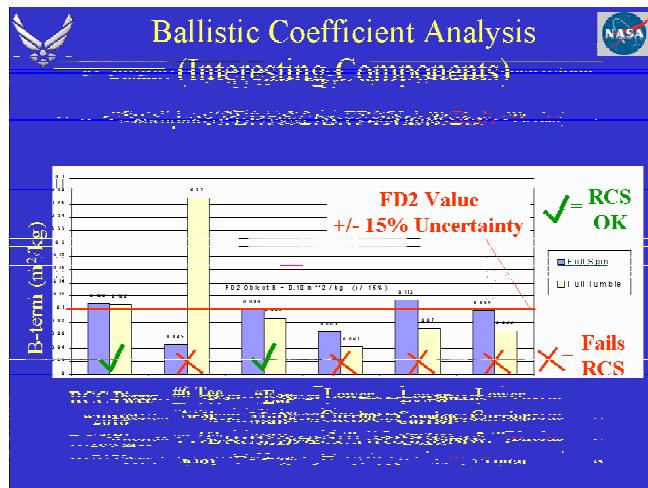
Figure 19- B-Term Analyses Results for RCC Tee seal and acreage pieces

Looking at the analysis of Figure 19, the RCC acreage piece “2018” fits very nicely with the observed on-orbit B-term data. Interestingly enough, the piece *only* fits the B-term if it is on the order of 0.33” thick. The RCC panels in the vicinity of the so-called “shock-shock” region of the wing are, in fact, 0.33” thick in the lower panel acreage regions. Most of the RCC on the Shuttle is only 0.25” thick, and this value is too

low to meet the B-term. So the analysis indicates that RCC panels originating in the areas of panels 8,9, or 10 could meet these criteria. The other components shown in Figure 19 were rejected based on their RCS test data.

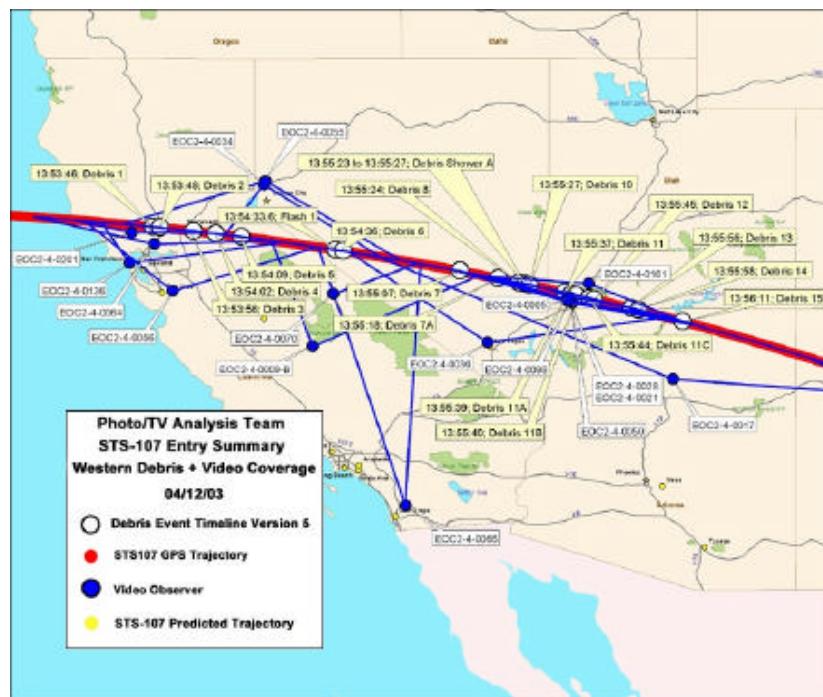
Figures 2-1 and 2-2 summarize the debris shedding events and flashes/flares observed in public video. These are shown on the entry ground track and include each photographer's location and approximate field of view recorded in video. Times listed in the figures for each event indicate the earliest each is seen in video. Exact debris shedding times were calculated based on detailed relative motion analysis as explained in detail in Section 4.2. Figure 2-3 shows the predicted ground impact areas for each debris shedding event.

Figure 2-1: Public Video Coverage of the Western United States STS-107 Entry Trajectory [21]

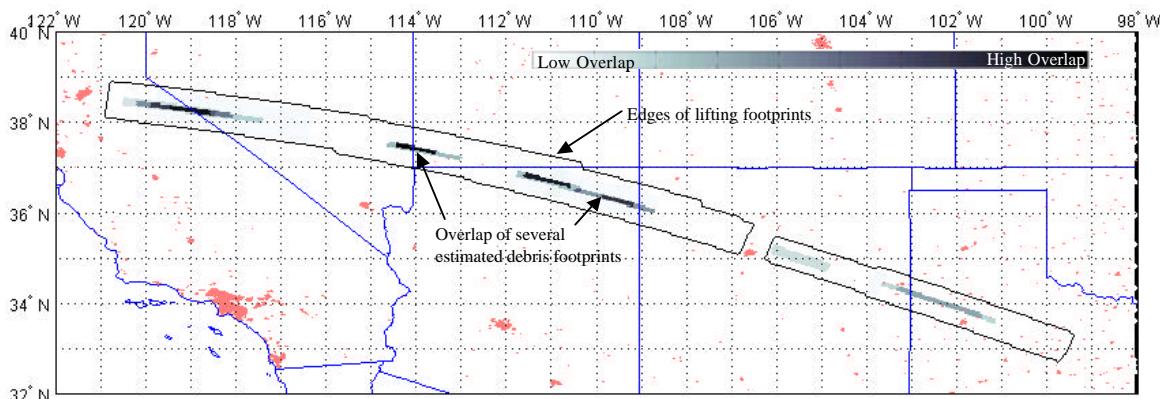
Figure 2-4: Combined Overlapping Ground Impact Footprints of Observed Debris 1 Through 16 [24]

Emphasis was then given to the areas in which the highest probability regions of multiple early debris shedding footprints overlap as shown in Figure 2-4. The darkest regions in the plot indicate the most overlap.

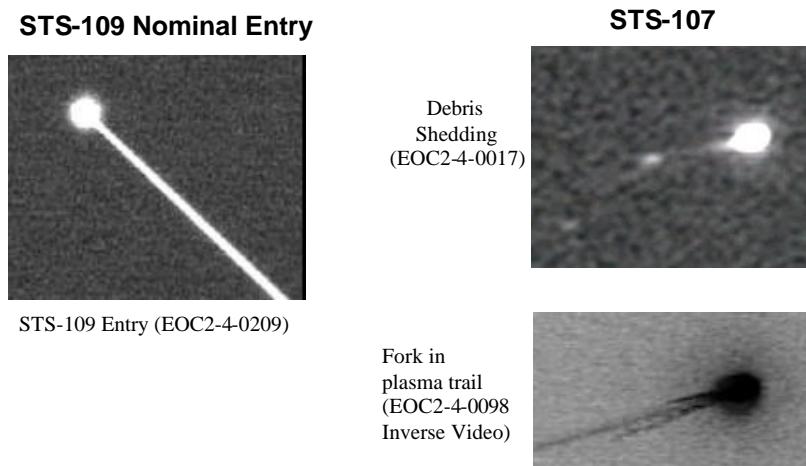
Figure 4-4: Example of Nominal Entry vs. STS-107 Entry

STS-107 videos were screened for off-nominal events. Observed off-nominal events include debris shedding, bright segments of the plasma trail, flares and flashes in the Shuttle plasma envelope, forks in the plasma trail emanating from the Shuttle plasma envelope, and parallel plasma trails. Entry videos from previous flights were also screened to characterize nominal events such as RCS firings. In none of the previous entry videos were any of the anomalous events described above seen. Examples are shown in Figure 4-4.

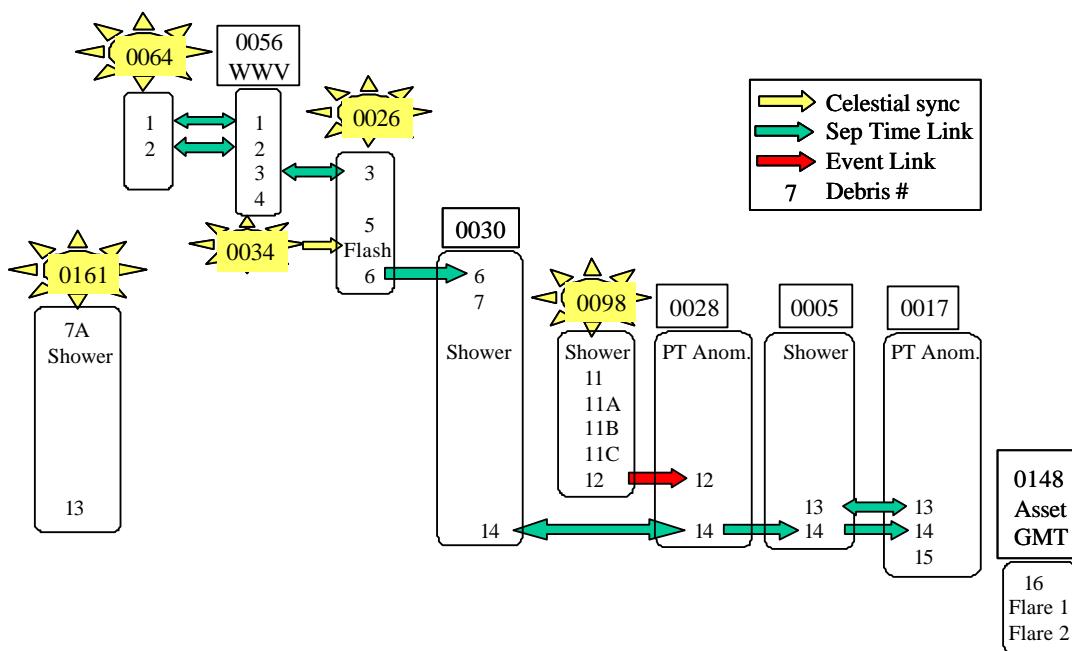
Figure 4-5: STS-107 Early Debris Shedding Events

Figure 4-5 is a summary of the multiple videos linked to provide times for the entire debris timeline. Some of these debris events were seen in videos not shown above. In those cases, the videos were not useful in providing timing information for the debris event but may be useful for further analysis of the event.

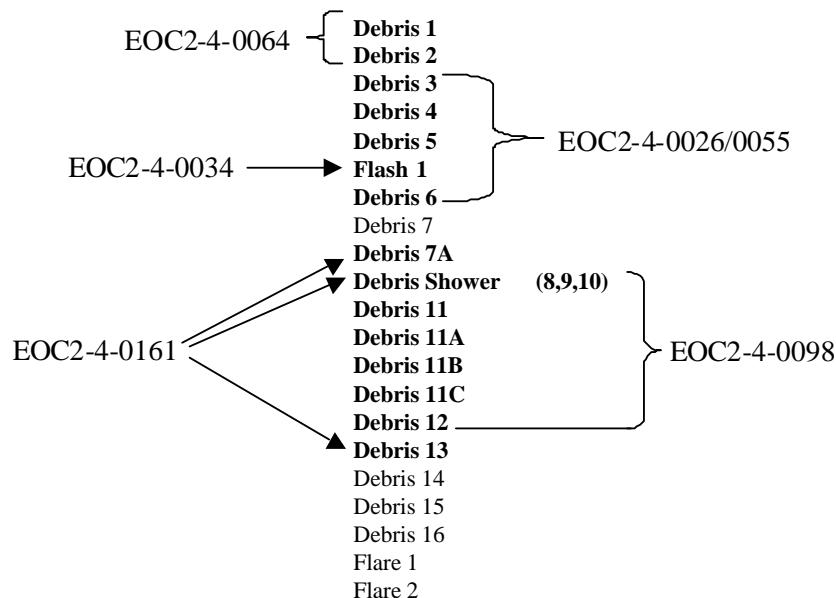
Figure 4-6: Debris Events Observed on Public Video Tapes with Celestial References

Even though only a small percentage of the videos that saw debris were able to be celestially referenced, these few videos did have observations of over 70% of the off-nominal events. These videos served as the starting point for the time sequencing of all the videos depicting the STS-107 entry between California and Arizona and eventually time synching debris 1 through 15.

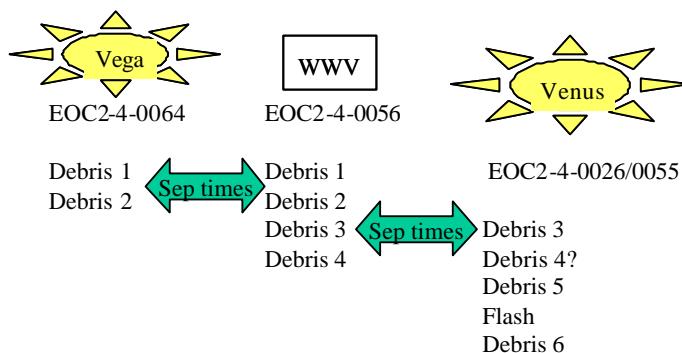
Figure 4-8: Overlapping Debris Observations with EOC2-4-0064 and EOC2-4-0026/0055

The relative motion team calculated the separation times for debris 1 and 2 using EOC2-4-0064 and EOC2-4-0056. The separation times for these debris agreed between the 2 videos to within 0.2 seconds. Similar analysis was done for debris 3 using videos EOC2-4-0056 and EOC2-4-0026. Debris 3 separation times agreed within 0.1 seconds. Therefore EOC2-4-0056 showed good agreement with both EOC2-4-0064 and EOC2-4-0026, providing an overlapping link between those two celestially synced videotapes.

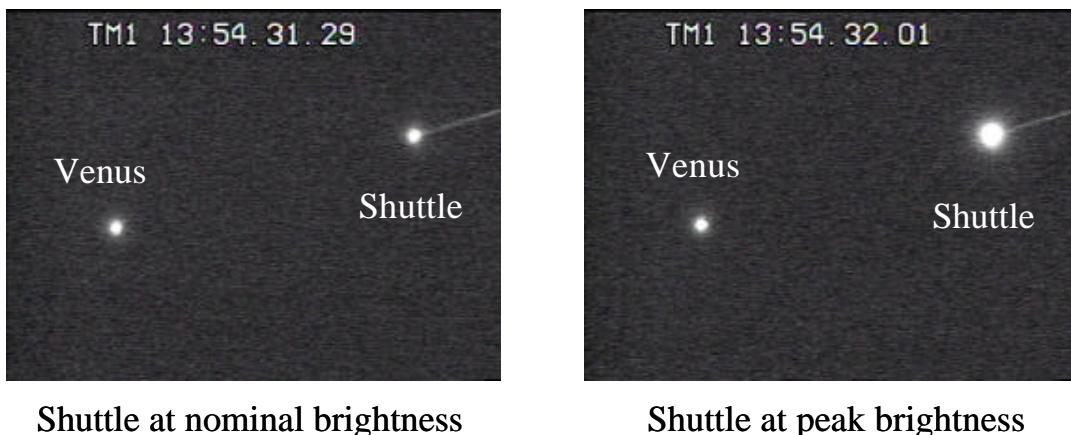
Figure 4-9: Flash 1 as Seen in EOC2-4-0026/0055

The Flash was observed on five videotapes. Four of these observed a brief brightening of the plasma trail, followed by debris 6 emerging from the Shuttle plasma envelope shortly after the flash. EOC2-4-0034 was too noisy to observe any debris (i.e., the brightness of random static, or noise, was the same or greater magnitude as that expected for the debris). Also, it was determined from the STS-107 RCS firing history that aft RCS jets R2R and R3R fired for a total of 0.26 seconds at the same time as the flash was observed. This duration matches the duration of the flash to within 0.04 seconds. However, based on analysis of previous nominal entry overflights, RCS firings do not result in a flash of the Shuttle plasma envelope or a brightening of the plasma trail. It is impossible to determine if the RCS firings contributed to the cause, or are an effect of this event. Therefore, it is concluded that the flash is an off-nominal event which may or may not be related to the RCS jet firing. The previous RCS firing occurred at GMT 13:51:45, which was prior to any video coverage of the STS-107 entry. Later RCS firings, at

Two of the tapes showing the flash had celestial syncs (EOC2-4-0026/0055, EOC2-4-0034). The peak brightening of the flash lasted for only 0.1 seconds and occurred at GMT 13:54:33.6 in both EOC2-4-0026/0055 and EOC2-4-0034, which were celestially synced. EOC2-4-0009B, EOC2-4-0066, and EOC2-4-0070 were then time synced based on the above peak flash time.

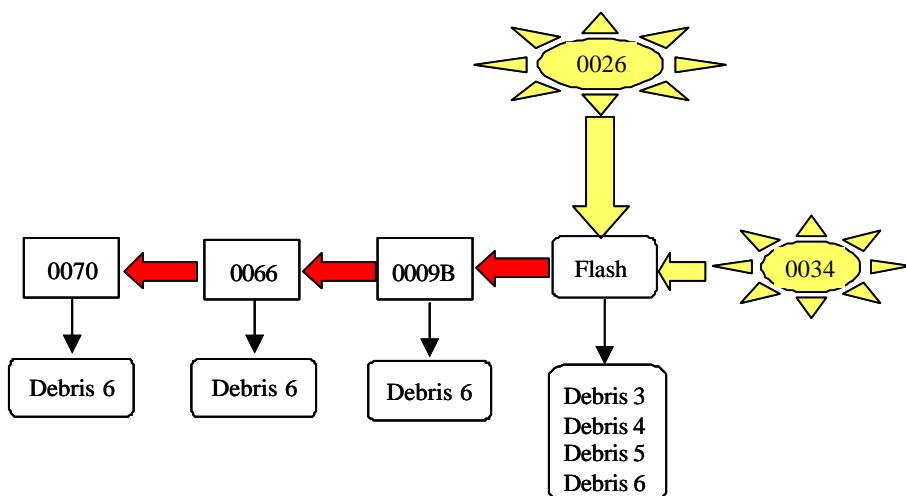
Figure 4-10: Overlapping Observations of Flash 1 and Debris 6

Note that even though four of the videos observed debris 6, the difference between the time of first observance of debris 6 emerging from the Shuttle plasma envelop varied by as much as 2.2 seconds. This can be explained by differences in field-of-view, viewer look angle to the Shuttle, and camera capability. In each of these cases, the debris may have had to travel a different distance away from the Shuttle before it could be distinguished as a separate object.

The relative motion team determined that debris 6 was shed immediately after the flash.

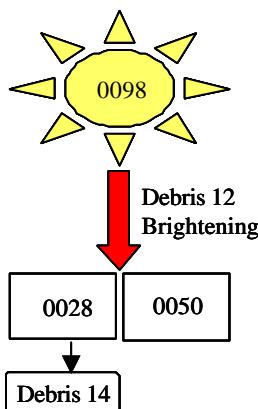
Figure 4-11: Debris 12 Brightening and Time Synchronization of Debris 14

Debris 12 brightened significantly for 1/30th of a second (one frame) in three videotapes (EOC2-4-0028, 0050, 0098), as it was well aft of the Shuttle plasma envelope. EOC2-4-0098 was celestially synced based on a visible TCA with the star Tania Australis; therefore, the time of this brightening event was known to be GMT 13:55:46.5. EOC2-4-0028 and EOC2-4-0050 were then time synchronized to this time for the debris 12 brightening. EOC2-4-0028 contained footage of debris 14, an event that was not on a celestially synced video, thereby providing an accurate time source for this debris event.

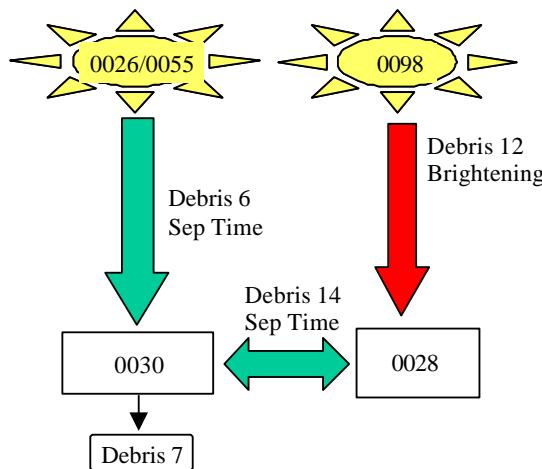
Figure 4-12: EOC2-4-0030 Links Second Two Celestial Reference Segments

Only one video, EOC2-4-0030, provided overlap between the California/Reno area observations and the Utah/Arizona observations of the STS-107 entry. EOC2-4-0030 starts with observations of debris 6 as the observer reported turning on his video camera shortly after seeing the Shuttle flash and ends with debris 14. No valid time sync information was reported by the observer, so the video was initially time synced to the apparent maximum elevation with the time from Skywatch. This time sync proved that the initial debris depicted on the tape was debris 6 and

the final debris on the tape was debris 14. Since the separation time for debris 6 was known based on relative motion analysis of EOC2-4-0026, the time sync for EOC2-4-0030 was updated to match the debris 6 separation time. The separation time for debris 14 was also known due to relative motion analysis of EOC2-4-0028 (which was linked to celestially synced EOC2-4-0098 through the debris 12 brightening). The separation time for debris 14 in EOC2-4-0030 matched the separation time of debris 14 in EOC2-4-0028 to within 0.1 seconds, therefore linking the Venus eclipse time sync of EOC2-4-0026/0055 to the Tania Australis TCA time sync of EOC2-4-0098.

EOC2-4-0030 was the only videotape that showed footage of debris 7. By linking this tape to EOC2-4-0026 and indirectly to EOC2-4-0098, the time of this debris event was now known.

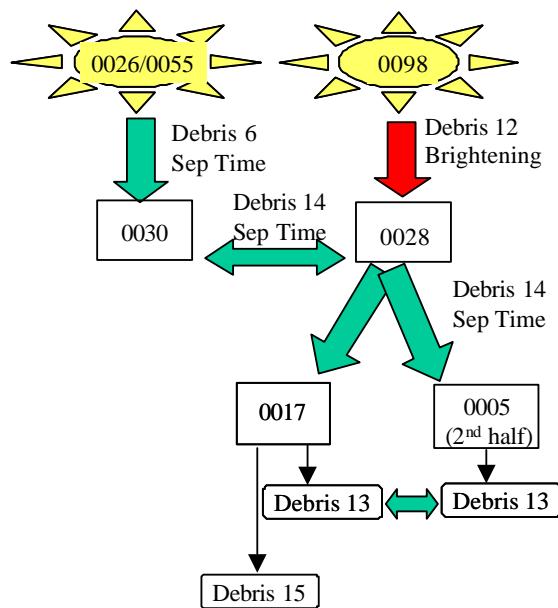
Figure 4-13: Additional Videos Time Synchronized to Establish Debris 15 Separation Time

Five videos show debris 14: EOC2-4-0005, EOC2-4-0017, EOC2-4-0021, EOC2-4-0028, and EOC2-4-0030. EOC2-4-0028 and EOC2-4-0030 have accurate time syncs based on the debris 12 brightening and debris 6 separation times, respectively. Based on relative motion analysis of EOC2-4-0028 and EOC2-4-0030, the debris 14 separation time is 13:55:56.7. This time was then used to update the time syncs of EOC2-4-0005 (second half) and EOC2-4-0017. EOC2-4-0005 has a break in the continuous footage in the middle of its track of the STS-107 entry, so only the footage after the break in coverage could be updated with this timing information. Relative motion analysis of EOC2-4-0021 debris 14 could not be done due to changes in zoom during the event. The time syncs for EOC2-4-0017 and EOC2-4-0005 (second half) were confirmed with agreement of debris 13 separation times within 0.1 seconds.

EOC2-4-0017 was originally time synced based on measuring camcorder clock drift at 7 days and 14 days after the STS-107 entry to correct the camcorder clock time imbedded in the video. Camcorder clock drift relative to true GMT was assumed to be linear over this time period but based on different battery uses between the two measurements, may not be. Time syncing EOC2-4-0017 based on the more accurate debris 14 separation time resulted in a 1.2 second shift earlier. Based on engineering judgment, this seemed to be a reasonable refinement of the time sync given the known rough assumptions of the camcorder clock drift.

EOC2-4-0017 was the only videotape which contained footage of debris 15, so the time for this event was now known.

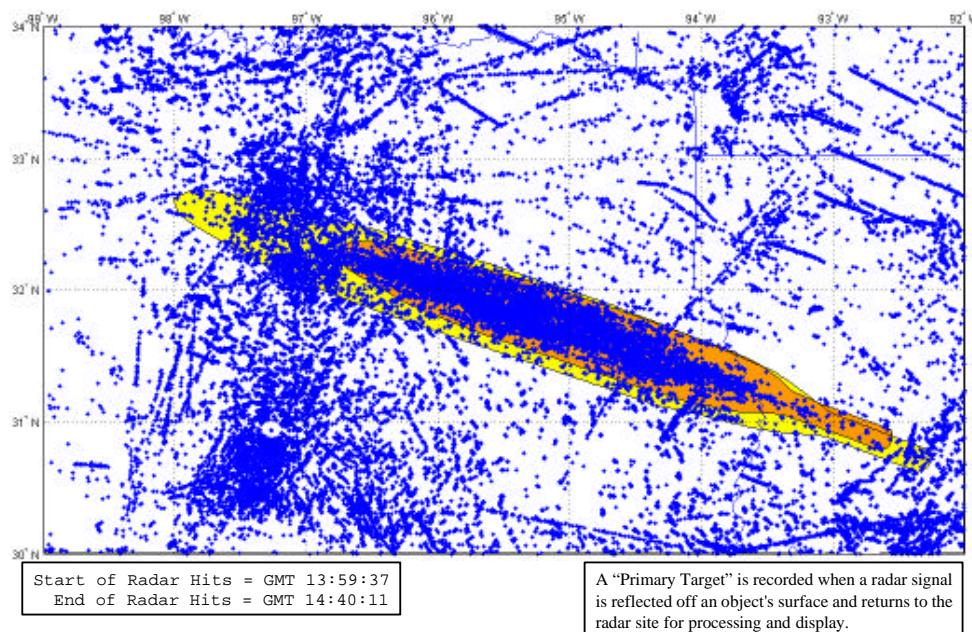
Figure 4-42: Estimated Columbia Primary Debris Fields and "Primary Targets" from Available ATC Radars, 13:59:37 - 14:40:11

Figure 4-42 superimposes all ATC radar hits for the period of time approximately starting at the time of the accident and extending for 40 minutes. This is a composite plot of the previous four figures. A clear clustering of radar hits is seen to fit extremely well in the 14:00:02.12 GMT debris footprint boundary.

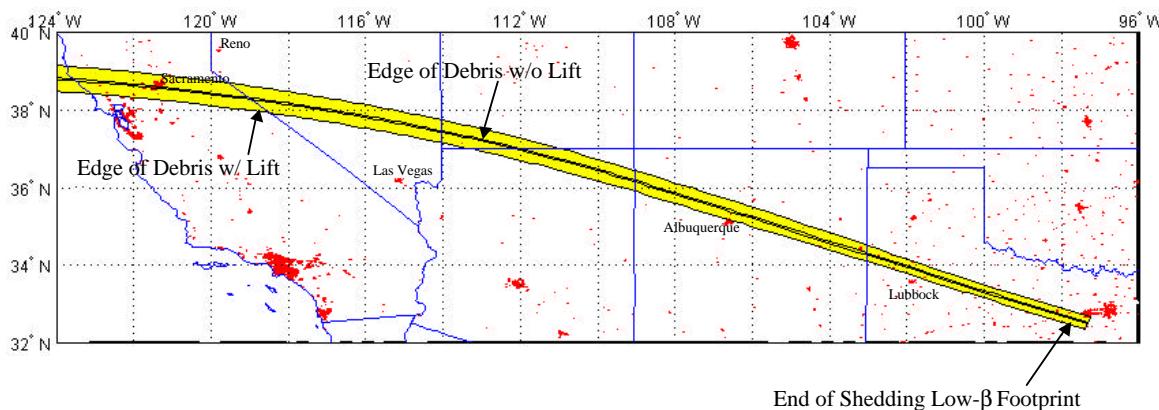
Figure 4-43: Probable Ground Impact Area for Shedding Low- $\beta$  Debris  
Ballistic Coefficient of 0.5 psf, 0-0.15 zL/D,  $C_d$  1.0

Figure 4-43 shows the "low-  $\beta$ " debris swath. Figures 4-44 and 45 show this swath laying over the "high-  $\beta$ " debris swath. Lifting and non-lifting footprints appear. The "without lift" footprints indicate where debris is more likely to land. The "with lift" footprints indicate the total area of expected impact (99% probability with 95% confidence). The footprints shown are the ground impact areas. The Debris Footprint Team also generated footprints for 80,000 ft altitude for use by the Radar Analysis Team as described in Section 5.

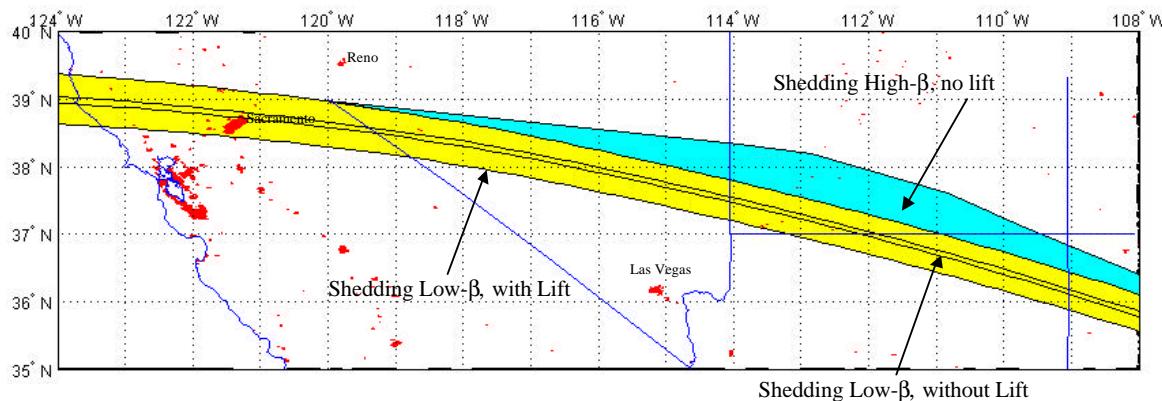
Figure 4-44: Probable Ground Impact Area for Shedding Debris  
Ballistic Coefficient of 0.5 psf, 0-0.15 L/D & 220 psf, 0 L/D,  $C_d$  1.0

Figure 4-44 shows the western half of the resulting ground impact debris swath that would capture any 0.5 psf debris shed pre-breakup, overlaid on the resulting ground impact debris swath that would capture any higher ballistic coefficient (up to 220 psf) debris shed pre-breakup. It is interesting to note that the 220 psf simulated debris footprint is not centered about the groundtrack, but tends to extend quite a bit to the north in this figure. This is due to the momentum of the higher- $\beta$  objects carrying them “straight” while the orbiter is banking toward the south.

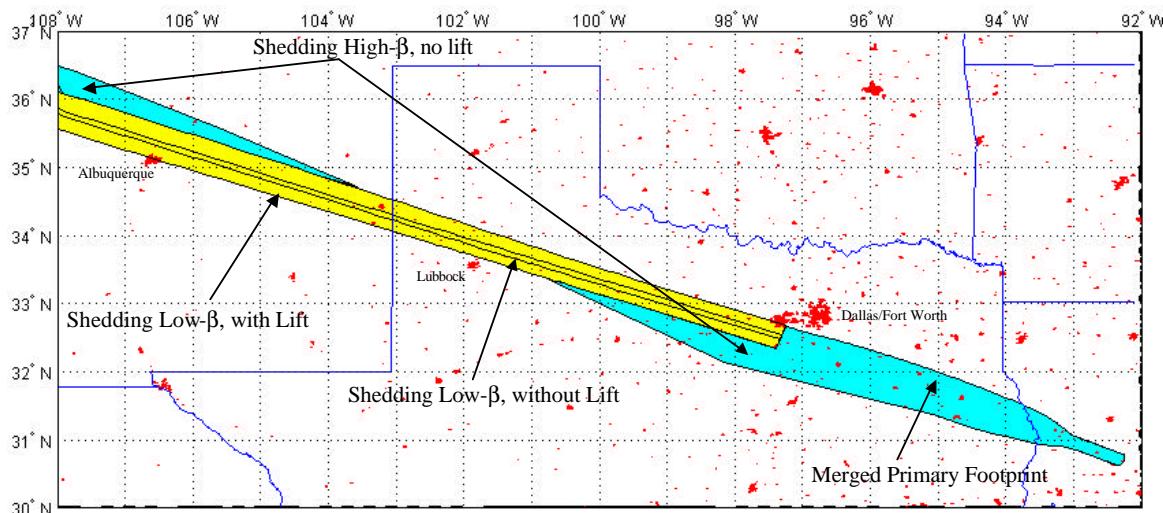
Figure 4-45: Probable Ground Impact Area for Shedding Debris  
Ballistic Coefficient of 0.5 psf, 0-0.15 L/D & 220 psf, 0 L/D,  $C_d$  1.0

Figure 4-45 shows the eastern half of the resulting ground impact debris swath that would capture any 0.5 psf debris shed pre-breakup, overlaid on the resulting ground impact debris swath that would capture any higher ballistic coefficient (up to 220 psf) debris shed pre-breakup. Here, note that the 220 psf simulated debris footprint is again not centered about the groundtrack, and begins to shift its extension from north of the groundtrack towards the south on this figure. This is due to the momentum of the higher- $\beta$  objects carrying them “straight”. While the Orbiter is banking toward the south initially, and thus high- $\beta$  objects tend to land north of the

groundtrack, that effect shifts as the Orbiter does a roll-reversal and begins banking toward the north, thus the high- $\beta$  objects then tend to land south of the groundtrack. Because of this, if any high- $\beta$  objects found south of the primary debris footprint's southern boundary would be a suspect for falling off the orbiter prior to the catastrophic breakup.

Although not shown here, it is possible that debris that fell off the Orbiter prior to catastrophic breakup could have landed within the primary debris footprint boundary. If such debris is found, the more west it is found, the more likely it is debris that came off pre-breakup.

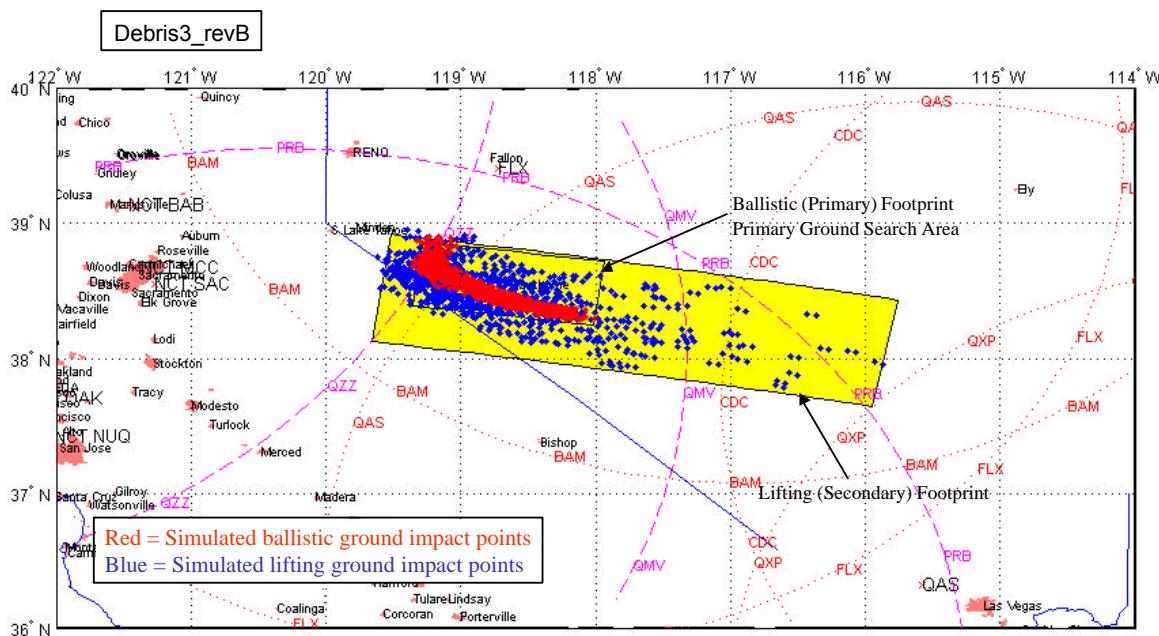
Figure 4-49: Probable Ground Impact Area for Debris 3  
and Simulated Impact Points for Observed Debris  
Separation Time 13:53:55.6 - 13:53:56.6Z  
Constant Ballistic Coefficients between 0.1 to 1.0 psf, 0-0.15 L/D, C<sub>d</sub> 1.0

Figure 4-49 shows how rectangular footprint shapes are applied to simulated debris, rather than "form-fitting" shapes, and how the rectangular shapes can be artificially wide whenever the simulated debris centerline is not parallel to the groundtrack, as just described. In this figure, the red points are the simulated ballistic (non-lifting) ground impact points for Debris 3.

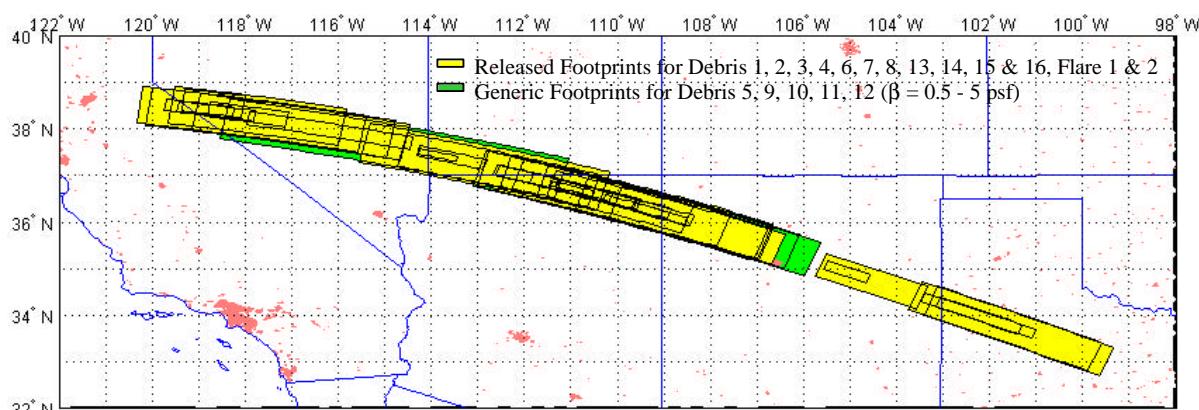
Figure 4-50: Combined Probable Ground Impact Areas  
Observed Debris Events 1, 2, 3, 4, 6, 7, 8, 13, 14, 15 & 16 and Assumed Debris at Flare 1 & 2  
Constant Ballistic Coefficients, 0-0.15 L/D,  $C_d$  1.0

Figure 4-50 shows overlapping debris footprint boundaries for all released debris footprints based on relative motion and ballistics analysis, as well as footprints based on assumed ballistics for Flare 1 and Flare 2, in yellow. This figure shows these results overlaid on results if one assumes a 0.5 - 5.0 psf ballistic coefficient range on videotaped debris whose relative motion and ballistic coefficients are still unknown, in green. Thus, the portion of green that is visible shows potential impact locations for debris 11 and 12 that are outside the released footprints. Note that based on videotaped debris alone, nearly all land under the entire groundtrack is a candidate for potentially finding Columbia debris.

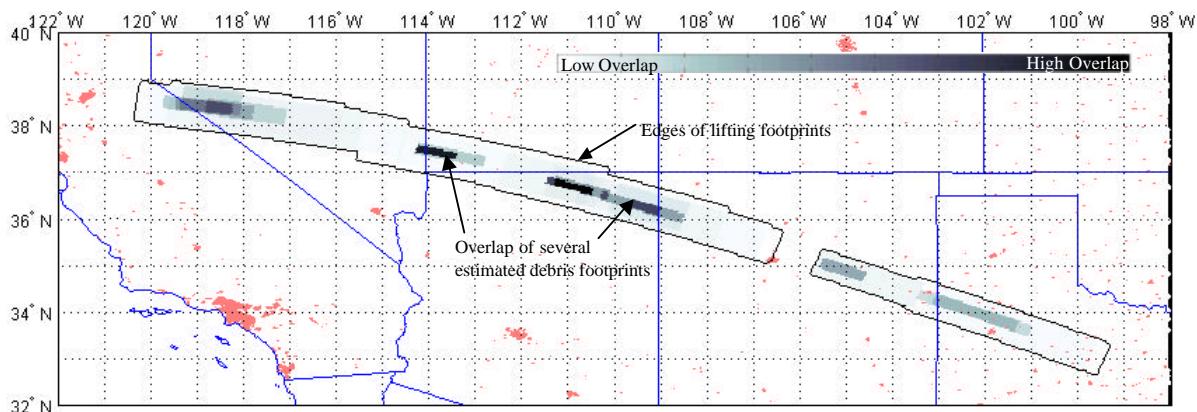
Figure 4-51: Overlapping Non-Lifting Probable Ground Impact Areas  
Observed Debris Events 1, 2, 3, 4, 6, 7, 8, 13, 14, 15 & 16 and Assumed Debris at Flare 1 & 2  
Constant Ballistic Coefficients, 0-0.15 L/D,  $C_d$  1.0

Figure 4-51 below depicts the amount of overlap among the released (yellow) debris footprints with an emphasis on the non-lifting areas. As more non-lifting areas overlap, the shading becomes darker. The darkest regions in the plot were given higher priority when all areas were prioritized as shown in Table 2-1. Prioritizing these areas and the radar search boxes is described in more detail in Section 5.

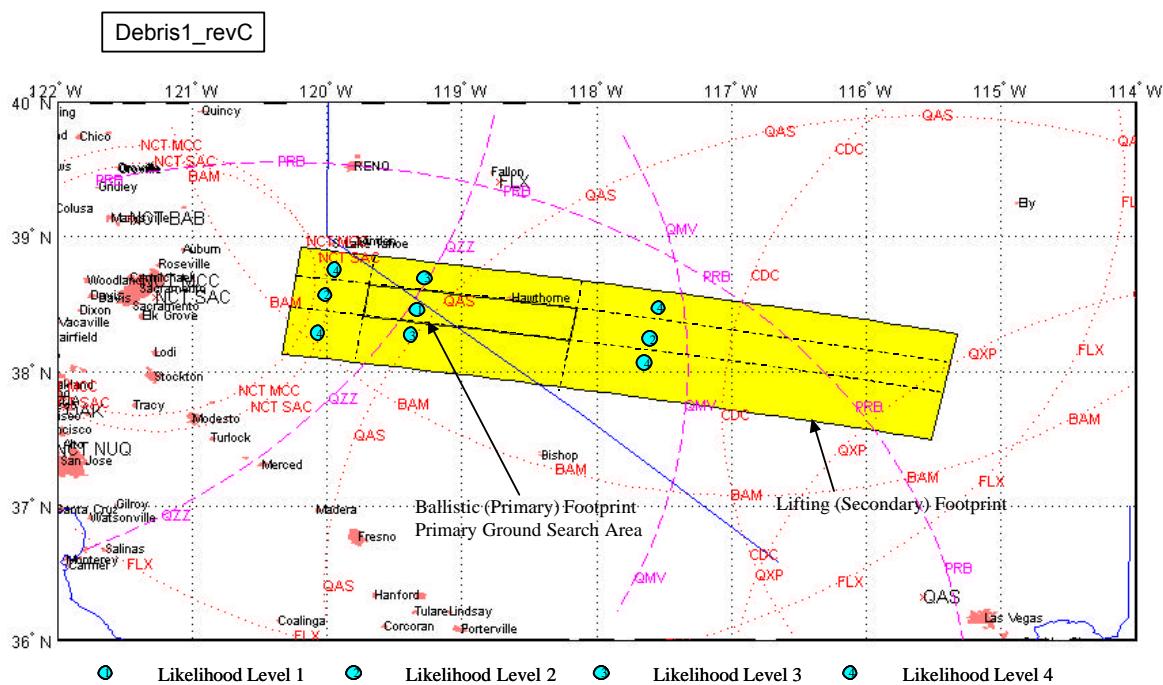
Figure 4-52: Probable Ground Impact Area for Debris 1  
Separation Time 13:53:44.2-13:53:45.4Z  
Constant Ballistic Coefficients between 0.6 to 1.6 psf, 0-0.15 L/D, Cd 1.0

The Aerospace Corporation independently validated the JSC ballistic coefficient, separation time, and both the ballistic (non-lifting) and lifting footprint boundaries, with similar, but slightly different methods for relative motion, ballistic coefficient estimation, and debris footprint estimation [30]. Aerospace calculated an Orbiter/Debris separation time of 13:53:45.4Z compared to a JSC estimate of 13:53:44.2 - 13:53:45.4Z. [23] [30] Likewise, the Aerospace ballistic coefficient was 0.5 - 1.5 psf [30] compared to a JSC estimate of 0.6 - 1.6 psf [23], both derived using day-of-entry density at event altitude.

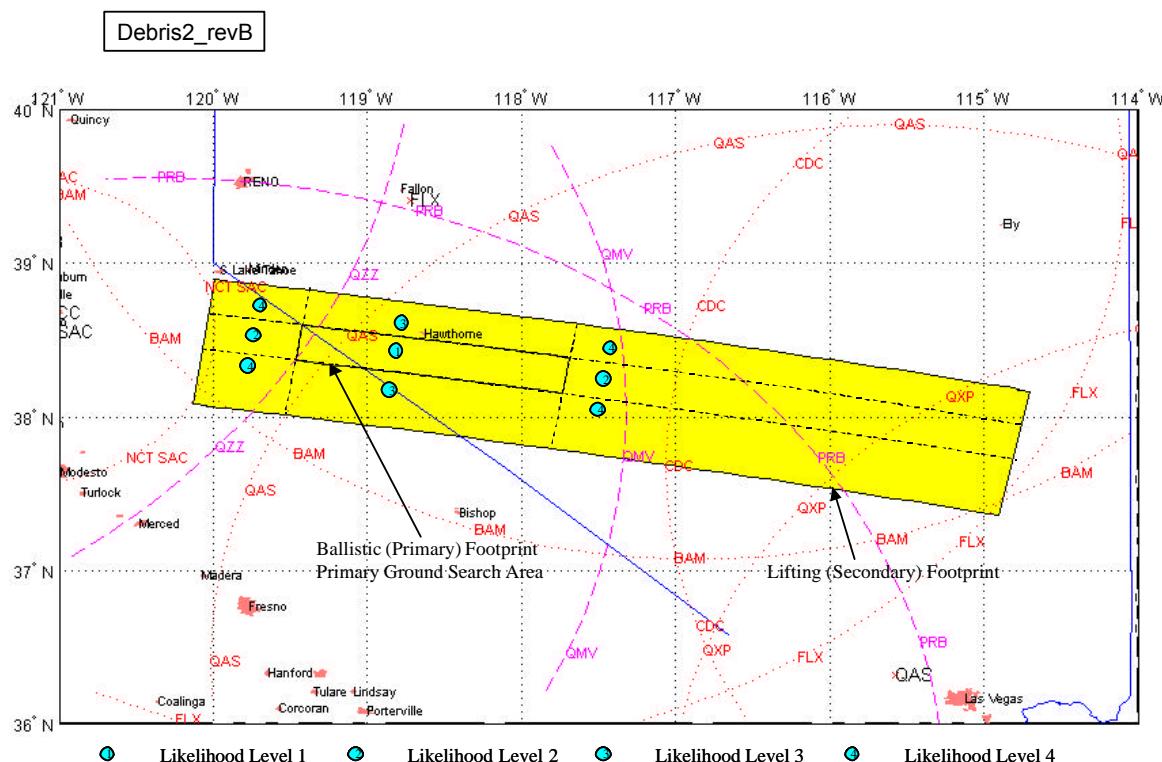
Figure 4-53: Probable Ground Impact Area for Debris 2  
 Separation Time 13:53:45.9 - 13:53:47.1Z  
 Constant Ballistic Coefficients between 0.7 to 1.9 psf, 0-0.15 L/D,  $C_d$  1.0

The Aerospace Corporation independently validated the JSC ballistic coefficient, separation time, and both the ballistic (non-lifting) and lifting footprint boundaries, with similar, but slightly different methods for relative motion, ballistic coefficient estimation, and debris footprint estimation [30]. Aerospace calculated an Orbiter/Debris separation time of 13:53:46.8 compared to a JSC estimate of 13:53:45.9 - 13:53:47.1. [23] [30] Likewise, the Aerospace ballistic coefficient was 1.0 - 2.0 psf [30] compared to a JSC estimate of 0.7 to 1.9 psf [23], both derived using day-of-entry density at event altitude.

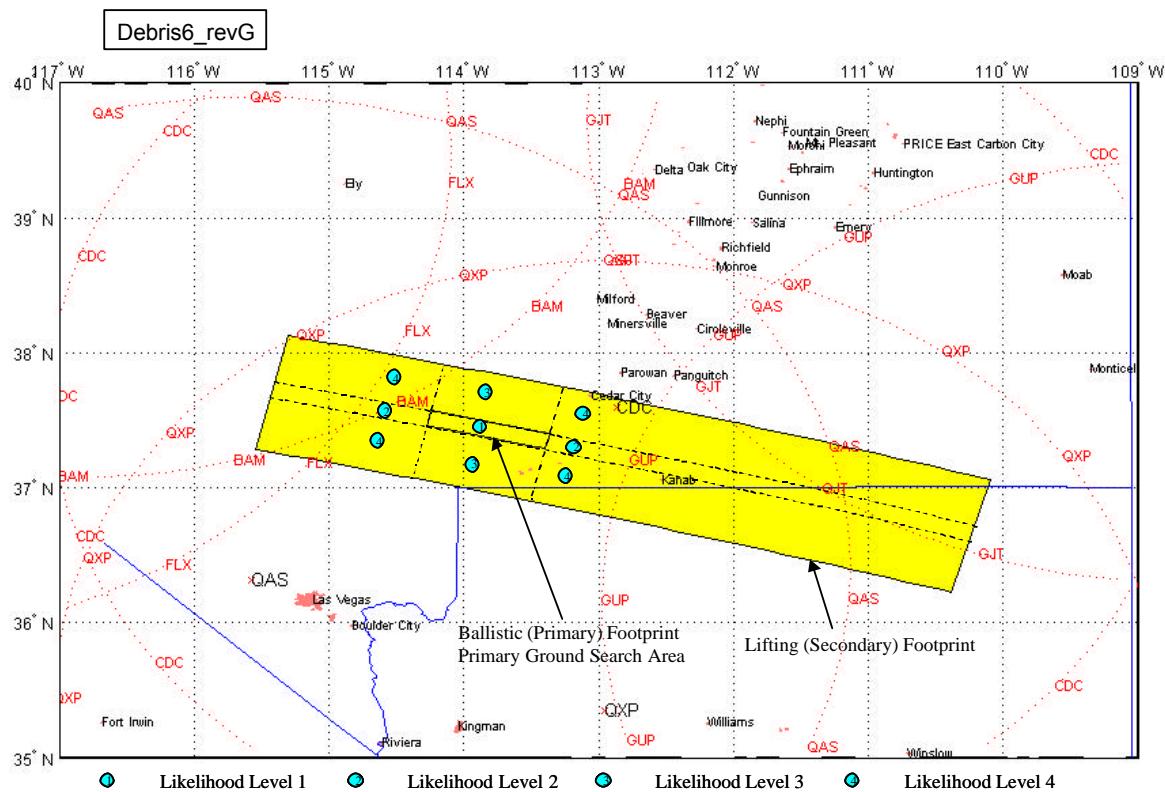
Figure 4-56: Probable Ground Impact Area for Debris 6  
Separation Time 13:54:33.7-13:54:34.7Z  
Constant Ballistic Coefficients between 3.0 to 4.0 psf, 0-0.15 L/D,  $C_d$  1.0

Video for this object was analyzed first due to the Orbiter and debris crossing of Venus, allowing accurate time estimation

The Aerospace Corporation independently validated the JSC ballistic coefficient, separation time, and both the ballistic (non-lifting) and lifting footprint boundaries, with similar, but slightly different methods for relative motion, ballistic coefficient estimation, and debris footprint estimation [30]. Aerospace calculated an Orbiter/Debris separation time of 13:54:33.72 compared to a JSC estimate of 13:54:33.7-13:54:34.7. [23] [30] The Aerospace ballistic coefficient matched the JSC range of 3.0 - 4.0 psf [30] [23], both derived using day-of-entry density at event altitude.

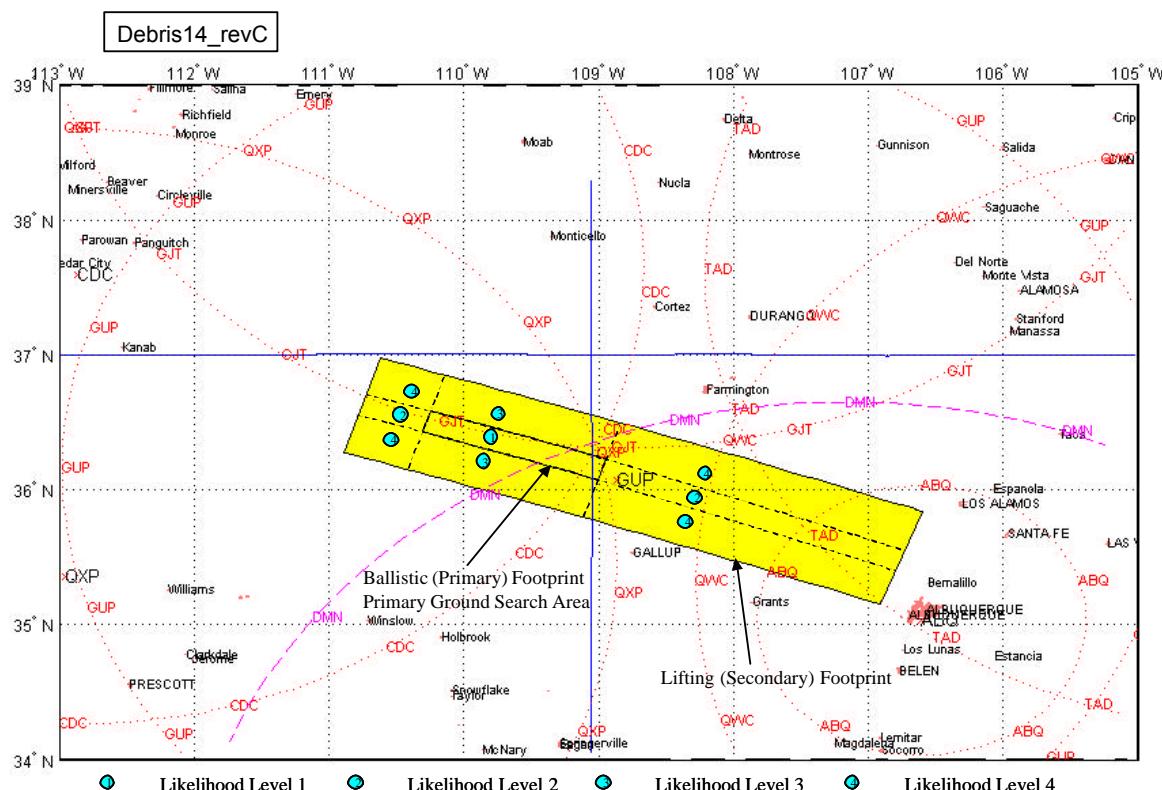
Figure 4-60: Probable Ground Impact Area for Debris 14  
Separation Time 13:55:56.2-13:55:57.2Z  
Constant Ballistic Coefficients between 1.0 & 2.4 psf, 0-0.15 L/D,  $C_d$  1.0

The Aerospace Corporation independently validated the JSC ballistic coefficient and both the ballistic (non-lifting) and lifting footprint boundaries, with similar, but slightly different methods for relative motion, ballistic coefficient estimation, and debris footprint estimation [30].

Aerospace calculated a ballistic coefficient of 1.0 - 2.0 psf [30] compared to a JSC estimate of 1.0 - 2.4 psf [23], both derived using day-of-entry density at event altitude.

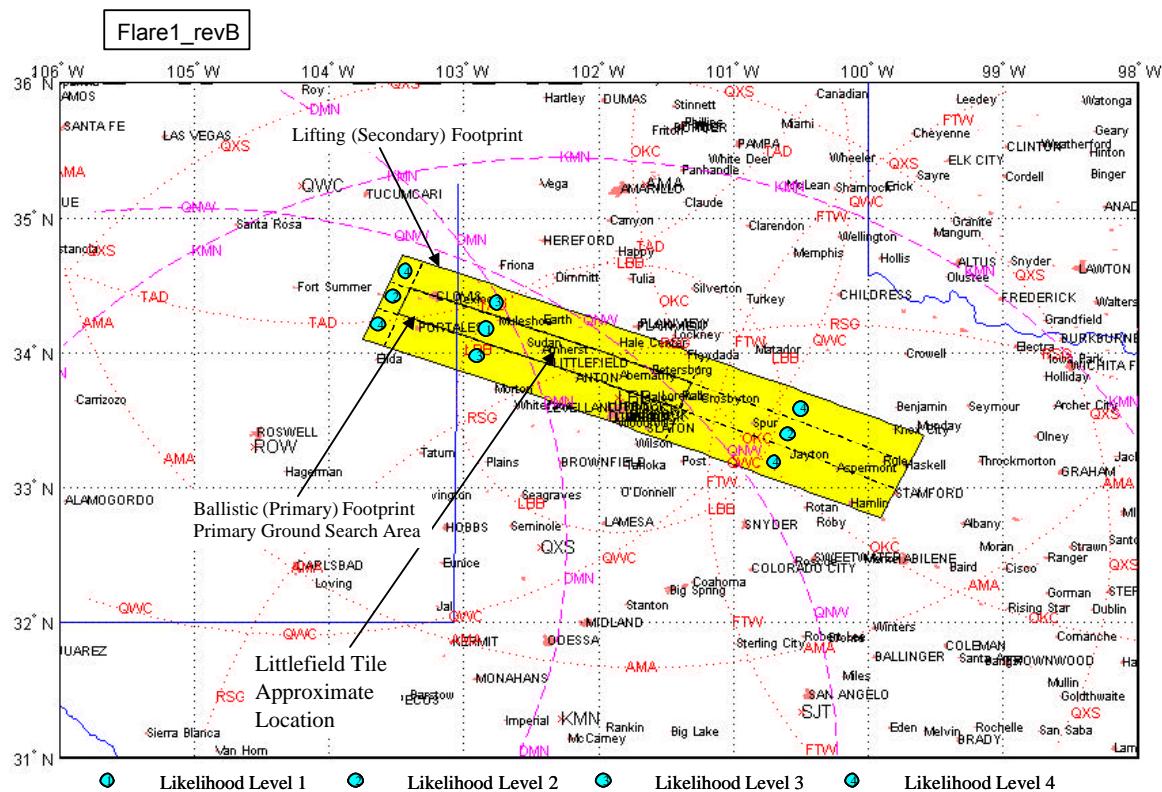
Figure 4-63: Probable Ground Impact Area for Assumed Debris Associated with Flare 1  
 Observed Flare at 13:57:54.7Z  
 Constant Ballistic Coefficients between 0.5 to 5.0 psf, 0-0.15 L/D,  $C_d$  1.0

Two flares are visible in video coverage [22]. No debris is visible in the video at or near the flare times; debris may be there but may not be visible due to: small size; lighting (in daylight now); and/or short time of observation (Orbiter leaves camera field-of-view immediately). It is possible that debris fell off the Orbiter at these two flare times. The simulation uses the assumed ballistic coefficient range of 0.5 - 5.0 psf since this range approximately bounds ballistic coefficients derived from video of other debris thus far.

Using this method, based on the impact location and ballistic coefficient range of 0.5 - 0.9 psf, the Littlefield Tile is estimated to have been shed between 13:57:49 - 13:58:20Z. This time range encompasses the observed times for Flare 1 and Flare 2. It is possible that if debris fell off the orbiter at Flare 1 or Flare 2, that the Littlefield Tile may be this debris or a portion of this debris. This is shown above in Figures 4-63 and 4-64.
