# COLUMBIA

## ACCIDENT INVESTIGATION BOARD

## VOLUME III

<b>OTHER TECHNICAL DOCUMENTS</b>	
Appendix E.1	Reader's Guide to Volume III .....	5
Appendix E.2	CoFR Endorsements .....	7
Appendix E.3	STS-107 Image Analysis Team Final Report .....	27
Appendix E.4	An Assessment of Potential Material Candidates for the "Flight Day 2" Radar Object Observed during the NASA Mission STS-107 .....	139
	<i>Columbia Early Sighting Assessment Team Final Report.....</i>	171

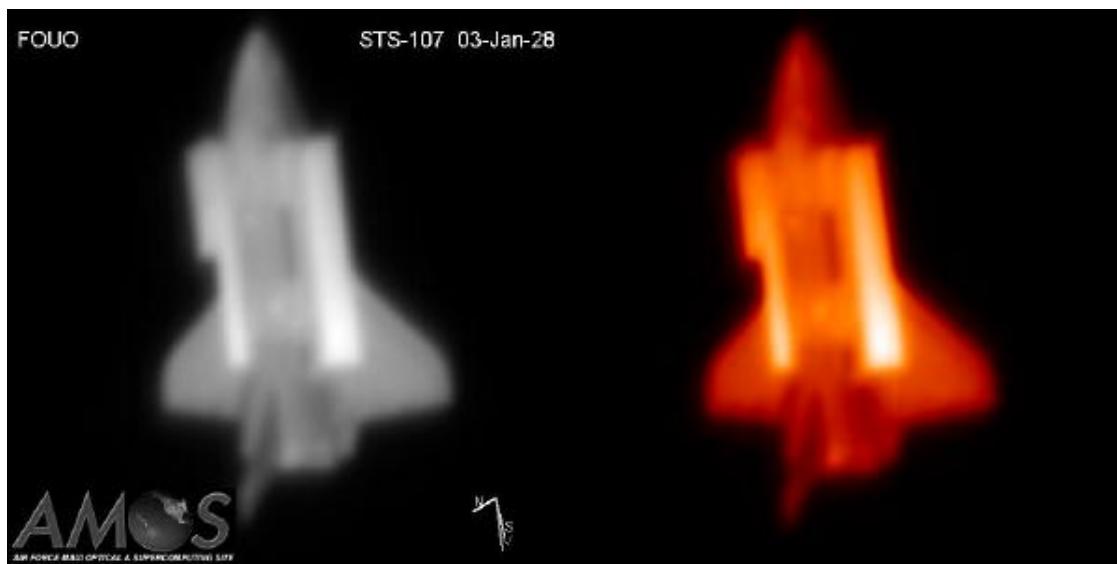
Figure 7-1: Example AMOS Visible Images of Columbia during STS-107 [4]

While these images taken from the ground of a manned spacecraft in orbit are fascinating, particularly when individual frames are strung together as a video, they show no discernible damage. The post-processed infrared images and the corresponding thermal mapping shown in Figure 7-3 below suggest that this capability may be valuable on future flights for detecting significant external damage, and this is under study by NASA JSC. To facilitate use of this capability for damage detection on future flights, the Air Force Research Lab (AFRL) has requested detailed material maps of the Orbiters.

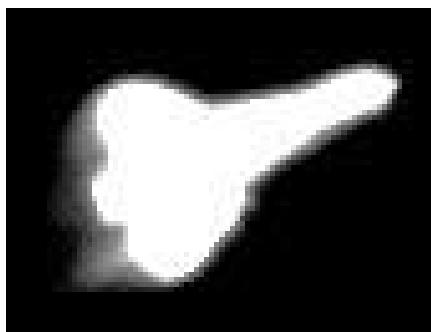
The images below in Figures 7-4 and 7-5 are representative of three stills and four videos taken by employees of the Starfire Optical Range at Kirtland AFB, New Mexico during STS-107 entry. They are not official DOD images and were taken through personal equipment, not the Starfire optics. Figure 7-4 is the image released to the press that sparked considerable early speculation regarding left wing leading edge damage and asymmetric wake.

Figure 7-4: Example Raw Still Taken by Starfire Optical Range Employees during STS-107 Entry [5]

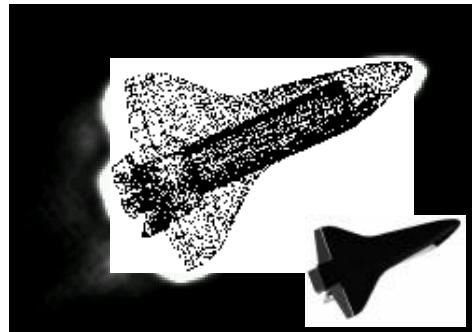
In support of this team's analysis, the ESAT provided Orbiter state vectors, a series of wire frame images of the Orbiter as viewed from Kirtland AFB throughout the pass and coordinated a series of solid model images. These Orbiter images were superimposed over the Kirtland images to help evaluate them for anomalies. Examples are shown in Figure 7-6.

Figure 7-6: Example Orbiter Wire Frame Superimposed over Raw Still Image Taken by Starfire Optical Range Employees during STS-107 Entry and the Associated Solid Model [5]

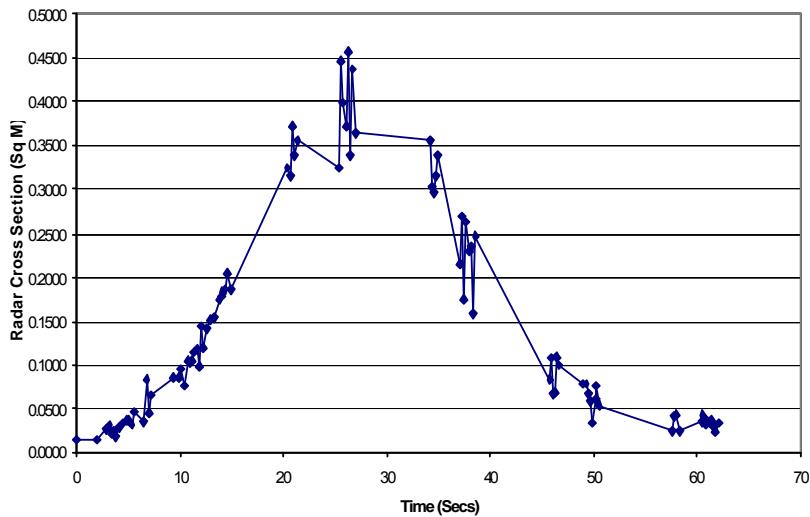
Several passes of radar cross section versus time data were obtained by a combination of the Cape Cod and Beale UHF phased array radars and the Kwajalein VHF/UHF radar. Data from the Cape Cod passes is shown in Figures 7-7, 8 and 9. Early interpretation of this data suggested a small plate-like, spinning or tumbling object. Orbital behavior indicated a relatively lightweight object which decayed after approximately 60 hours in orbit. [2] It was also pointed out that, "had the SSN been tasked, it could have supplied additional data." [1] This will be included in a follow on activity to generically review DOD tracking capability for possible changes to routine and contingency tasking on all future Shuttle flights.

Figure 7-7: Cape Cod Track on January 17, 1857Z [2]

The radar cross section of the object in orbit varied from approximately  $0.1 - 0.7 \text{ m}^2$ . The ballistic coefficient of the object in orbit was estimated to be  $0.102 \text{ m}^2/\text{kg}$  by Air Force Space Command [2] with good agreement by JSC Engineering at  $0.09 - 0.11 \text{ m}^2/\text{kg}$ . [23]

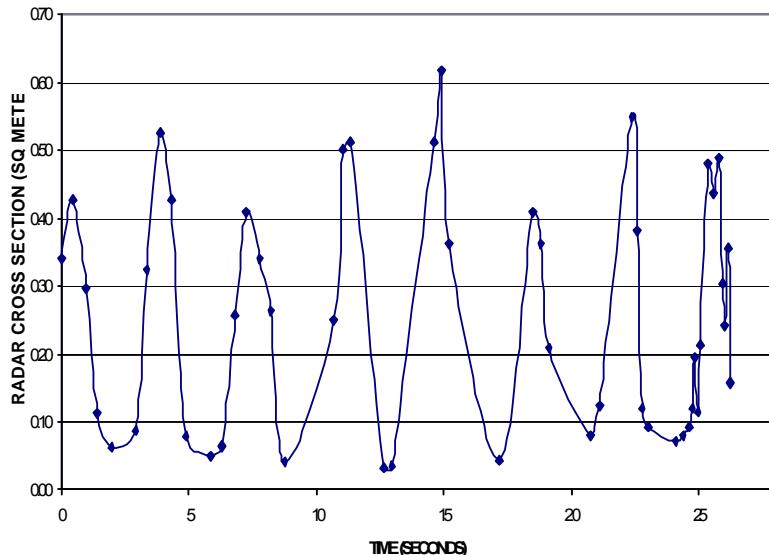
Figure 7-8: Cape Cod Track on January 18, 2029Z [2]

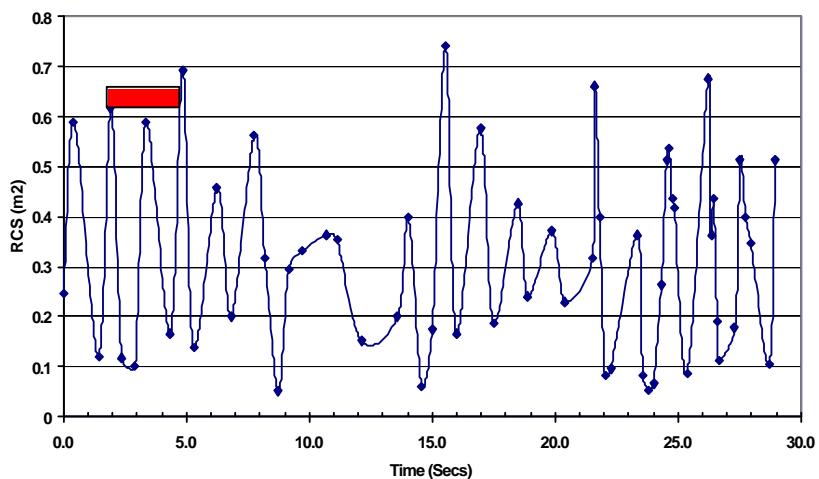
Figure 7-9: Cape Cod Track on January 19, 1539Z [2]

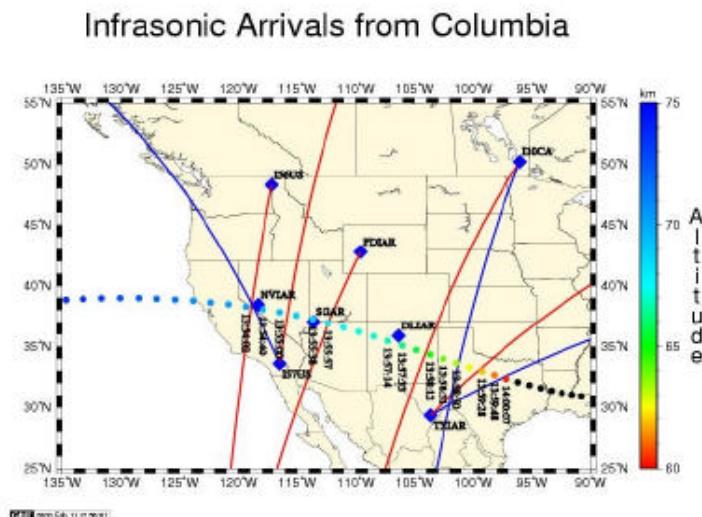
The Orbiter was first detected as it crossed the California coast and was observed all the way to break-up over Texas. All stations observed multiple signals associated with sound generated during the entry. These signals may be explained by various atmospheric multi-pathing phenomena, but it is possible that some come from debris. When combining the data with the entry trajectory, it was concluded that there do not appear to be other sources of infrasound in the vicinity of the Orbiter. [18]

Figure 8-1: Projected track, altitude, time GMT, and infrasonic detections for the Columbia reentry based on using PMCC with time windows greater than 30 s.  
(The red lines indicate the observed azimuth of the first arrival, and the blue lines the azimuth of any secondary arrivals.) [18]

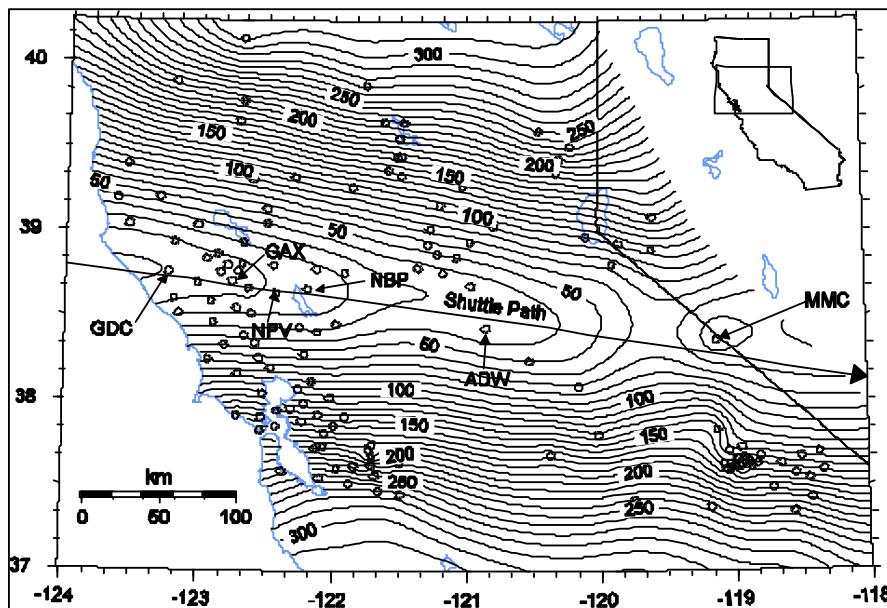
Several stations recorded the bow shock wave as well as some secondary signals associated with the Orbiter flyby. In order to assess unique features of this entry, NASA provided the STS 107 trajectory and four past missions that over flew the southwestern United States. Unfortunately the seismic stations do not routinely record non-earthquake data. Thus, very limited comparisons could be made to previous entries. However, this entry appeared consistent with others that have been observed in the past, and no distinctive features were seen in the STS-107 data. No specific conclusions could be made with regard to the secondary signals, and no obvious signals were present that indicated any debris impacts along the flight path. [19]

Figure 8-4. Contour map of observed arrival times of sonic boom from Space Shuttle Columbia. Contour interval is 10 s. Open circles depict locations of seismic stations recording the sonic boom. Shuttle path is shown as a straight arrow. [19]
